NOTICE OF VIOLATION

On June 4, 2024, Energy Safety conducted an inspection of PacifiCorp's WMP initiatives in the vicinity of the city of Mount Shasta, California. The inspection report is enclosed herewith. Energy Safety found the following violation:

INSPECTION REPORT

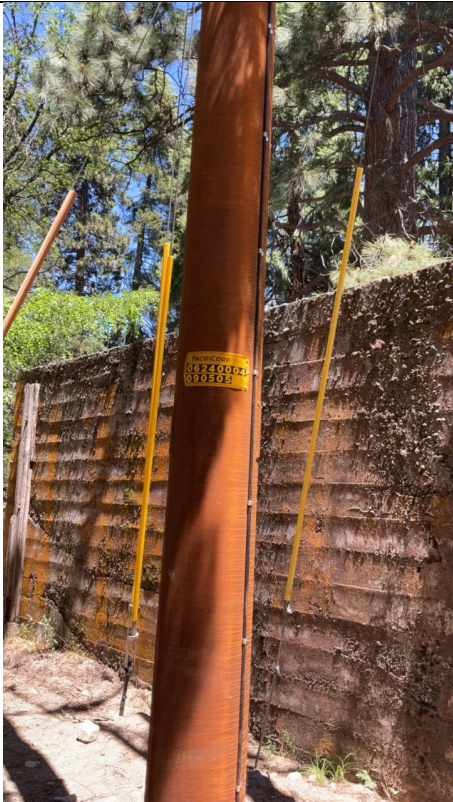
A close-up photograph of a utility pole. A yellow tag is attached to the pole with the text "STRUCTURE ID: 90505". The pole is surrounded by trees and a stone wall.

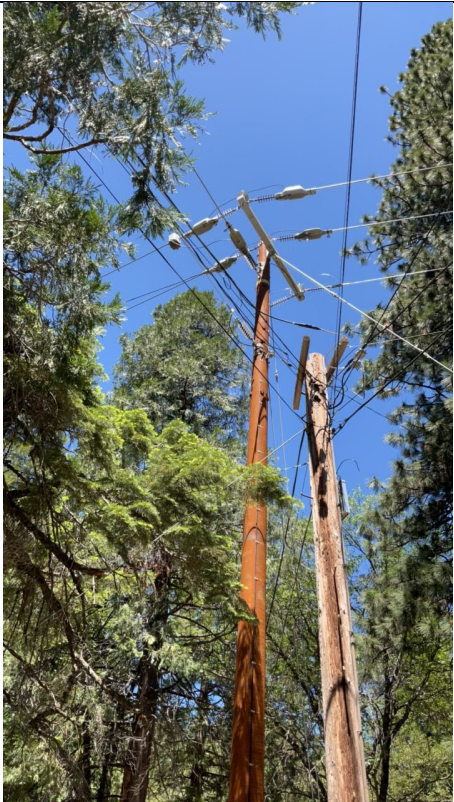
A photograph showing a utility pole with multiple cross-arms and wires. The pole is surrounded by trees and a clear blue sky.
<p>Item1Gimg1: Pole ID</p>	<p>Item1Gimg2: Assets on the pole</p>

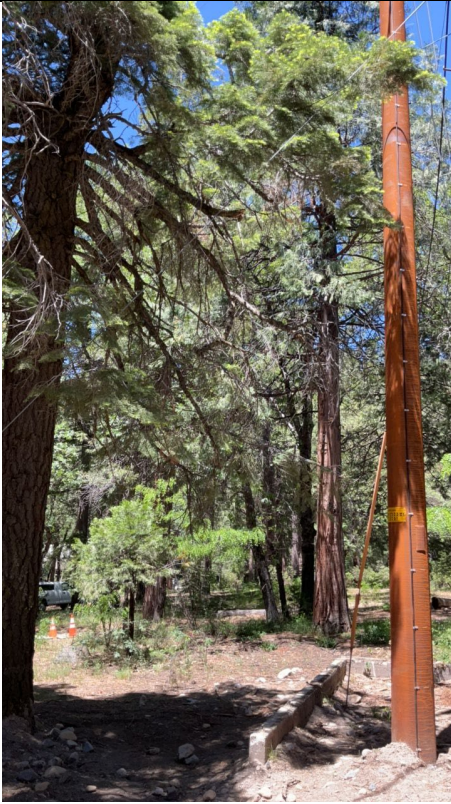
The reported location provided by PacifiCorp indicated that work per WMP initiative number 8.2.3.1.2- Pole Clearing was completed.⁹ The pole (ID 90505) is located in Mount Shasta City Park, near the intersection of Nixon Road and North Mount Shasta Boulevard and at GPS coordinates 41.3271629996257, -122.323769769563. The inspector observed a white fir tree with dead branches within the 10-foot radius of the pole and approximately 10 feet from ground. The inspector's observation is documented in Violation 1 photographs, which are attachments to this report. Photo numbers Item1IA1Img1, Item1IA1Img2, Item1IA1Img3, Item1IA1Img4 depict dead branches approximately 10 feet from ground.

Energy Safety concludes that Violation 1 is "Minor" because the branches within the 10-foot radius are not near the conductors.

Item1IA1Img1: Dead branches are within the 10-foot radius of the pole and approximately 10 feet from the ground.

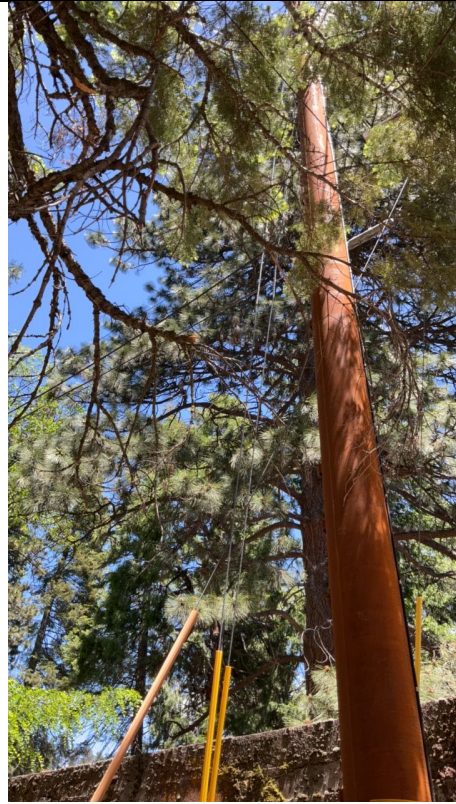
Item1IA1Img2: Dead branches are within the 10-foot radius of the pole and approximately 10 feet from the ground.
