NOTICE OF VIOLATION

Violation 1. Energy Safety observed that in implementing 2024 WMP initiative 8.1.3.1 – Distribution Detailed Inspections and Remediations, SCE failed to completely remediate a damaged secondary neutral on pole ID 1601717E, Grid Hardening ID 413647057-1601717E, at coordinates 37.1972558377877 -119.201249924051. Energy Safety considers this completeness violation to be in the Moderate risk category.

INSPECTION REPORT

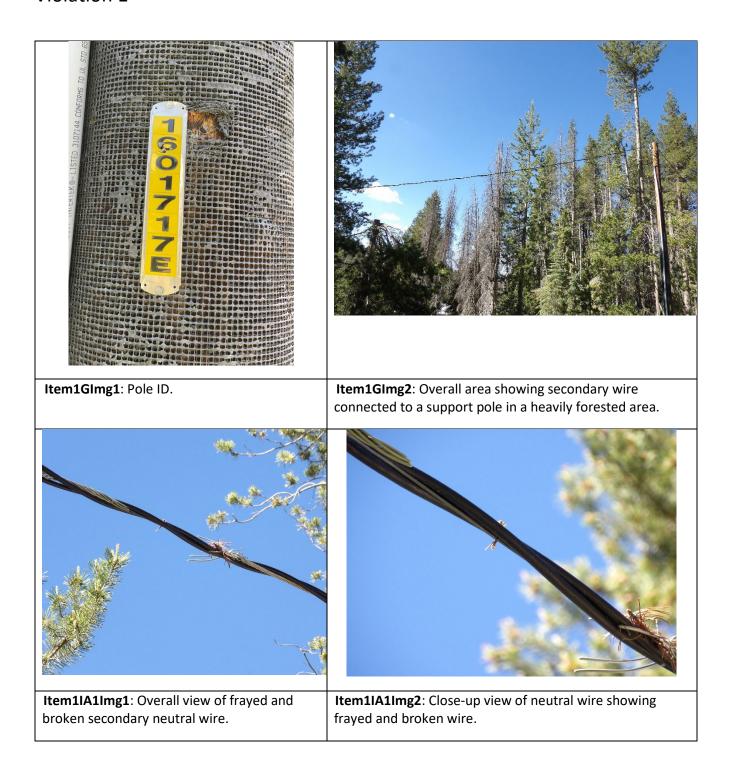
Exhibit A: Photo Log Structure ID: 1601717E Violation 1

On pole ID 1601717E, Grid Hardening ID 413647057-1601717E, at 55451 Flintridge Ave, Lakeshore, CA 93634, 37.1972558377877, -119.201249924051, SCE reported the completed work as: repaired a damaged/broken distribution secondary cable/conductor on pole (REPAIR DAMAGE SEC CBL/CND POLE). Upon arrival Energy Safety observed a frayed and damaged distribution secondary neutral wire. The inspector's observation is documented in Violation 1 photographs, which are attachments to this report. Photo numbers Item1GImg1, Item1GImg2, Item1IA1Img1, and Item1IA1Img2 depict a frayed and damaged distribution secondary neutral wire connected by one unbroken strand.

- Southern California Edison's 2024 WMP initiative 8.1.3.1 Distribution Detailed Inspections and Remediations reported REPAIR DAMAGE SEC CBL/CND POLE work as completed at pole ID 1601717E.
- 2. The pole is within High Fire Threat District (HFTD) Tier 3, and a heavily forested area.
- 3. The secondary neutral wire is frayed and broken connected by one unbroken strand.
- 4. This one unbroken neutral strand is supporting the weight of the energized secondary conductors.
- 5. This one neutral strand is in danger of failing.

Energy Safety may prescribe a timeframe for resolution of a violation associated with the assigned risk category.² Within 30 days from the issuance date of this NOV, the electrical corporation must provide a response advising Energy Safety of corrective actions taken or planned to remedy the above identified violation(s) and prevent recurrence. Alternatively, the electrical corporation must advise Energy Safety that it will not correct the violation, including the reasoning or justification for inaction and all supporting documentation.³ SCE should note that, in the case of this NOV, the violation is expected to be corrected within two months of receipt of this NOV.
