NOTICE OF VIOLATION

INSPECTION REPORT

Electrical Corporation:	Bear Valley Electric Service, Inc. (BVES)
Report Number:	NOV ESD_BVES_GCA_20240806_1158
Inspector:	Gary Candelas
WMP Year Inspected:	2024
Quarterly Data Report (QDR) Referenced:	Quarter 1 (Q1)
Inspection Selection:	Energy Safety inspected the locations based on BVES's Q1 QDR.
Relevant WMP Initiative(s):	8.2.3.3- Clearance (VM-9)
Date of inspection:	August 6, 2024
City and/or County of Inspection:	Sugarloaf, California
Inspection Purpose:	Assess the accuracy of BVES's QDR data, completeness of its work, compliance with WMP requirements, and compliance with its protocols.

Exhibit A: Photo Log

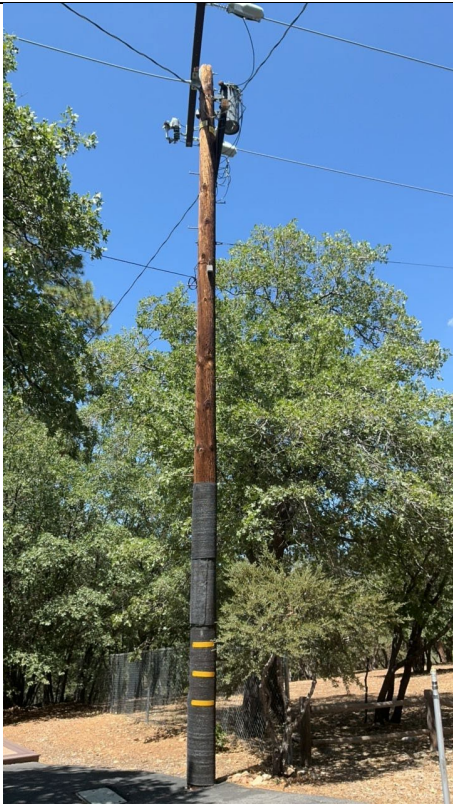
<p>Item1Gimg1: Image of pole P_9919 from Inyo Avenue as reference point.</p>	<p>Item1IA1img1: View from pole looking north to oak tree branches within 72 inches of the conductor. Oak tree shows evidence of previous trimming for utility vegetation management.</p>

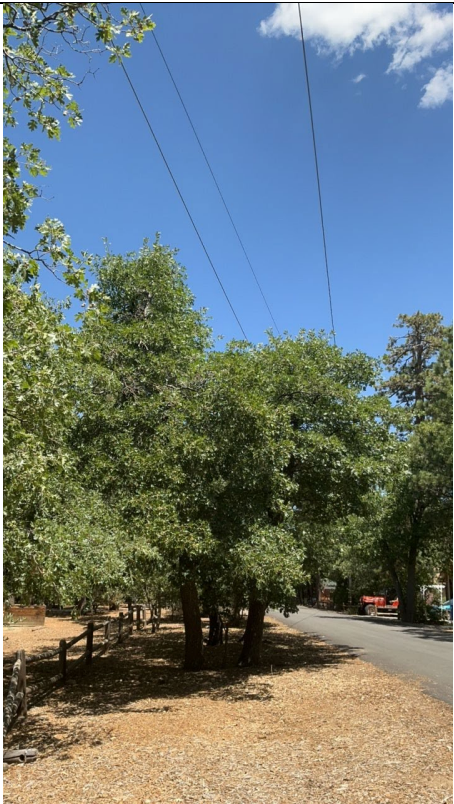
BVES reported that work for clearing program (VM-09 WMP initiative number 8.2.3.3) in this area had been completed. BVES's Q1 QDR data indicated that the trees along the primary conductor span were trimmed in March 2024. At 0.2 span north from pole P_9919, near GPS coordinates 34.2423475941069, -116.837331151718, the inspector observed that an oak tree was growing directly under the conductors and had branches that were within the 72-inch (6 feet) clearance distance required by BVES's WMP. The inspector measured both the tree height and conductor height at the insulator on the pole with Nikon Forestry Pro II laser rangefinder. The oak tree measured 339.6 inches (28.3 feet) in height to the tallest branch, and the conductor height at the insulator measured 354 inches (29.5 feet). The difference between the highest branch and the conductor was no more than 14.4 inches (1.2 feet), which conflicted with the 72-inch (6 feet) maintenance requirement stated in BVES's WMP. The inspector's observation is documented in Violation 1 photographs, which are attachments to this report. Photo numbers Item1IG1Img1, Item1IA1Img1, Item1IA1Img2, Item1IA1Img3 depicts the tree branches that were within 72 inches of the conductors.

Energy Safety concludes that Violation 1 is "Moderate" because the vegetation encroaching into the minimum clearance requirements may contact the conductor before BVES next inspects and trims or removes the tree.

In accordance with Energy Safety Guidelines,² within 30 days from the issuance of this NOV, BVES must provide a response informing Energy Safety of corrective actions taken or planned to remedy the above identified violation and prevent recurrence. Alternatively, should BVES disagree with the NOV, BVES must submit to Energy Safety a response stating it disagrees with the violation, the reason or justification for the disagreement

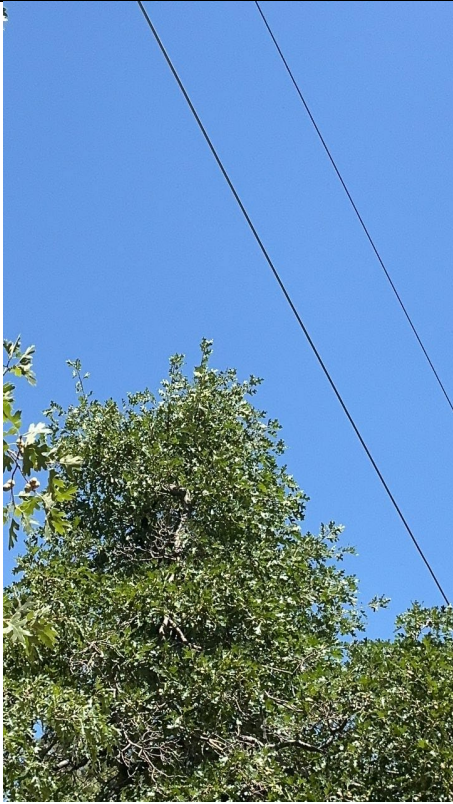
Item1IA1img2: Zoomed in image of oak tree branches of concern within 72 inches of the conductor. Inspector took the image 341.3 degrees north of the conductor.
