#### NOTICE OF VIOLATION

On August 7, 2024, Energy Safety conducted an inspection of SCE's WMP initiatives in the vicinity of the city of Simi Valley, California. The inspection report is enclosed herewith. Energy Safety found the following violation:

## **INSPECTION REPORT**

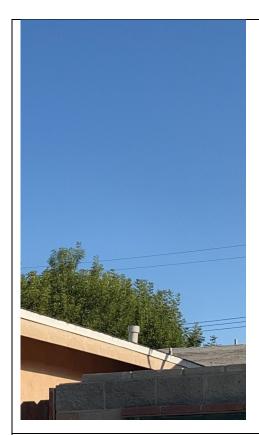
SCE reported that work for the Expanded Clearing program (VM-7 WMP initiative number 8.2.3.3.1) in this area had been completed. SCE's Q1 QDR data indicated that the subject tree was trimmed in March 2024. At mid-span east from pole ID 201839770, near GPS coordinates 34.269457880598, -118.712438057201, the inspector observed that an ash tree (*Fraxinus*) branch was within the 4-foot clearance distance and growing directly underneath the conductors. The inspector measured both the tree height and conductor height with the Nikon Forestry Pro II laser rangefinder. The ash tree measured 28.4 feet in height to the tallest branch, and the conductor height measured 30.5 feet. Therefore, the difference between the ash branch and conductor was no more than 2.1 feet, which conflicted with the requirement stated in SCE's WMP. The inspector's observation is documented in Violation 1 photographs, which are attachments to this report. Photo numbers Item1IA1Img1, Item1IA1Img2, and Item1IA1Img3 depict the ash tree branch that was within 4 feet of the conductors.

**Item1IA1Img1**: Ash tree breaking minimum clearance requirements. Photograph was taken facing 328.9 degrees northwest from Ish Drive.

In accordance with Energy Safety Guidelines,<sup>2</sup> within 30 days from the issuance of this NOV, SCE must provide a response informing Energy Safety of corrective actions taken or planned to remedy the above identified violation and prevent recurrence. Alternatively, should SCE disagree with the NOV, SCE must submit to Energy

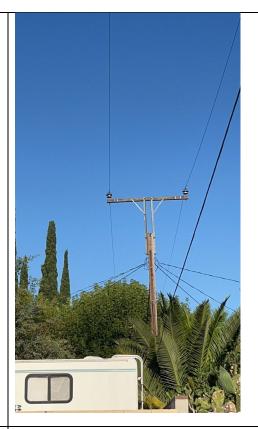
**Item1IA1Img2**: Ash tree breaking minimum clearance requirements. Tree appears to be growing directly under the lines and has evidence of previous vegetation management work. Photograph was taken facing 263 degrees west from Buyers Street.

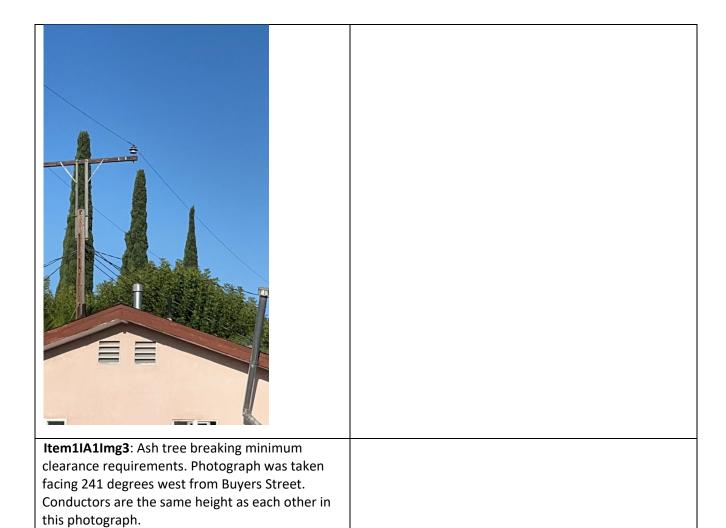
Energy Safety concludes that Violation 1 is "Moderate" because the vegetation encroaching into the minimum clearance requirements may contact the conductor before SCE next inspects and trims or removes the tree.
