NOTICE OF VIOLATION

INSPECTION REPORT

| Report Number: | NOV_ESD_SCE_GCA_20240807_0650 |
| Relevant WMP Initiative(s): | 8.2.3.3.1 Expanded Clearing (VM-07) |

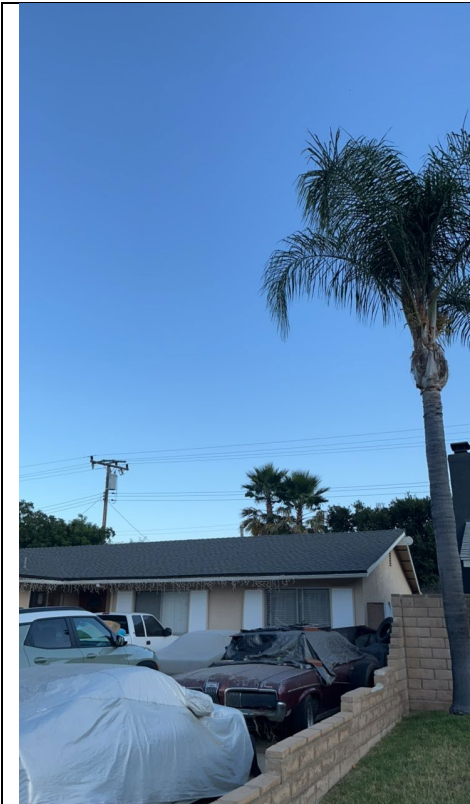
SCE reported that work for the Expanded Clearing program (VM-7 WMP initiative number 8.2.3.3.1) in this area had been completed. SCE's Q1 QDR data indicated that the subject palms were trimmed in March 2024. At 0.2 span in the northeast from pole ID 1538971E (behind 2127 Cheam Avenue in Simi Valley), near GPS coordinates 34.274415870592, -118.66467334529254, the inspector observed two California palms (*Washingtonia filifera*) growing under the conductor and had fronds that were within the 4-foot clearance distance requirement as indicated in SCE's WMP. The inspector measured both the palm height and conductor height with the Nikon Forestry Pro II laser rangefinder. The palms measured 28.1 feet in height to the tallest fronds, and the pole at the conductor height at the insulator measured 30.8 feet. The difference between the highest palm frond and the conductor was no more than 2.7 feet, which conflicted with the 4 feet requirement stated in SCE's WMP. The inspector's observation is documented in Violation 1 photographs, which are attachments to this report. Photo numbers Item1IA1Img1, Item1IA1Img2, Item1IA1Img3 depict the two California palms that were within 4 feet of the conductors.

Energy Safety concludes that Violation 1 is "Moderate" because the vegetation encroaching into the minimum clearance requirements may contact the conductor before SCE next inspects and trims or removes the palms.

Item1IA1Img1: California palms breaking minimum clearance requirements. Photograph was taken from the north side of the sidewalk along Cheam Avenue facing 298.3 degrees northwest.

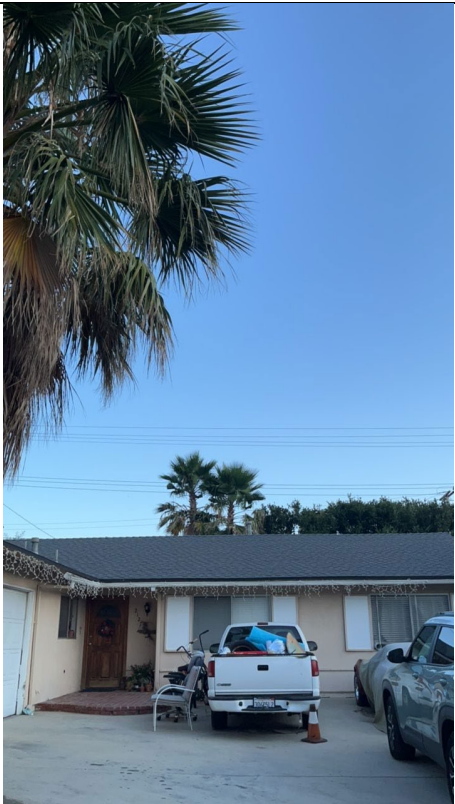
Item1IA1Img2: California palms breaking minimum clearance requirements. Photograph was taken from the south side of the sidewalk along Cheam Avenue facing 319.8 degrees northwest.

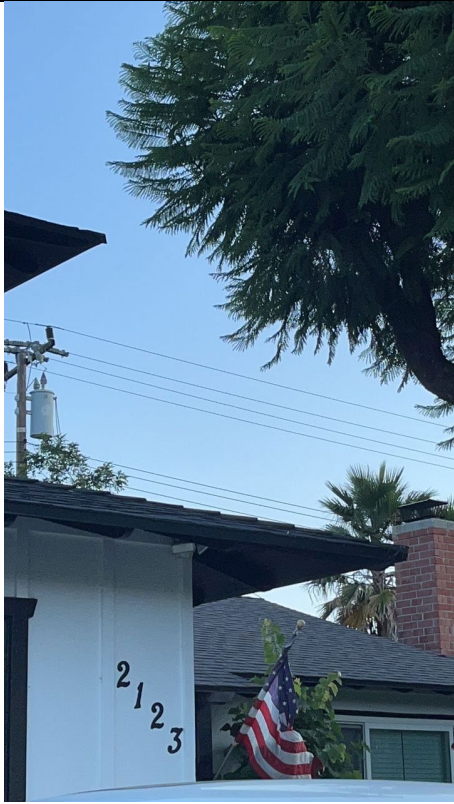
Item1IA1mg3: California palms breaking minimum clearance requirements. Photograph was taken from the north side of the sidewalk along Cheam Avenue facing 355.8 degrees north.
