October 1, 2024

BY ENERGY SAFETY E-FILING

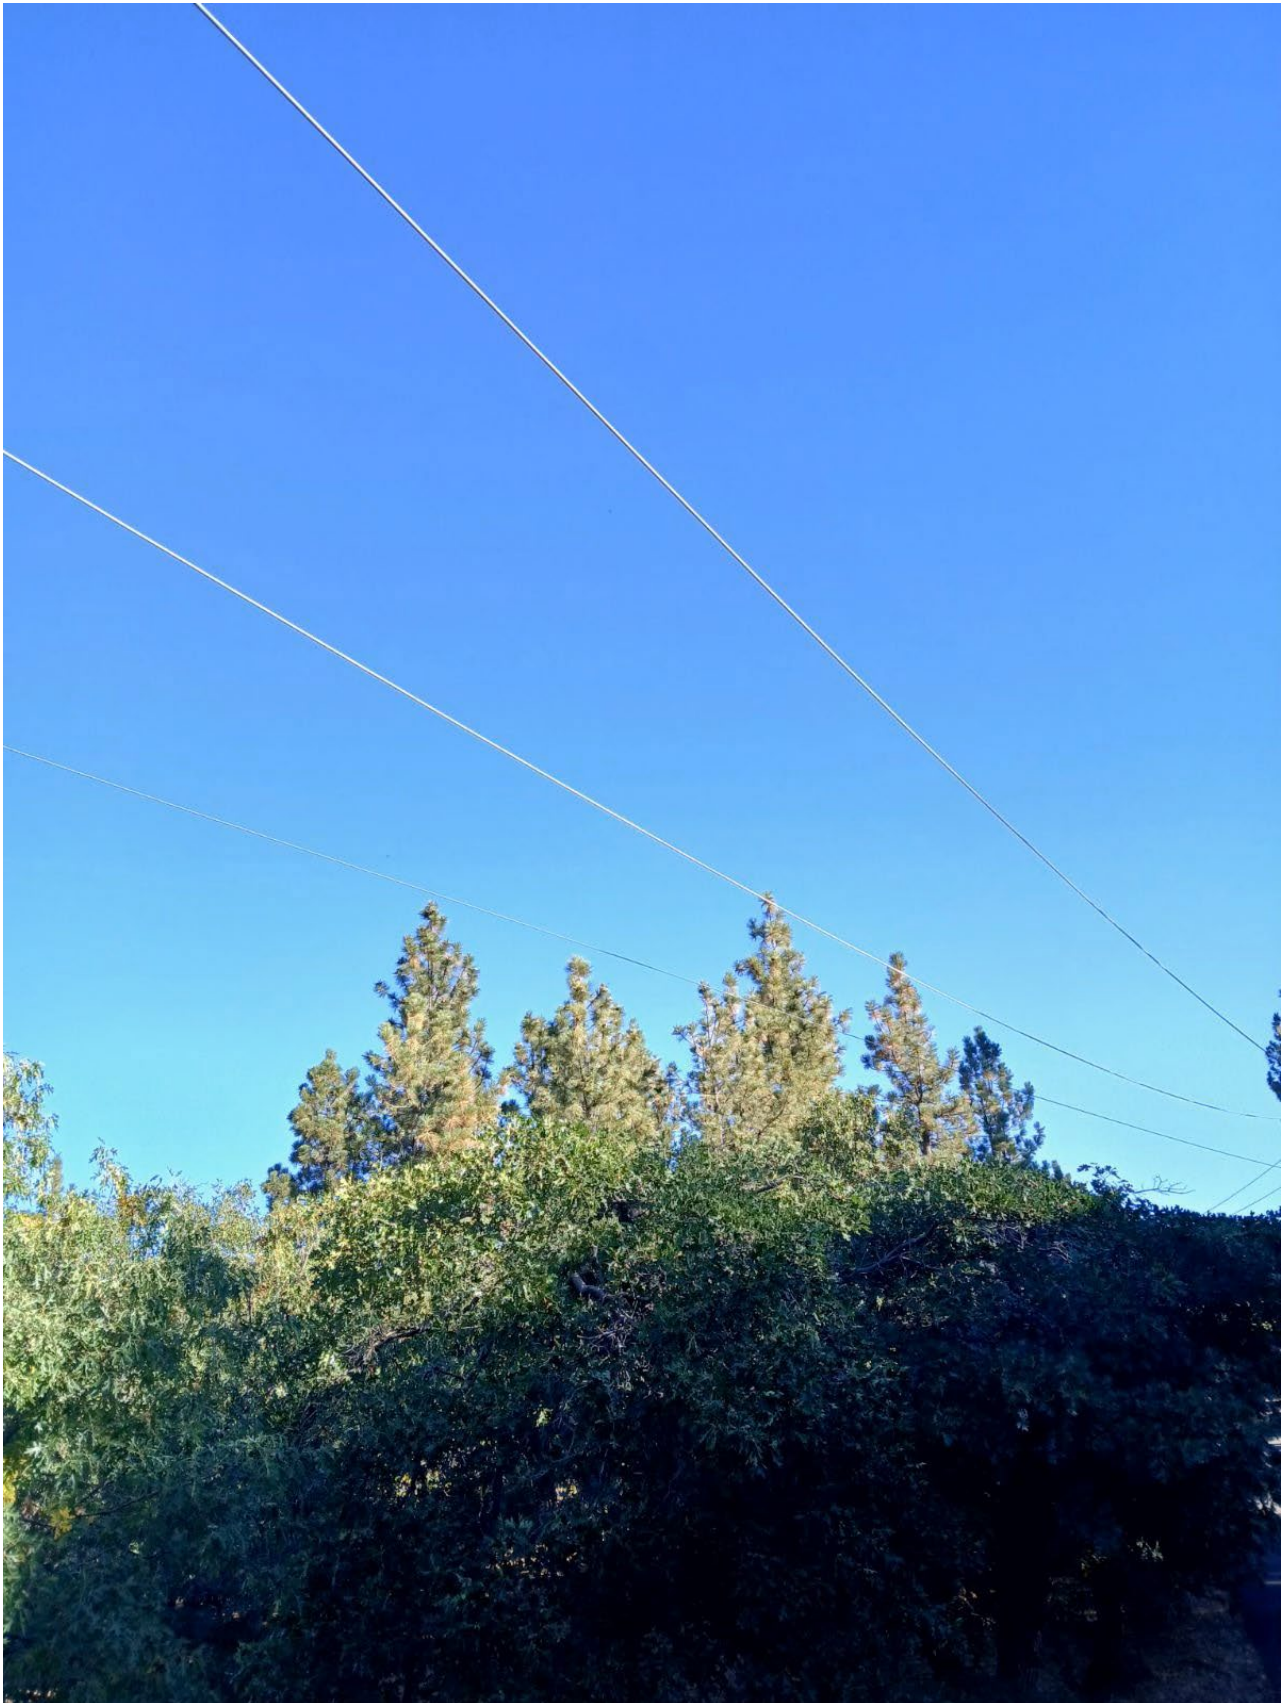
After Trimming on August 29, 2024
