NOTICE OF VIOLATION

INSPECTION REPORT

Electrical Corporation:	Liberty Utilities
Report Number:	NOV ESD_LU_KJO_20241008_0823
Inspector:	Kelsea Jones
WMP Year Inspected:	2024
Quarterly Data Report (QDR) Referenced:	Quarter 2 (Q2)
Inspection Selection:	Energy Safety inspected the locations based on Liberty’s Q2 QDR.
Relevant WMP Initiative(s):	8.2.3.3 Clearance (WMP-VM-VFM-05)
Date of inspection:	October 8, 2024
City and/or County of Inspection:	Kings Beach, California
Inspection Purpose:	Assess the accuracy of Liberty’s QDR data, completeness of its work, compliance with WMP requirements, and compliance with its protocols.

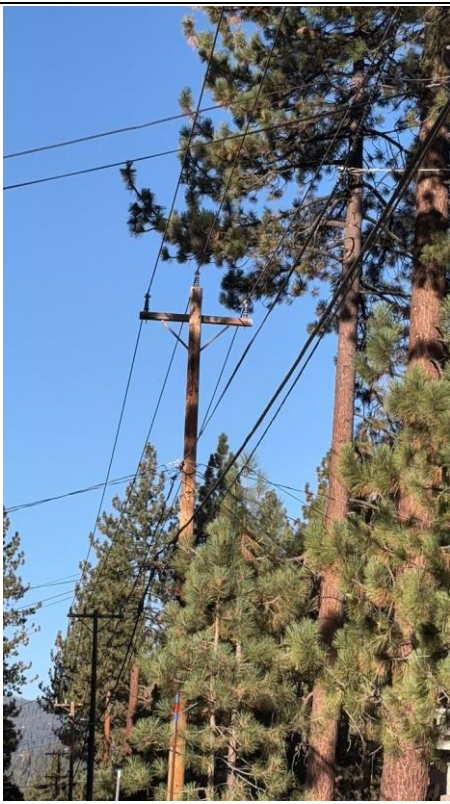
Liberty's Q2 QDR reported that work to achieve a 12-foot radial clearance distance (WMP-VM-VFM-05 initiative number 8.2.3.3) for trees along this span was completed in May 2024. At 0.1 span north of pole ID 286848 (in front of 8465 Cutthroat Avenue in Kings Beach), near GPS coordinates 39.242530, -120.023469, the inspector observed a Jeffrey pine (*Pinus jeffreyi*) with limbs within 12 feet of conductors. The inspector measured the distance between the pine and the conductor with a Nikon Forestry Pro II laser rangefinder. One limb overhanging above the lines measured approximately 6.5 feet away from the covered conductors. The inspector observed clearance work along this span, including at the subject tree. However, this pine was not trimmed enough to achieve the "Maintenance Clearance Distance" as outlined in the WMP. The inspector's observations are documented in Violation 1 photographs, which are exhibits to this report. Photo numbers Item1IA1Img1, Item1IA1Img2, Item1IA1Img3 shows the limb violating maintenance clearance distances.

Energy Safety concludes that Violation 1 is "Minor" because the vegetation may contact the covered conductor during snow/ice loading conditions and cross phase before Liberty next inspects and trims the span, but limbs closer to the conductors were removed in this vegetation management cycle.

Item1IA1mg1: View of Jeffrey pine with limb that could contact both conductors and cause arcing between the two phases. Evidence of previous vegetation work, including limb removal on the subject tree. Photograph taken from Cutthroat Avenue facing west. Tree is north of pole 286848. Zoomed.

In accordance with Energy Safety Guidelines,² within 30 days from the issuance of this NOV, Liberty must provide a response informing Energy Safety of corrective actions taken or planned to remedy the above identified violation and prevent recurrence. Alternatively, should Liberty disagree with the NOV, Liberty must submit to Energy Safety a response stating it disagrees with the violation, the reason or justification for the disagreement and all supporting documentation.³ This response shall be filed in the Energy Safety e-Filing

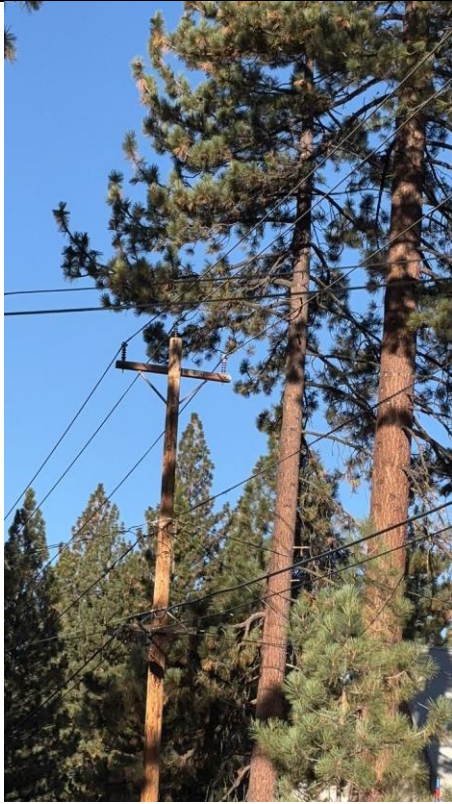
Item1IA1mg2: Photograph taken from Cutthroat Avenue facing west. Tree is north of pole 286848. Zoomed.
