NOTICE OF VIOLATION

INSPECTION REPORT

Electrical Corporation:	San Diego Gas & Electric Company
Report Number:	CAD_SDGE_LOK_20241009_0804
Inspector:	Lovepreet Kaur
WMP Year Inspected:	2024
Quarterly Data Report (QDR) Referenced:	Quarter 2 (Q2)
Inspection Selection:	Energy Safety viewed the contents of the Q2 QDR and performed an analysis that resulted in the selection of the WMP initiatives and locations referenced in this report.
Relevant WMP Initiative(s):	8.1.2.10.1 Avian Protection Program (WMP.972)
Date of inspection:	October 9, 2024
City and/or County of Inspection:	El Cajon, San Diego County
Inspection Purpose:	Assess the accuracy of SDG&E’s QDR data, completeness of its work, compliance with WMP requirements, and compliance with its protocols.

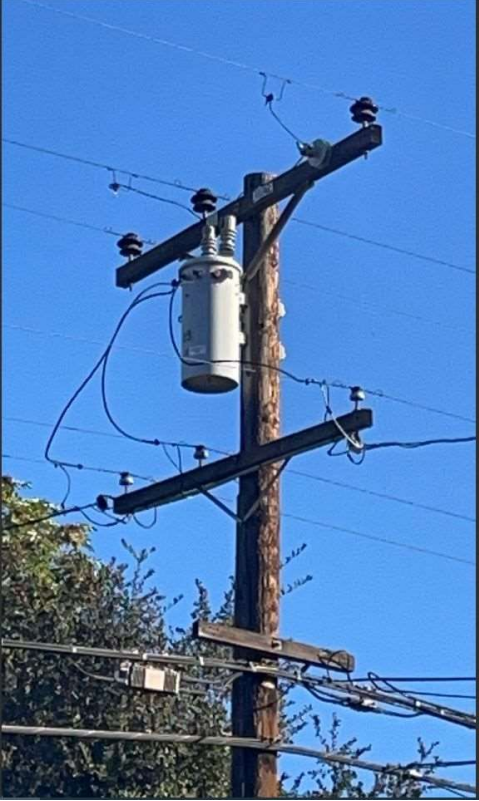
On Pole ID P76656, Grid Hardening ID 530000350444-P76656 at 15532 Olde Highway 80, El Cajon, CA, 92021, USA, 32.85594773165022, -116.8373373489954 the inspector observed that avian protection covers were not installed. The inspector's observation is documented in Violation 1 photographs, which are attachments to this report. Photo numbers Item1Gimg1, Item1Gimg2, and Item1IA1img1 depict that no avian protection covers were installed.

A close-up photograph of a utility pole showing a transformer and various electrical components. The transformer and other parts are not covered with avian protection covers, which is a violation.
<p>Item1IA1img1: No avian protection covers</p>
