NOTICE OF VIOLATION

INSPECTION REPORT

Electrical Corporation:	Liberty Utilities
Report Number:	CAD_LU_CAC17_20241016_0916
Inspector:	CAC17
WMP Year Inspected:	2024
Quarterly Data Report (QDR) Referenced:	Quarter 2 (Q2)
Inspection Selection:	Energy Safety viewed the contents of the 2024 Q2 QDR and performed an analysis that resulted in the selection of the WMP initiatives and locations referenced in this report.
Relevant WMP Initiative:	8.1.2.3 Distribution Pole Replacements
Date of inspection:	October 16, 2024
City and County of Inspection:	South Lake Tahoe, El Dorado County
Inspection Purpose:	Assess the accuracy of Liberty Utilities’ QDR data, completeness of its work, compliance with WMP requirements, and compliance with its protocols.

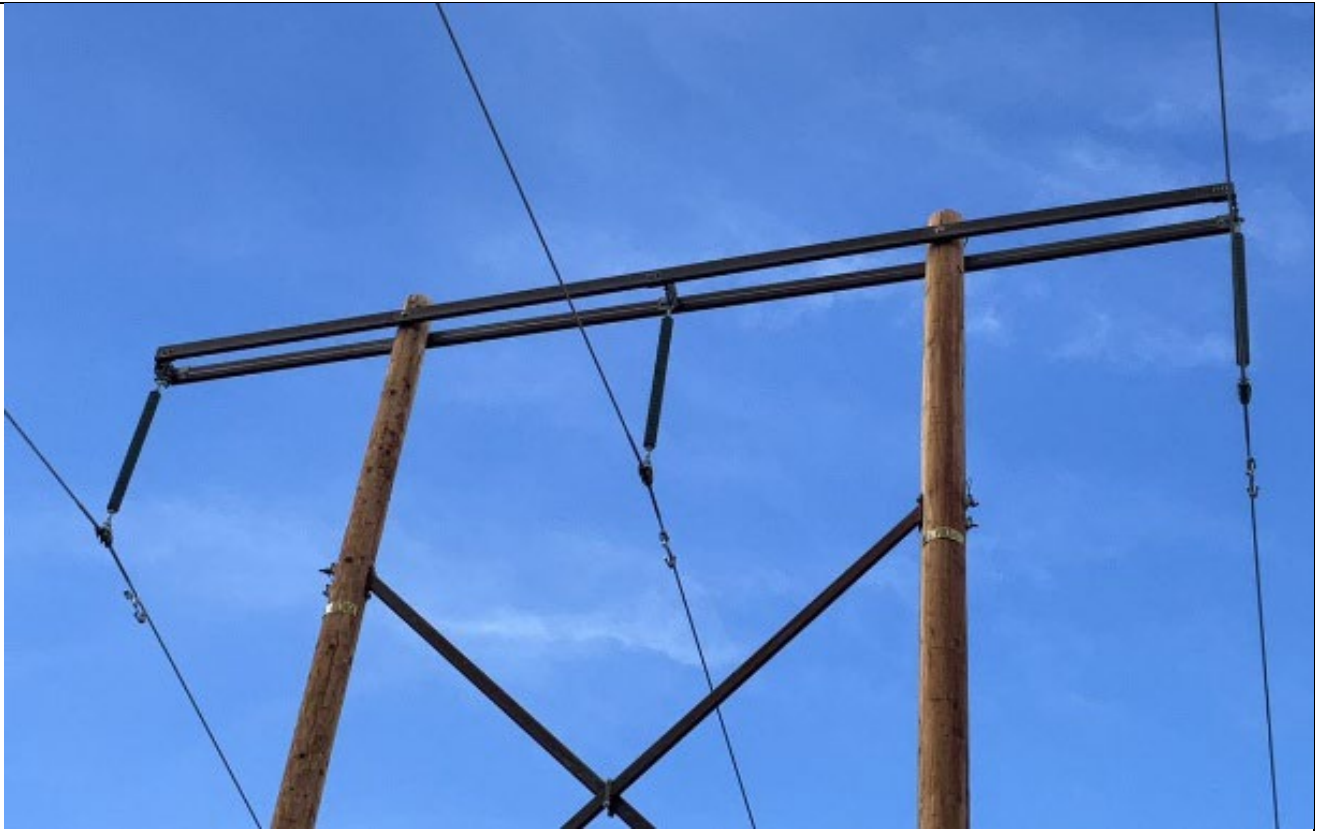
On Pole ID 296943, Grid Hardening ID c08ef8ff-b904-4b2c-9b7a-f5ec4d02185e, near the Meyers substation, South Lake Tahoe, CA, USA (or approximately 2,500 feet due south from 2039 High Meadow Trail, South Lake Tahoe, CA, USA), 38.891428, -119.958043, the inspector observed a transmission-only H-structure where Distribution Pole Replacements initiative work was reported. The inspector's observation is documented in Violation 1 photographs, which are attachments to this report. Photo numbers Item1IA1Img1, Item1IA1Img2, Item1IA1Img3, and Item1IA1Img4 depict a 120 kV transmission H-structure with no distribution lines.

Item1IA1Img3: New steel crossarms for 120 kV transmission structure with no distribution conductors

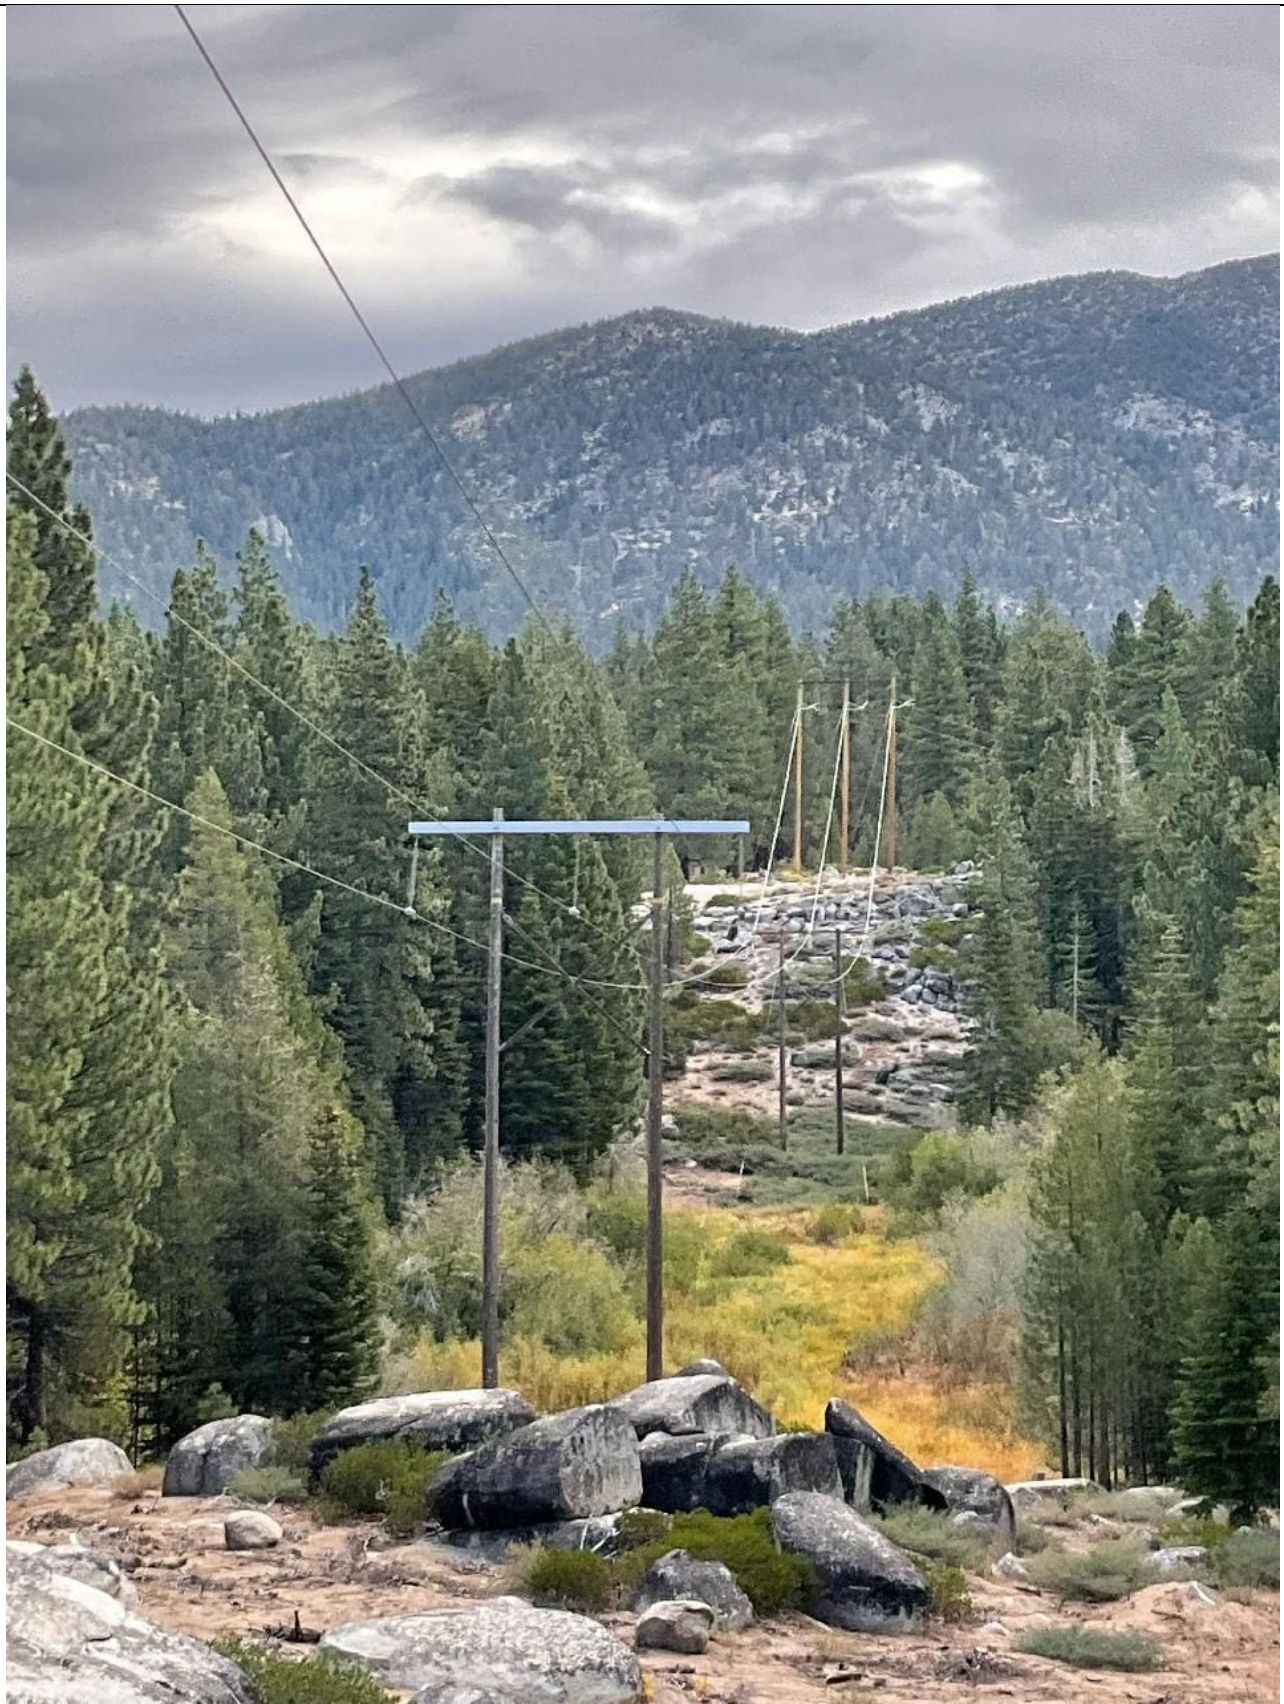
Item1IA1Img4: Overall section of 120 kV transmission line 111 with no distribution conductors

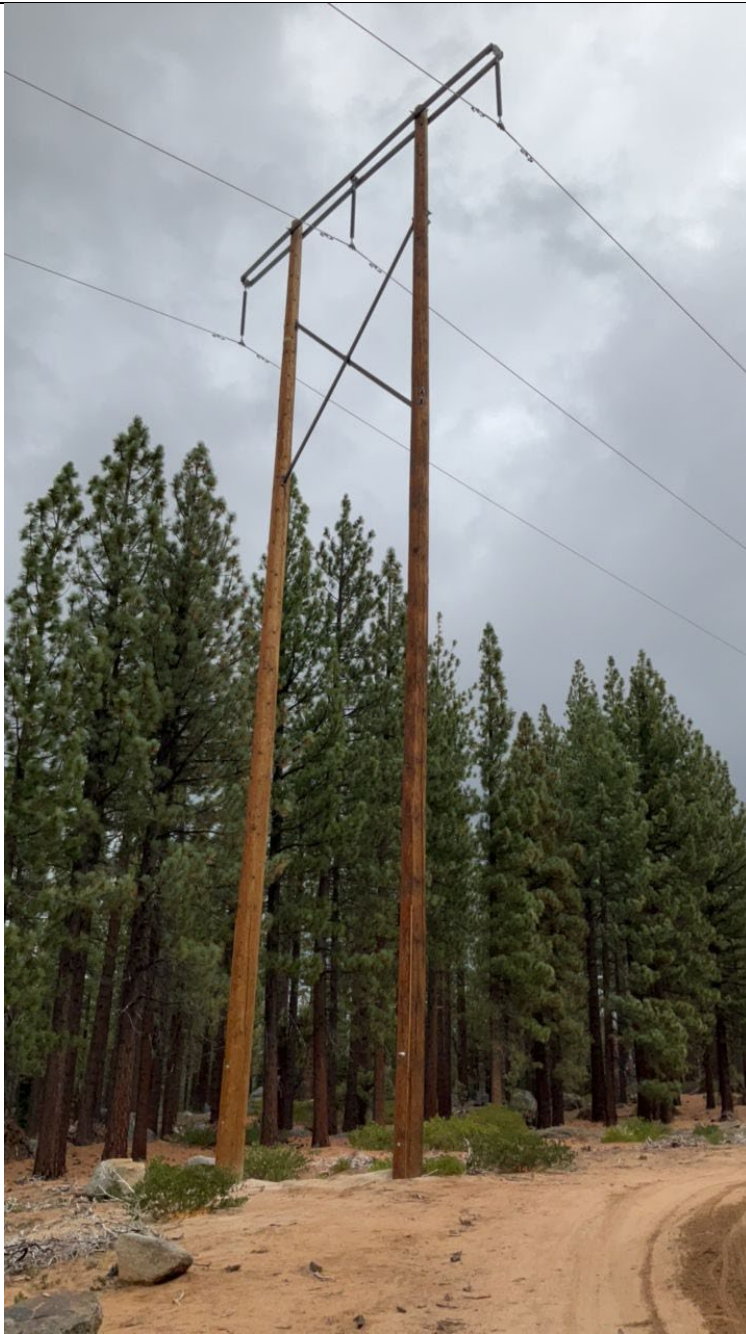
On Pole ID 296938, Grid Hardening ID 3e844e3d-4274-4b58-b89f-4d9b01e6d81f, near the Meyers substation, South Lake Tahoe, CA, USA (or approximately 2,200 feet due southeast of 1784 Pioneer Trail, South Lake Tahoe, CA), 38.885092, -119.970193, the inspector observed a transmission-only H-structure where Distribution Pole Replacements initiative work was reported. The inspector's observation is documented in Violation 2 photographs, which are attachments to this report. Photo numbers Item2IA1Img1, Item2IA1Img2, and Item2IA1Img3 depict a 120 kV transmission H-structure with no distribution lines.

Item2IA1Img3: New steel crossarms for 120 kV transmission structure with no distribution conductors
