**RE: San Diego Gas & Electric Company's Response to Notice of Violation – NOV
ESD_SDGE_CAC23_20240924_1133**

A. Violation 1 – Wood and Slash Management, Failure to Adhere to Protocol near P414181.

Open NOV Update: NOV ESD CAC23 20240924 1133

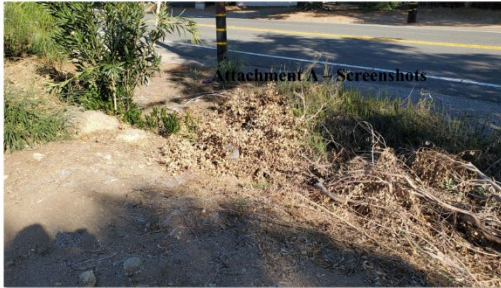
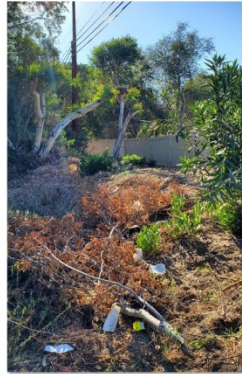
1

Trees trimmed by 3rd-party include oak.
No oak was assigned to SDG&E tree contractor to work.

SDG&E investigated this NOV related to tree trimming debris left in the field on December 20, 2024. On that date, SDG&E interviewed the adjacent property owner who stated that he had hired a contractor to perform tree trimming within and adjacent to his property. That contractor performed the work in September, 2024. He acknowledged the debris was likely the result of his hired contractor, apologized for the confusion, and stated he would have his contractor return to complete the clean-up.

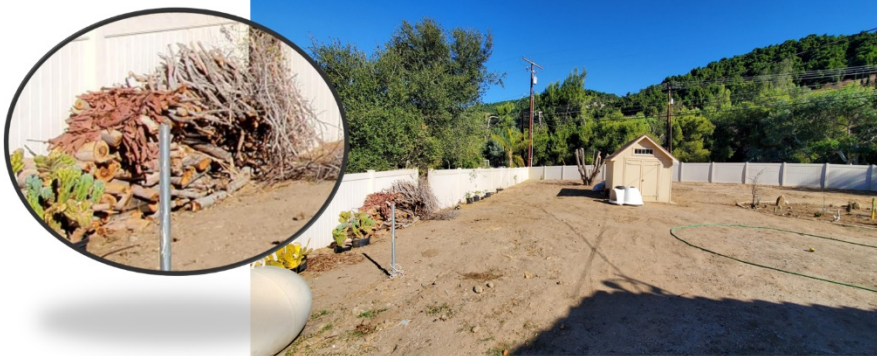
2

Debris cleared and stacked by 3rd-party contractor inside property.

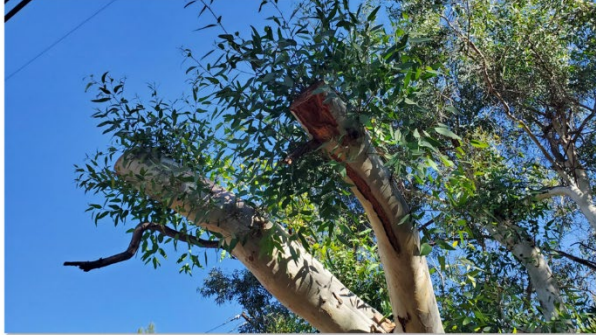
3

Improper pruning cuts (“heading”; “stubbing”) made by 3rd-party.
Post-pruning resprouting consistent with ~ 2-3 months’ growth

SDG&E further corroborates the debris left on site was not related to its line-clearance operations based on the following: 1) SDG&E performed line clearance tree trimming on June 5, 2024, more than three months prior to the date the third-party performed work. The condition of the tree debris on the ground did not comport with the elapsed time following SDG&E trimming. 2) The presence of topping or heading cuts on the trees is not consistent with SDG&E trimming. 3) The amount of resprouting at the point where cuts were made is consistent with the timeframe following the third-party trimming.

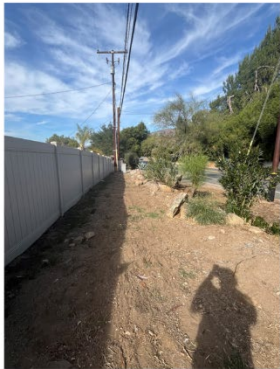
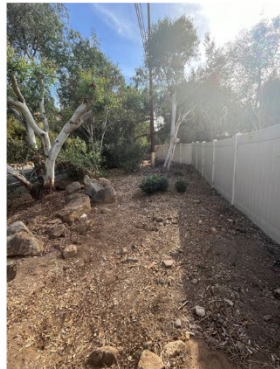
4

12/23/24 - All vegetation debris removed by 3rd-party

A follow-up visit by SDG&E on December 23, 2024 confirmed that the property owner had removed all remaining tree trimming debris from the site.
