NOTICE OF VIOLATION

On January 16, 2025, Energy Safety conducted inspections of PacifiCorp's WMP initiatives in the vicinity of the city of McCloud. The inspection report is enclosed herewith. Energy Safety found the following violation:

Violation 1. Energy Safety observed that in implementing 2024 WMP initiative 8.2.3.2 – Clearance (VM-03), PacifiCorp failed to achieve completeness of required clearance near pole ID 132403, at coordinates 41.22475828, -122.14927276 in a High Fire Threat District (HFTD) Tier 2 area. Energy Safety considers this violation to be in the "Minor" risk category.

INSPECTION REPORT

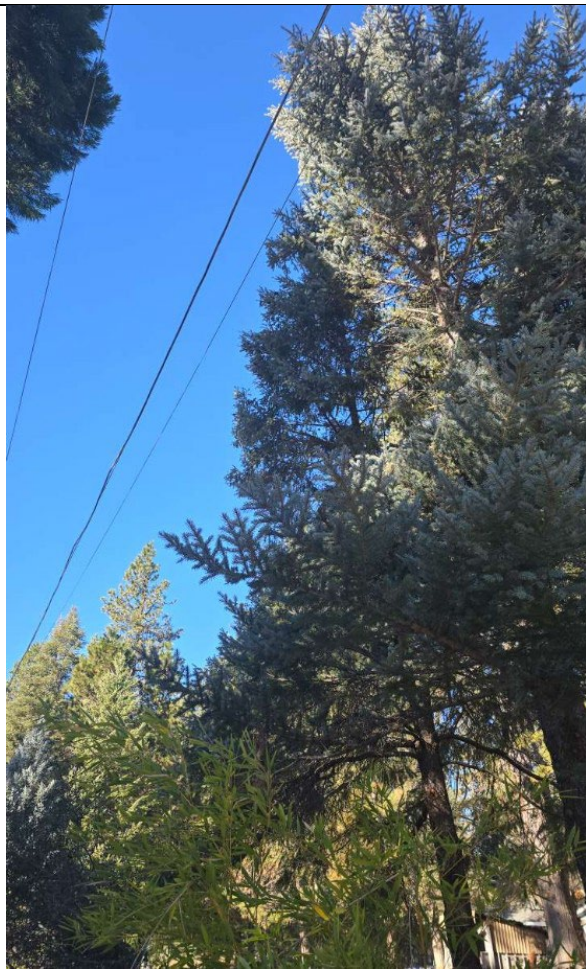
Energy Safety concludes that Violation 1 is "Minor" because the growth rate for the Douglas fir (*Pseudotsuga menziesii*) suggests it will not encroach upon the conductor before the 12-month mitigation timeframe but should be remediated prior to the next planned routine maintenance program inspection in 3 years.

PacifiCorp reported that it completed vegetation clearance work to achieve 12-foot radial clearance distance under its vegetation clearance program (WMP initiative number 8.2.3.2) near pole ID 132403. According to PacifiCorp's DR 291, PacifiCorp trimmed a 43-foot tall and 12-inch diameter at breast height Douglas fir along Papoose Lane near GPS coordinates 41.22475828, -122.14927276 in August 2024. Although the inspector observed clearance work at the subject tree, this Douglas fir was not trimmed enough to achieve the minimum clearance distance as outlined in the WMP. Using a Nikon Forestry Pro II laser rangefinder, the inspector measured the closest overhanging branch of the subject tree at 7.7 feet above the conductor. The slow-growing nature of the Douglas fir and the fact that other branches on the tree show signs of earlier trims indicate that PacifiCorp did not complete the trim work according to its WMP. The inspector's observations are documented in Violation 1 photographs, which are exhibits to this report. Photos 1 through 4 show that reported work at the location did not meet the 12-foot clearance requirement.

Photo 3: Douglas fir branch 7.7 feet from distribution conductor. Photo taken facing northeast from the pole.

Energy Safety has designated this violation as minor risk. PacifiCorp must correct the violation pursuant to the timeline provided in Table 1.⁶

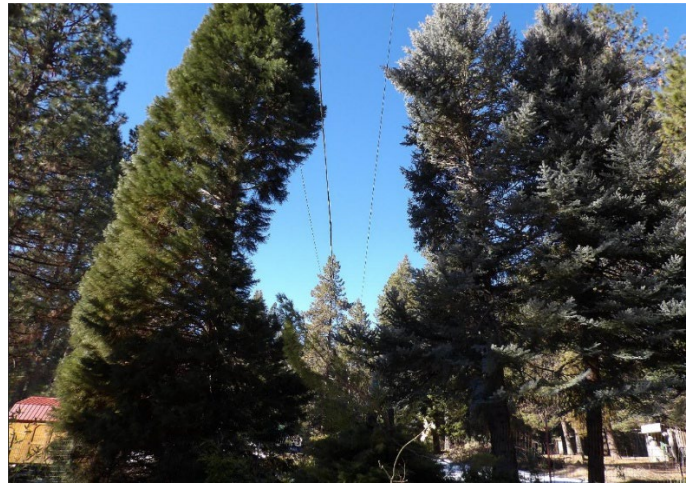
Photo 4: Douglas fir branch (seen in top third of the tree on the right side of the photo) is within 7.7 feet of distribution conductors.
