**CALIFORNIA UNDERGROUND FACILITIES SAFE EXCAVATION BOARD
INVESTIGATION DIVISION
INVESTIGATION REPORT**

DATE: February 7, 2025
CASE No.: 23NTS00002

Executive Summary:

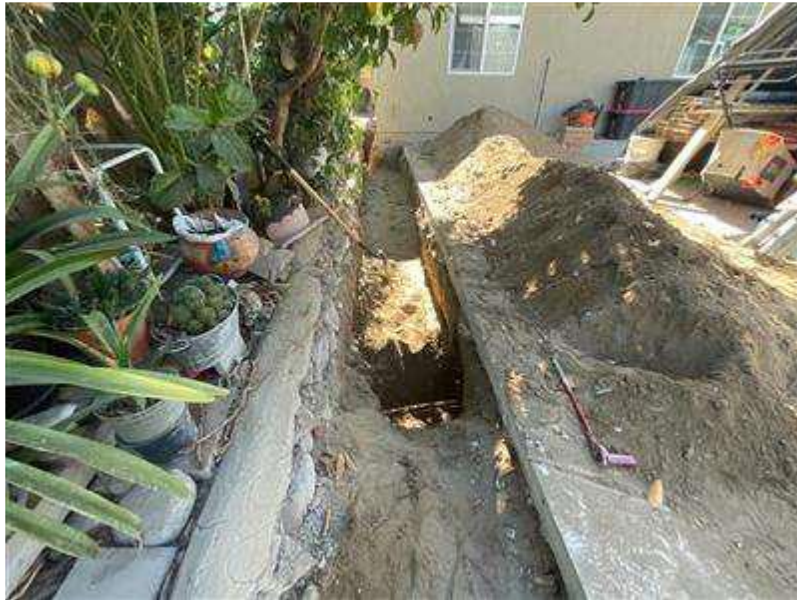
Photo 1 provided by Southern California Gas Company depicts the backyard jobsite. (Exh. 1.)

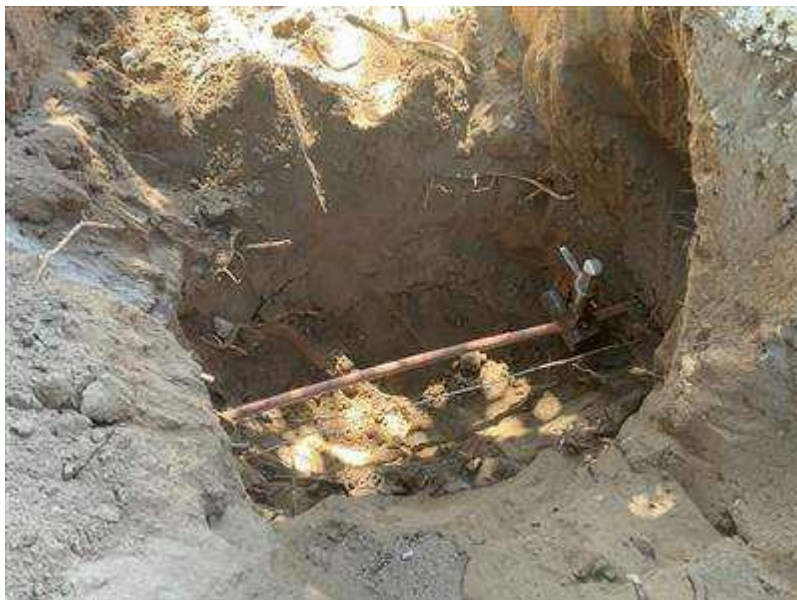
Regarding the excavation and damage to the natural gas line, Supervisor Medina explained in his interview that Robert Morfin, the sole excavator at the jobsite, was using a shovel to dig the backyard trench. Morfin, cutting through tree roots with a shovel, cut natural gas line approximately halfway through causing a leak. There were no explosions or injuries. (Exh. 2.)

Photo 2 provided by Southern California Gas Company depicts the half-inch natural gas line. (Exh. 1.)

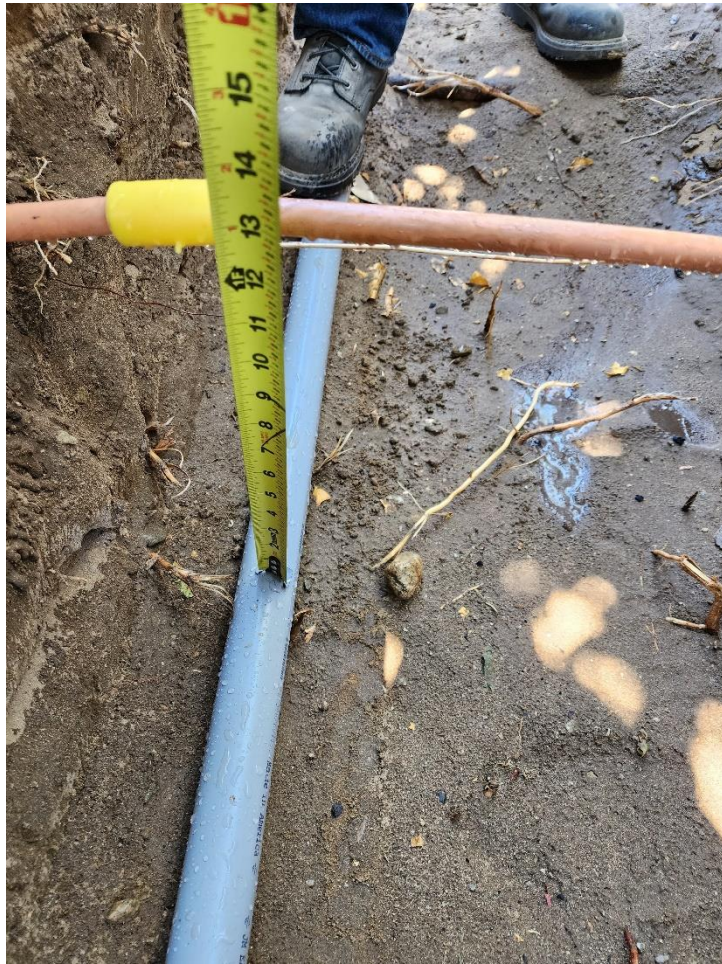
Photo 3 provided by ARM Construction depicts the half-inch natural gas line. (Exh. 4.)

On July 27, 2023, you sent me a brief email that said, "I only have the repair' with an attachment of a picture of a trench, 2 lines and a measuring stick.

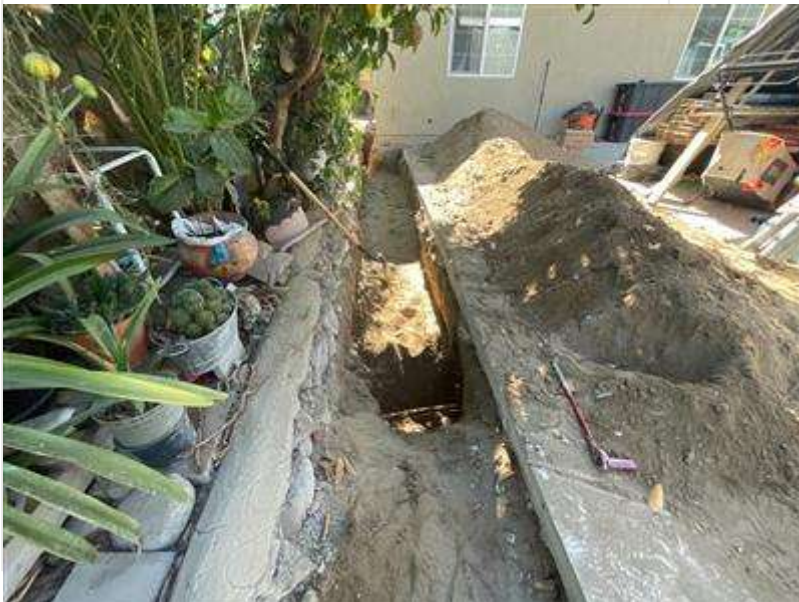
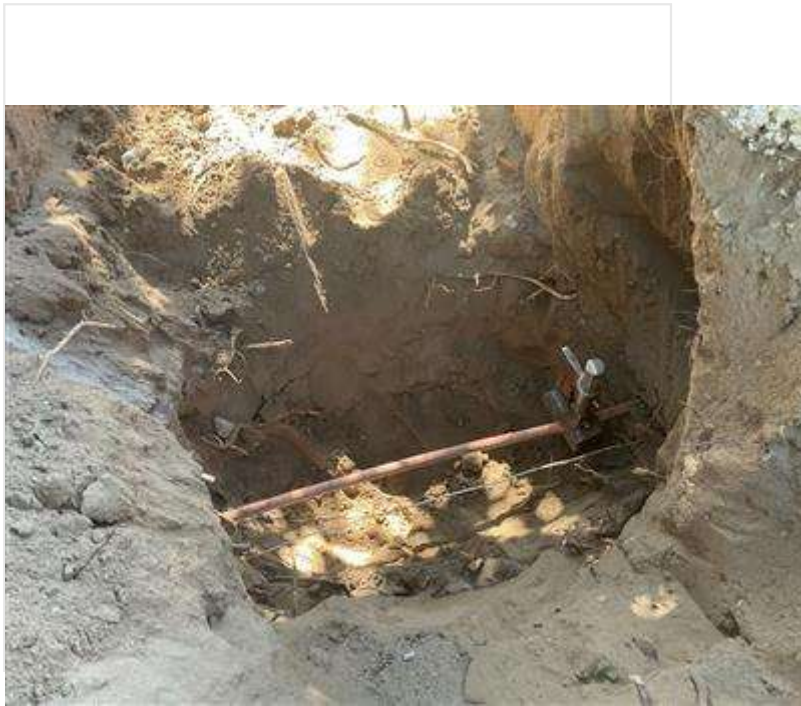
Contractor hit 1/2" plastic service with a shovel. They did not have a valid USA ticket. They requested a USA ticket after the fact. The damage occurred on the left side of the house. It was a branch service that was hit, going to the neighbors house.

Upload photo of excavation location. The photo should be taken at a wide angle and include location identifiers such as buildings in the background, street signs, bridges, freeways, etc.:

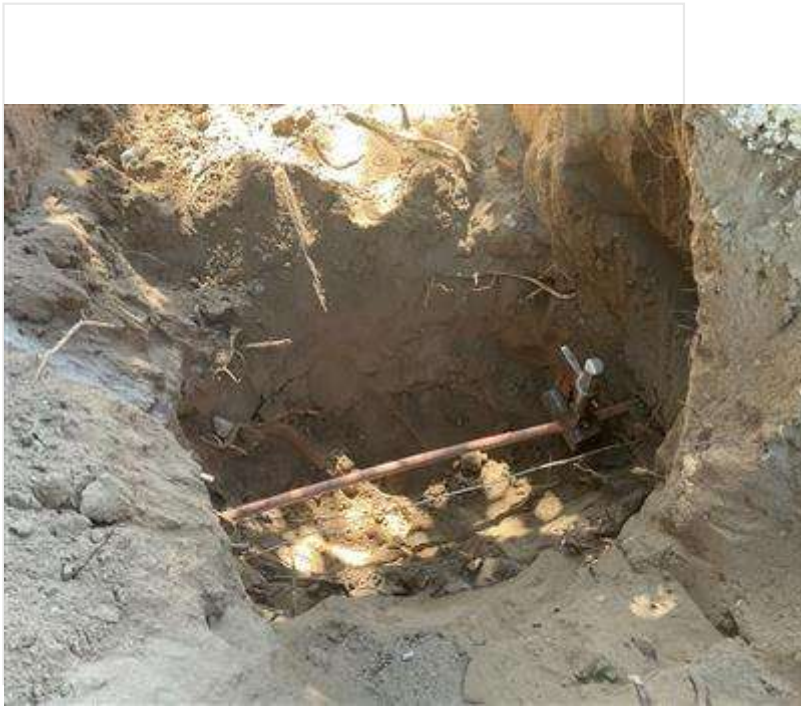
Natural Gas

Shovel

Upload photo depicting the damaged facility
