NOTICE OF VIOLATION

INSPECTION REPORT

Violation 1

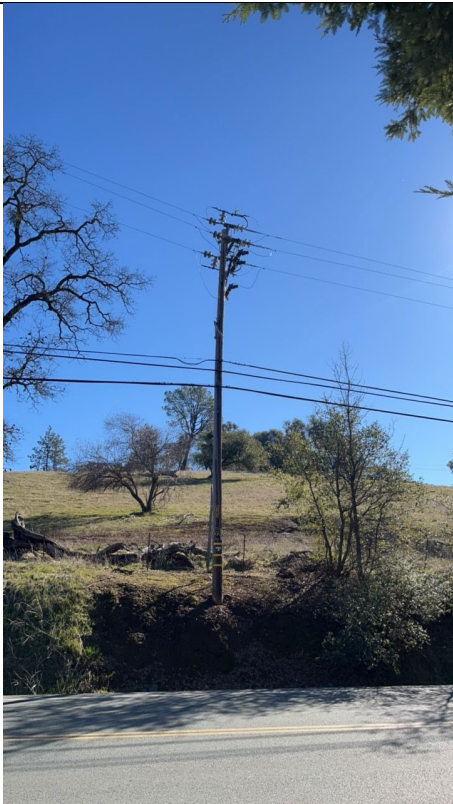
A photograph showing a wooden utility pole standing on a grassy hillside next to a paved road. The pole has several power lines attached to it. The background shows a clear blue sky and some trees.

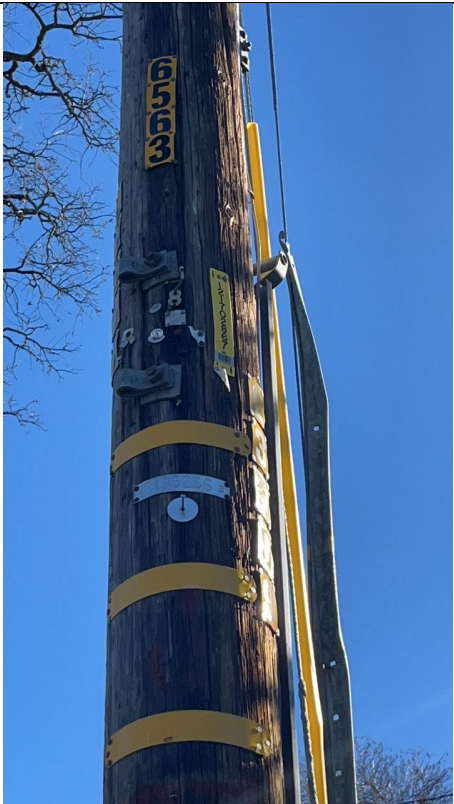
A close-up photograph of a wooden utility pole. The pole is dark brown and has several yellow bands wrapped around it. A yellow label with the number '121702867' is visible near the top. The background is a clear blue sky.
<p>Item1GImg1: Overall Pole</p>	<p>Item1GImg2: Pole ID</p>

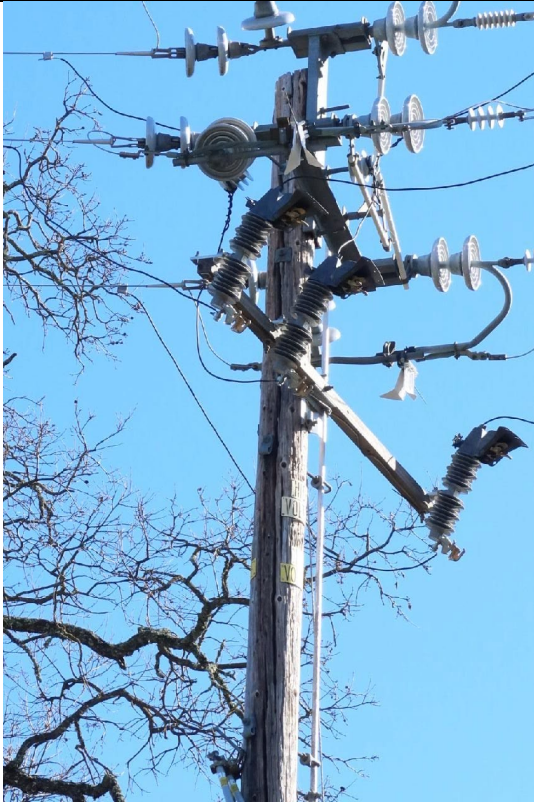
On pole ID 121702867, Grid Hardening ID 31658288 at 379-325 New York Ranch Road, Jackson, CA 95642, USA, 38.36037254723159, -120.76546862422926, the inspector observed that the fuses were not attached to the cutouts. The inspector's observation is documented in Violation 1 photographs, which are attachments to this report. Photo numbers Item1GImg1, Item1GImg2, Item1IA1Img1, Item1IA1Img2 depict incomplete installation of CalFire-exempt fuses. PG&E reported that work on WMP initiative 8.1.2.10.5 – Non-Exempt Expulsion Fuses were completed at this location.

1. The CalFire-exempt fuses were not attached to the cutouts.

Item1IA1Img1: Empty fuse cutouts

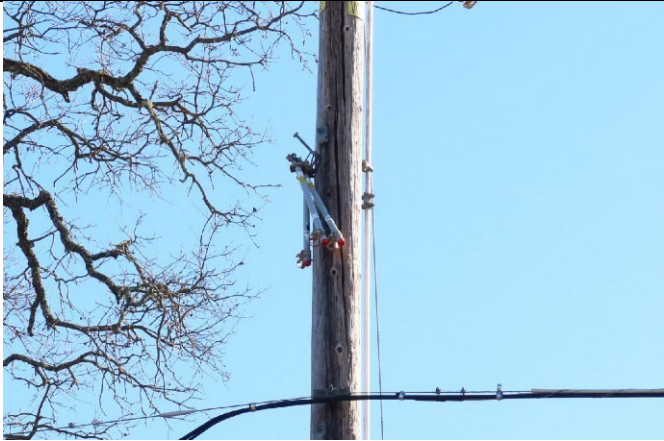
Item1IA1Img2: Hanging CalFire-exempt Fuses
