NOTICE OF VIOLATION

INSPECTION REPORT

Electrical Corporation:	Southern California Edison Company
Report Number:	CAD_SCE_CAC12_20250114_0940
Inspector:	CAC12
WMP Year Inspected:	2024
Quarterly Data Report (QDR) Referenced:	Quarter 2 (Q2)
Inspection Selection:	Energy Safety reviewed the contents of the Q2 QDR and performed an analysis that resulted in the selection of the WMP initiatives and locations referenced in this report.
Relevant WMP Initiative(s):	8.1.3.1 Distribution Detailed Inspections and Remediations (IN-1.1)
Date of inspection:	January 14, 2025
City and/or County of Inspection:	Santa Paula, Ventura County
Inspection Purpose:	Assess the accuracy of Southern California Edison Company’s QDR data, completeness of its work, compliance with WMP requirements, and compliance with its protocols.

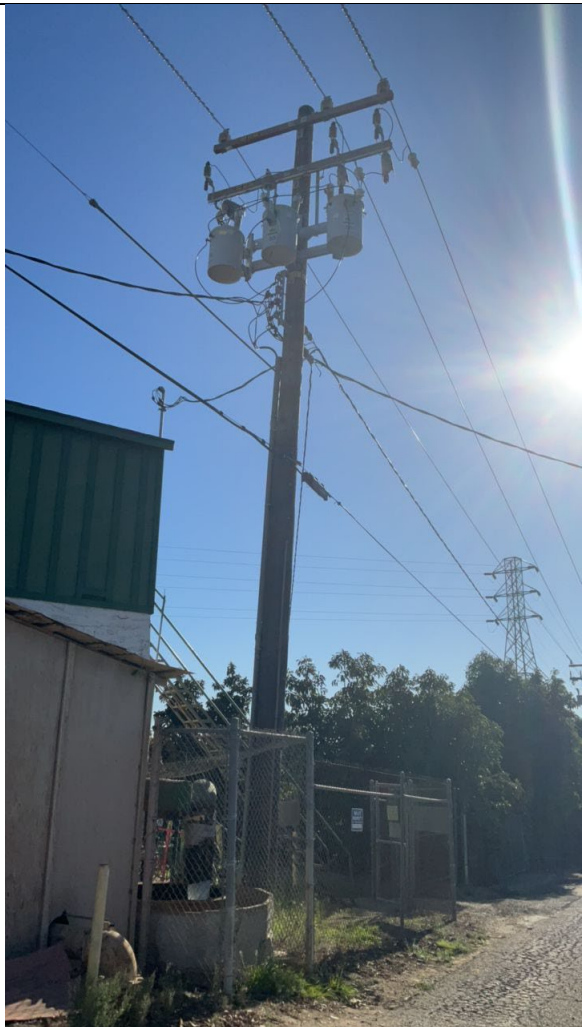
Item1GImg1: Overall pole.

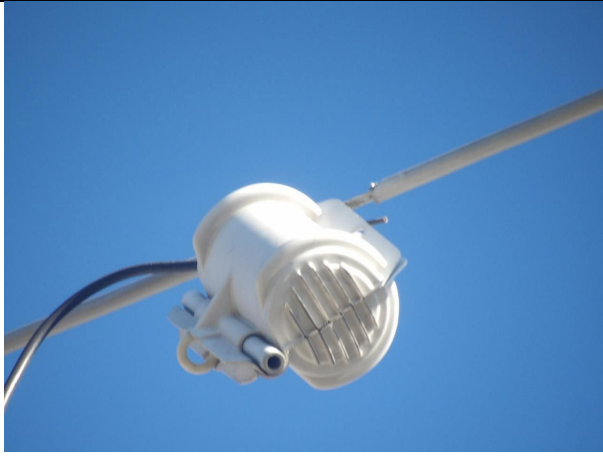
On Pole ID 1748841E, Grid Hardening ID 413697990-1748841E, at 10999 Williams Canyon Rd, Santa Paula, CA 93060, USA, 34.303118, -119.168255, the inspector observed a connector wildlife cover that was loose and at a different angle than the others. The inspector's observation is documented in Violation 1 photographs, which are attachments to this report. Photo numbers Item1IA1Img1 and Item1IA1Img2 depict a loose connector wildlife cover.

Item1IA1Img1: Close-up view of loose connector wildlife cover.

1. Southern California Edison Company's 2024 WMP 8.1.3.1 Distribution Detailed Inspections and Remediations work, remediation of the loose connector wildlife cover, was identified as complete at this location.
2. The connector wildlife cover is loose.
3. DC-535 (23 of 35) states, "While wildlife covers were initially introduced to protect high priority wildlife, additional benefits are procured when discussing wildfire mitigation. By utilizing the correct wildlife covers, electrical events that may result in incandescent particles or other debris will likely be mitigated due to the added fire, track, and arc resistant protection."⁹

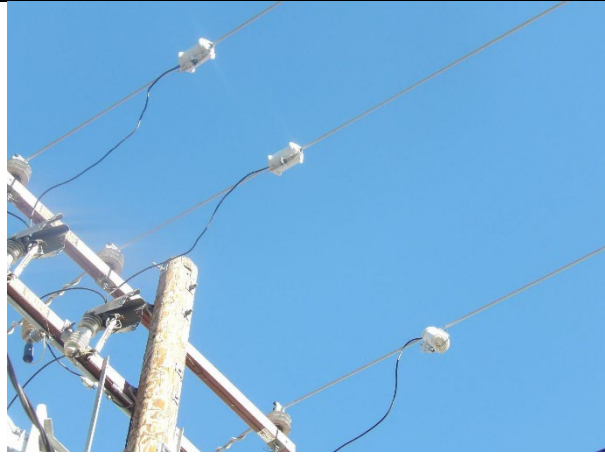
Item1IA1Img2: View of loose connector wildlife cover and adjacent connector wildlife covers.
