NOTICE OF VIOLATION

Violation 1. Energy Safety observed that in implementing 2024 WMP initiative 8.1.3.1 - Distribution Detailed Inspections Remediations (IN-1.1), SCE failed to complete remediation of the loose transformer hanger bolt on Pole ID 1898072E, Grid Hardening ID 414080465-1898072E, at coordinates 35.142054, -118.512856. Energy Safety considers this completeness violation to be in the Minor risk category.

INSPECTION REPORT

| Report Number: | CAD_SCE_CAC12_20250203_1607 |

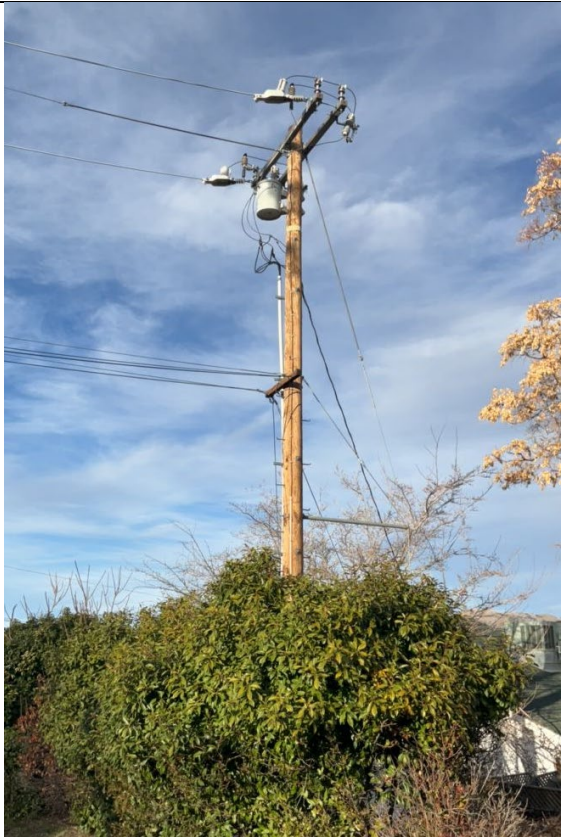
Item1GImg1: Overall pole.

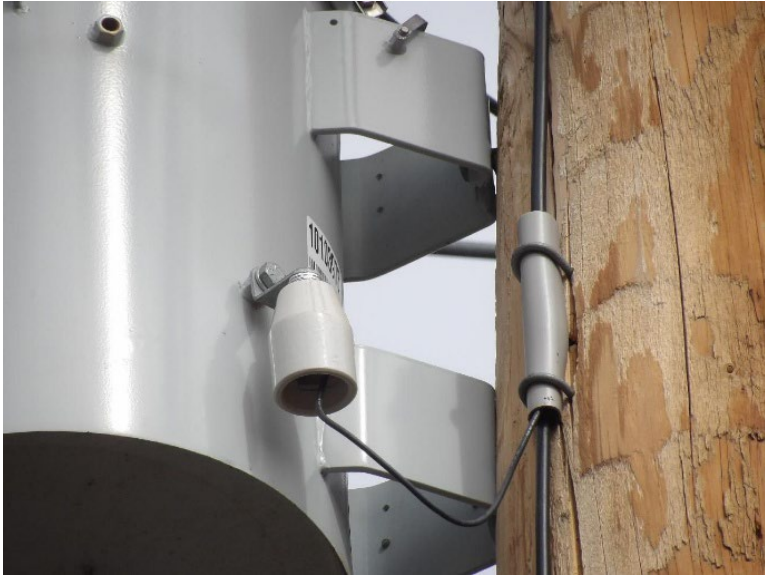
On Pole ID1898072E, Grid Hardening ID 414080465-1898072E, at 21508 Country Club Drive, Tehachapi, California, GPS Coordinates 35.142054, -118.512856, the inspector observed a loose transformer bolt. The inspector's observation is documented in Violation 1 photographs, which are attachments to this report. Photo number Item1IA1Img1 depicts a loose transformer bolt. Per information provided by SCE on September 16, 2024, the notification concerning the loose transformer bolt was completed.

1. Southern California Edison Company's 2024 WMP 8.1.3.1 Distribution Detailed Inspections and Remediations work, remediation of a loose transformer bolt was reported complete at this location.
2. The transformer is loose, and the top hanging bracket is not flush with the pole.
3. SCE Distribution Construction Standard SL-515 (sheet 8 of 8) depicts a side profile image of a pole mounted transformer, and demonstrates proper installation of top and bottom hanging brackets that are flush with the pole.⁹

Item1IA1mg1: Loose transformer bolt hardware

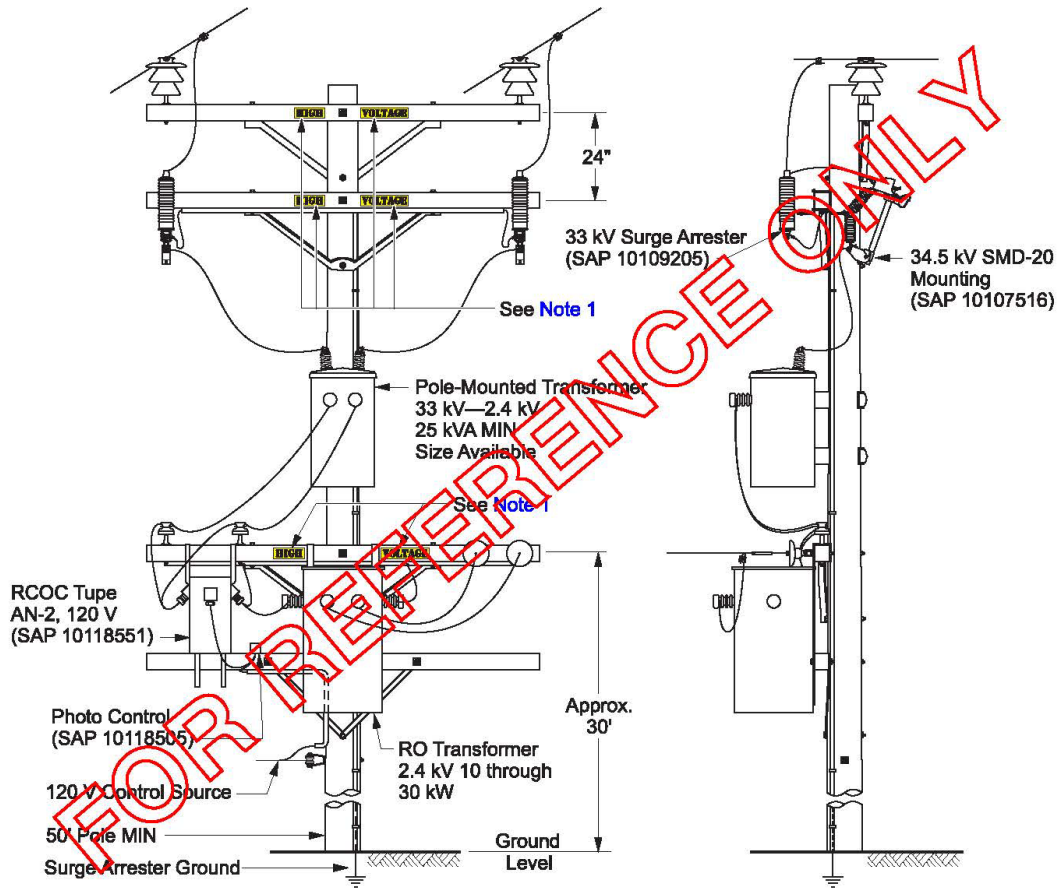
Figure SL 515–7: 6.6 "A" RO Transformer — 33 kV–2.4 kV (Using RCOC Switch)

Scope SL 515.3 6.6 "A" RO Transformer — 33 kV–2.4 kV
