## NOTICE OF VIOLATION

On March 05, 2025, Energy Safety conducted an inspection of PG&E's WMP initiatives in the vicinity of the city of Strawberry Valley in a High Fire Threat District (HFTD) Tier 3. The inspection report is enclosed herewith. Energy Safety found the following violations:

Violation 1. Energy Safety observed that in implementing 2024 WMP initiative 8.2.2.2.3 VM for Operational Mitigations (VMOM), PGE failed to adhere to its protocol of wood and slash management near pole ID 121273918 near coordinates 39.55953300657906, -121.12117412164933. Energy Safety considers this violation for adherence to protocol to be in the "Moderate" risk category.

# INSPECTION REPORT

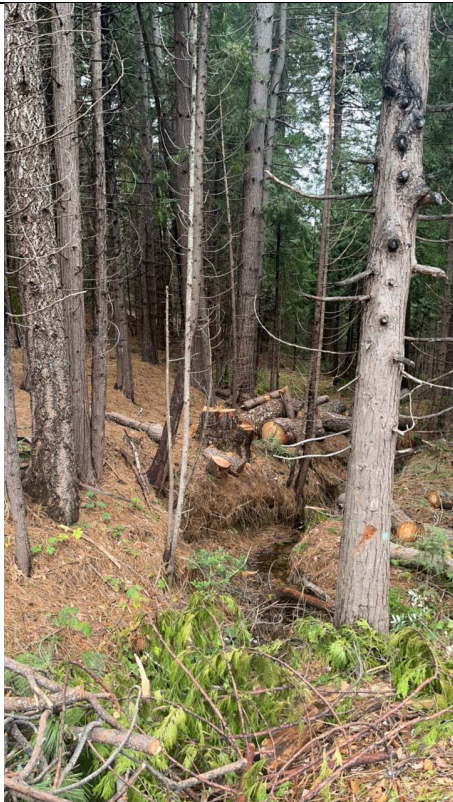
**Item1G1mg1:** Photo of general area showing slash piles and woody debris near the removed Douglas fir stump.

Energy Safety's inspector observed slash, wood chips, and woody debris from the Douglas fir and the Ponderosa pine, most of which appeared to have been felled and left in place. Additionally, the inspector observed a pile of slash debris that was higher than 18 inches. According to PG&E's protocol all slash management pile must be left at an average depth of less than 18 inches from the ground surface. The inspector's observation is documented in Violation 1 photographs, which are exhibits to this report. Photo numbers Item1IA1Img1, Item1IA1Img3, and Item1IA1Img5 depict a slash pile over 18 inches in height, and Item1GImg1, Item1GImg2, Item1IA1Img2, Item1IA1Img4, and Item1IA1Img6 depict several other slash piles, chips and woody debris associated with PG&E's work.

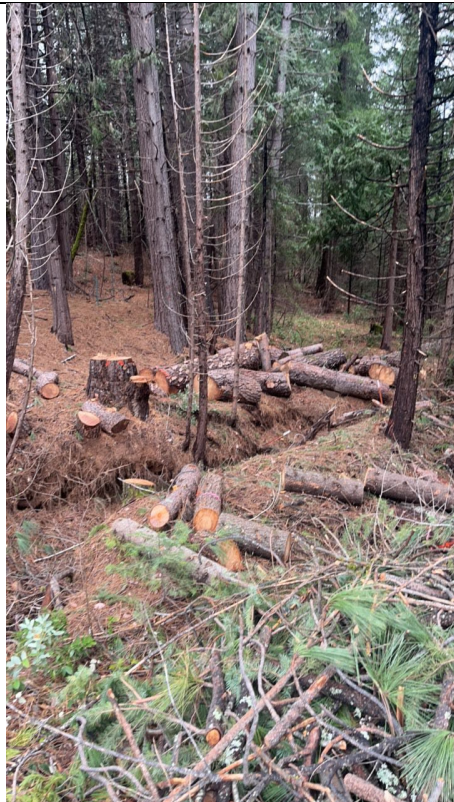
**Item1G1mg2:** Another photo of the general area showing slash piles and woody debris near the removed Douglas fir stump.

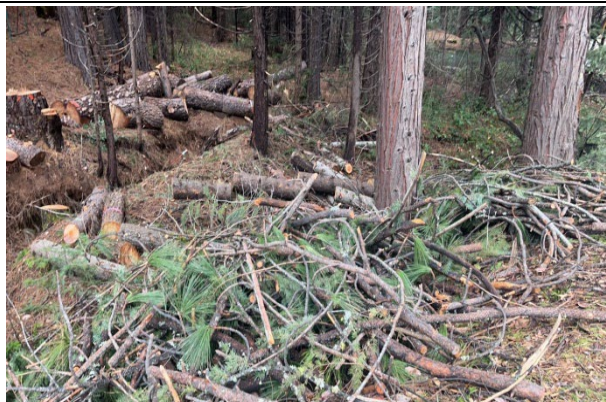
Energy Safety considers Violation 1 "Moderate" because the slash pile is over 18 inches in height and located in HFTD Tier 3, creating a potential fuel source for wildfire.

**Item1IA1mg3:** Photo of the slash pile over 18 inches in height in the front.

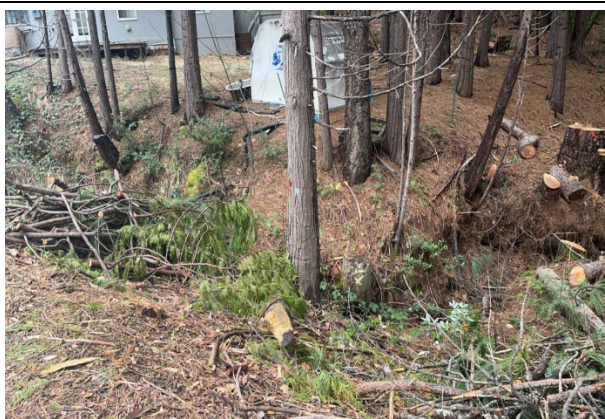
**Item1IA1mg2:** Photo of distributed slash piles in wider view.

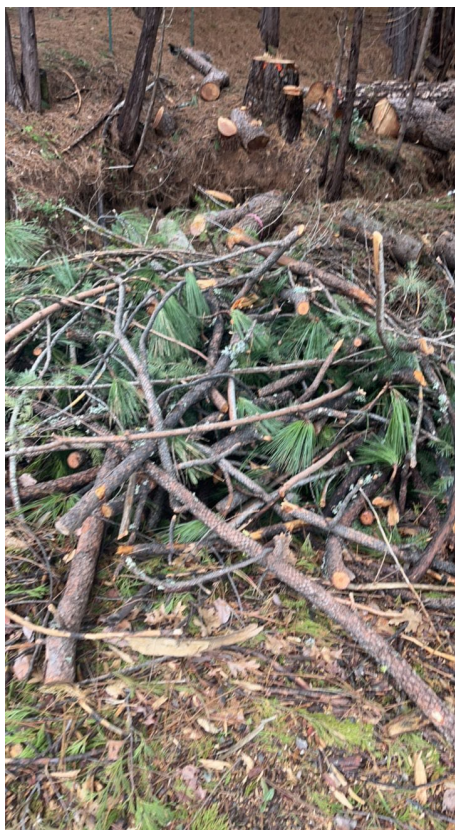
**Item1IA1Img5:** Same slash pile of closer view of photo of slash pile over 18 inches in height.

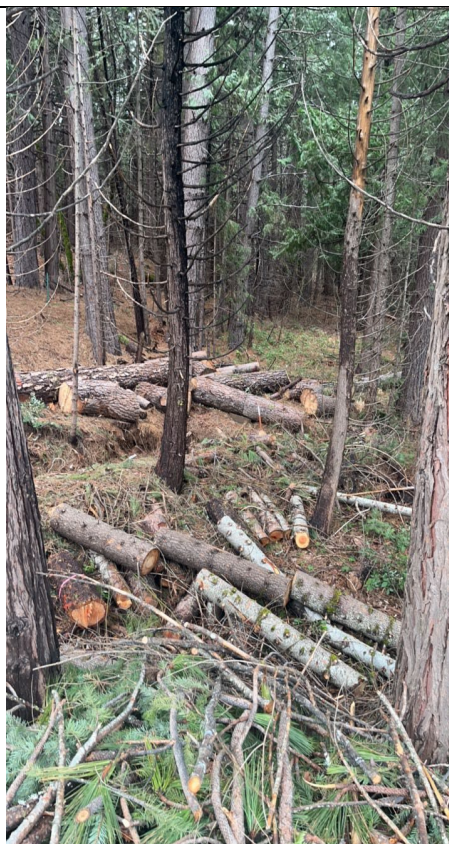
**Item1IA1Img6:** Photo of other slash piles and woody debris of the removed Douglas fir and the Ponderosa pine.
