**NOTICE OF VIOLATION**

On January 29, 2025, Energy Safety conducted an inspection of Southern California Edison Company's WMP initiatives in the vicinity of the city of Tehachapi, California. The inspection report is enclosed herewith. Energy Safety found the following violation(s):

# INSPECTION REPORT

Structure ID: 1699190E

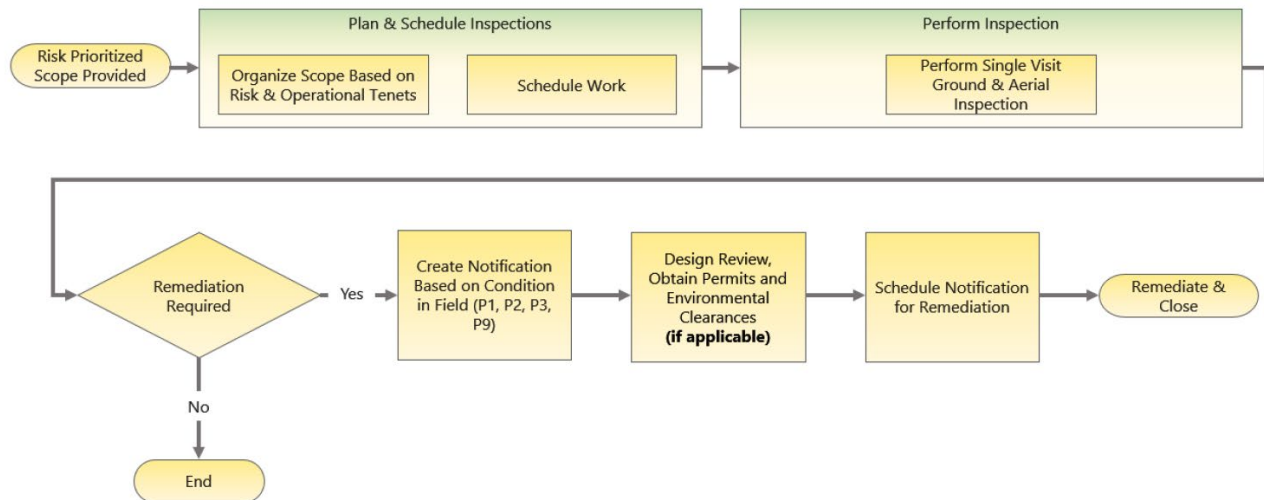
**Figure 8-1a - Distribution Detailed Inspections and Remediations Workflow**

1. "The frequency of [High Fire Risk-Informed inspections] varies by the location-specific risk... within SCE's [High Fire Risk Area] and emergent conditions. Issues identified by inspectors during the detailed inspections are prioritized for remediation to be completed within [General Order 95] compliance timelines. Remediations can be repairs to or replacements of existing assets depending on asset condition. For example, SCE repairs ground molding with that is found to be broken/damaged with an exposed ground wire at the public level. Also, SCE replaces wood guy guards if found to be missing, damaged or outdated."<sup>7</sup>
2. The following is a workflow diagram from SCE's WMP showing the conditions under which SCE will execute remediations under initiative number 8.1.3.1:<sup>8</sup>

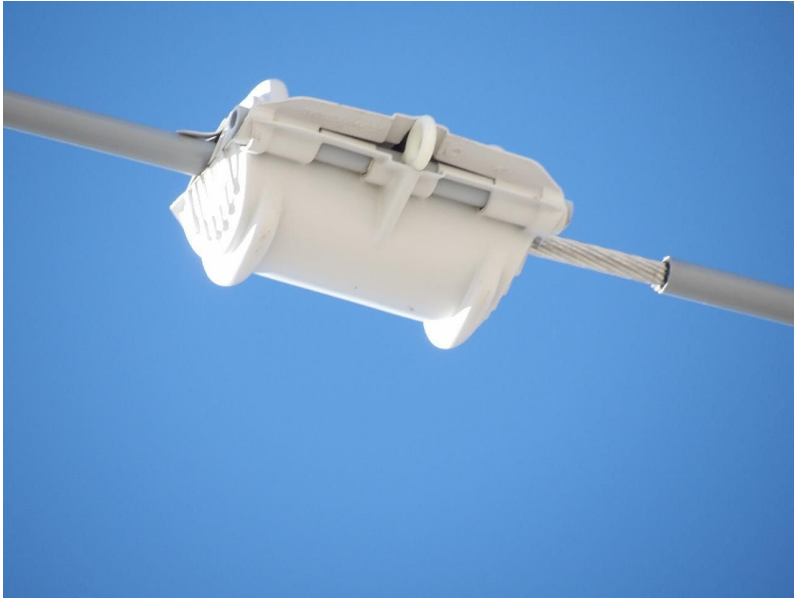
**Item1IA1Img1:** Close-up view of bare conductor outside of wildlife cover.

On Pole ID 1699190E, Grid Hardening ID 413812742-1699190E, at 22701 CA-202, Tehachapi, CA 93561, USA, 35.119395, -118.533614, the inspector observed exposed conductor near a wildlife cover. The inspector's observation is documented in Violation 1 photographs, which are attached to this report. Photo number Item1IA1Img1 depicts exposed conductor near the wildlife cover. Per information provided by SCE to the Compliance Inbox on January 3, 2025, at 10:22 am, the condition of the exposed conductor was remediated.

1. Southern California Edison Company's 2024 WMP 8.1.3.1 Distribution Detailed Inspections and Remediations (IN-1.1) work, specifically remediation of exposed conductor, was identified as complete at this location.
2. Exposed conductor was observed.
