May 21, 2025

Patrick Doherty, Compliance Program Manager
Compliance Assurance Division
Office of Energy Infrastructure Safety
California Natural Resources Agency
715 P Street 20th Floor
Sacramento, CA 95814

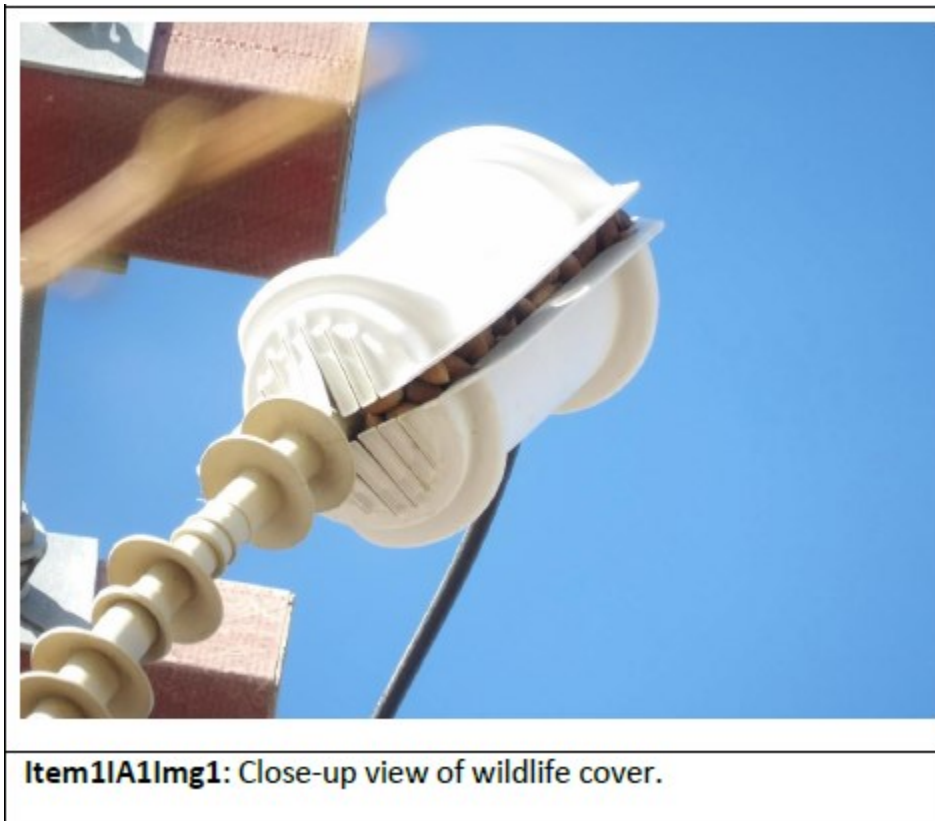
Screenshot #1: Excerpt of SCE's Distribution Overhead Construction Standards

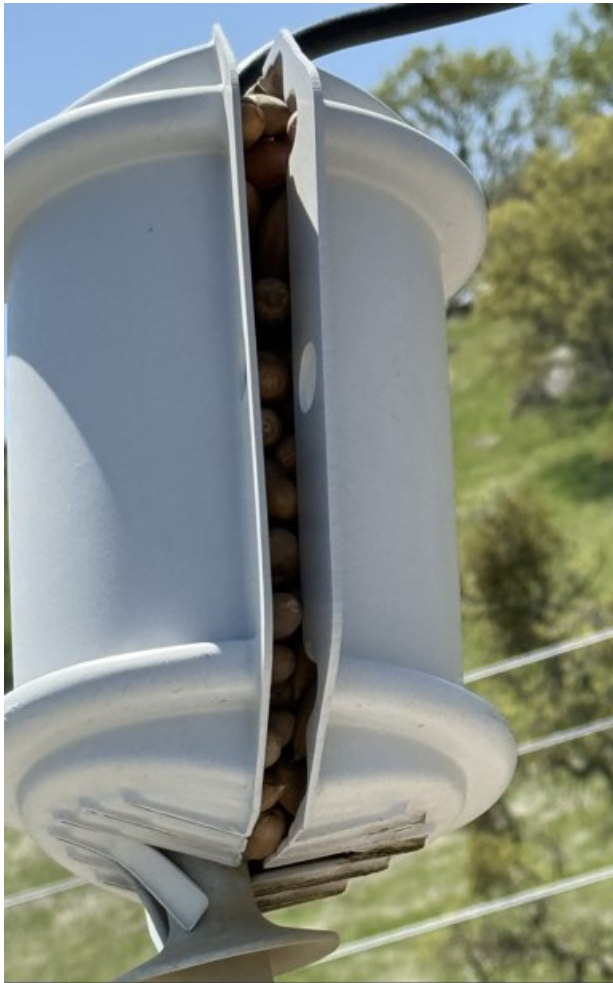
Photo #4: After photo from April 23, 2025
