SUBJECT: Southern California Edison Company's Response to Notice of Violation
- NOV_CAD_SCE_CAC12_20250203_1607

Energy Safety’s Notice states that in implementing 2024 WMP initiative 8.1.3.1 - Distribution Detailed Inspections Remediations (IN-1.1), SCE failed to complete remediation of the loose transformer hanger bolt on Pole ID 1898072E, Grid Hardening ID 414080465-1898072E, at coordinates 35.142054, -118.512856.

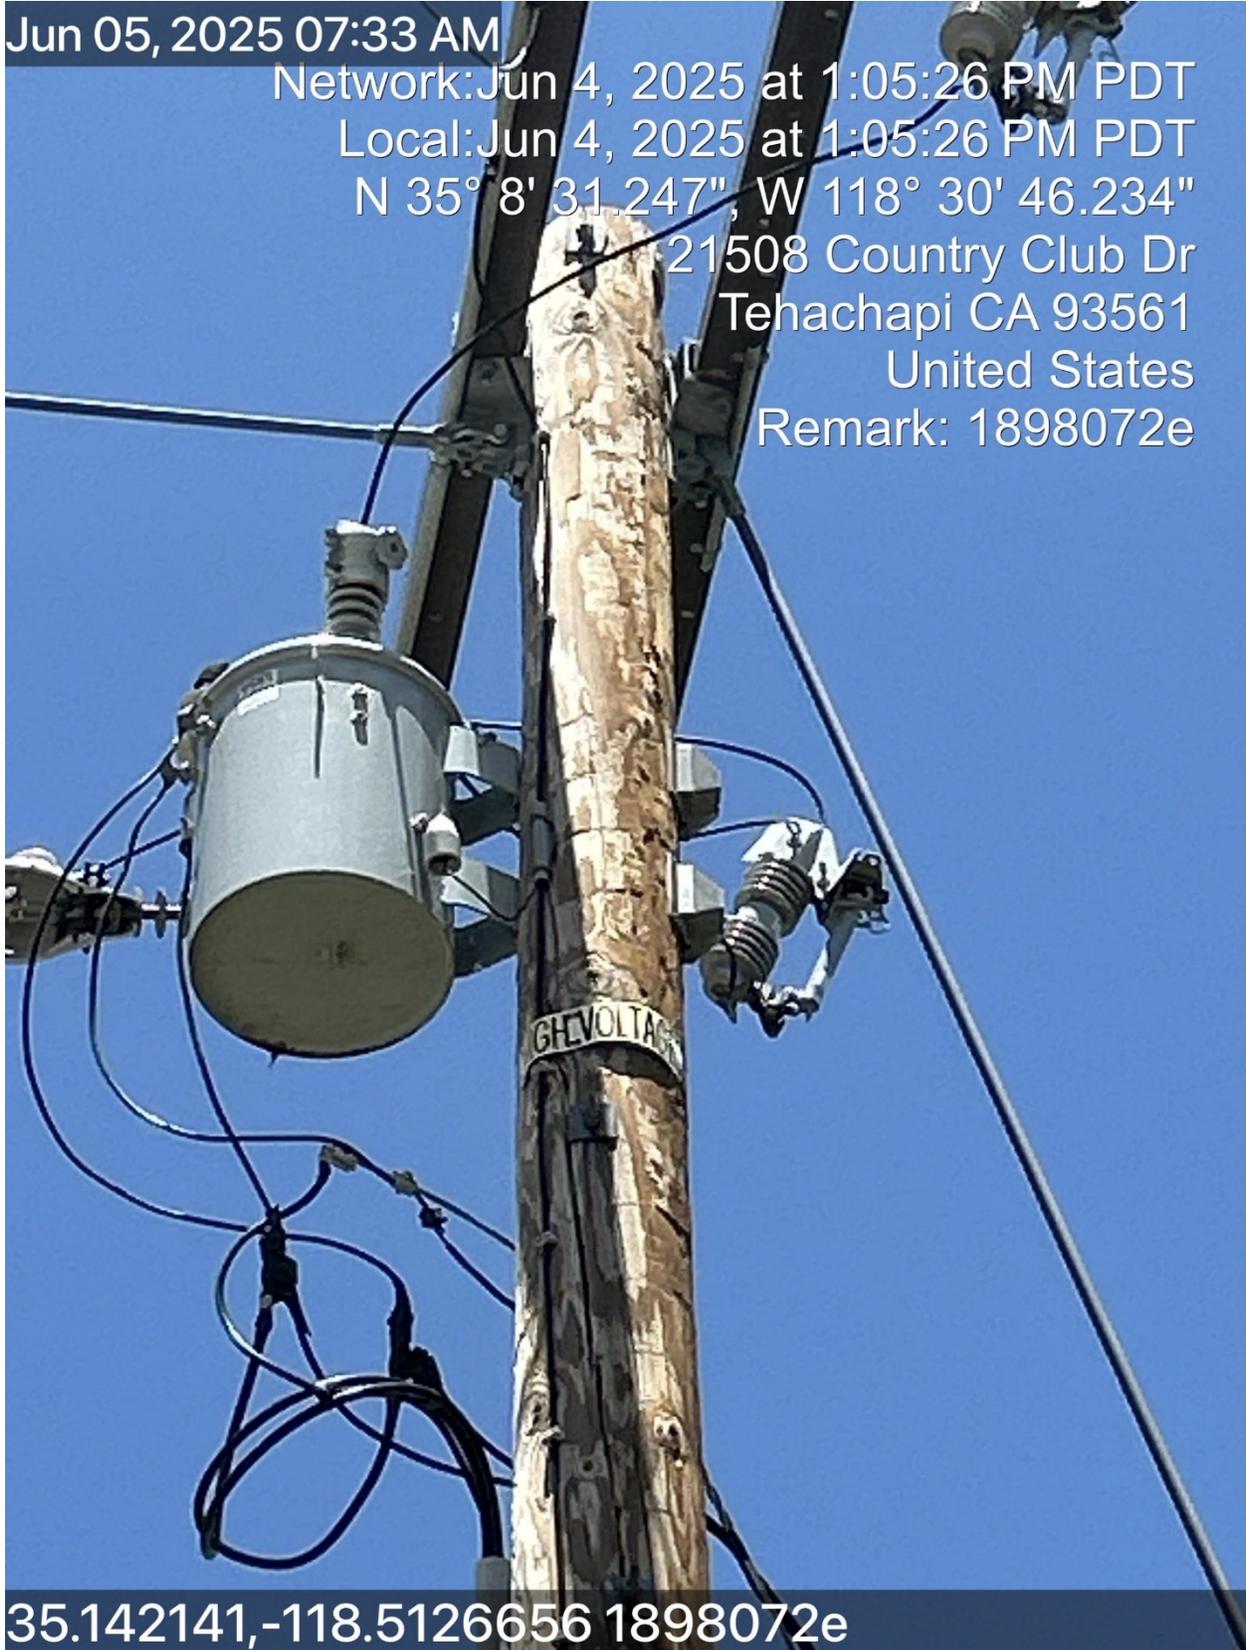
Remark: 1898072e

response to this Notice found that there was a loose transformer bolt. Loose bolts can be a result of fluctuations in the weather or pole vibrations.

On June 4, 2025, SCE personnel tightened the loose bolt on structure 1898072E to ensure the transformer bracket is now flush with the pole. Please find the photo evidence below of the secured transformer.
