June 10,2025

Patrick Doherty, Compliance Program Manager
Compliance Assurance Division
Office of Energy Infrastructure Safety
California Natural Resources Agency
715 P Street 20th Floor
Sacramento, CA 95814

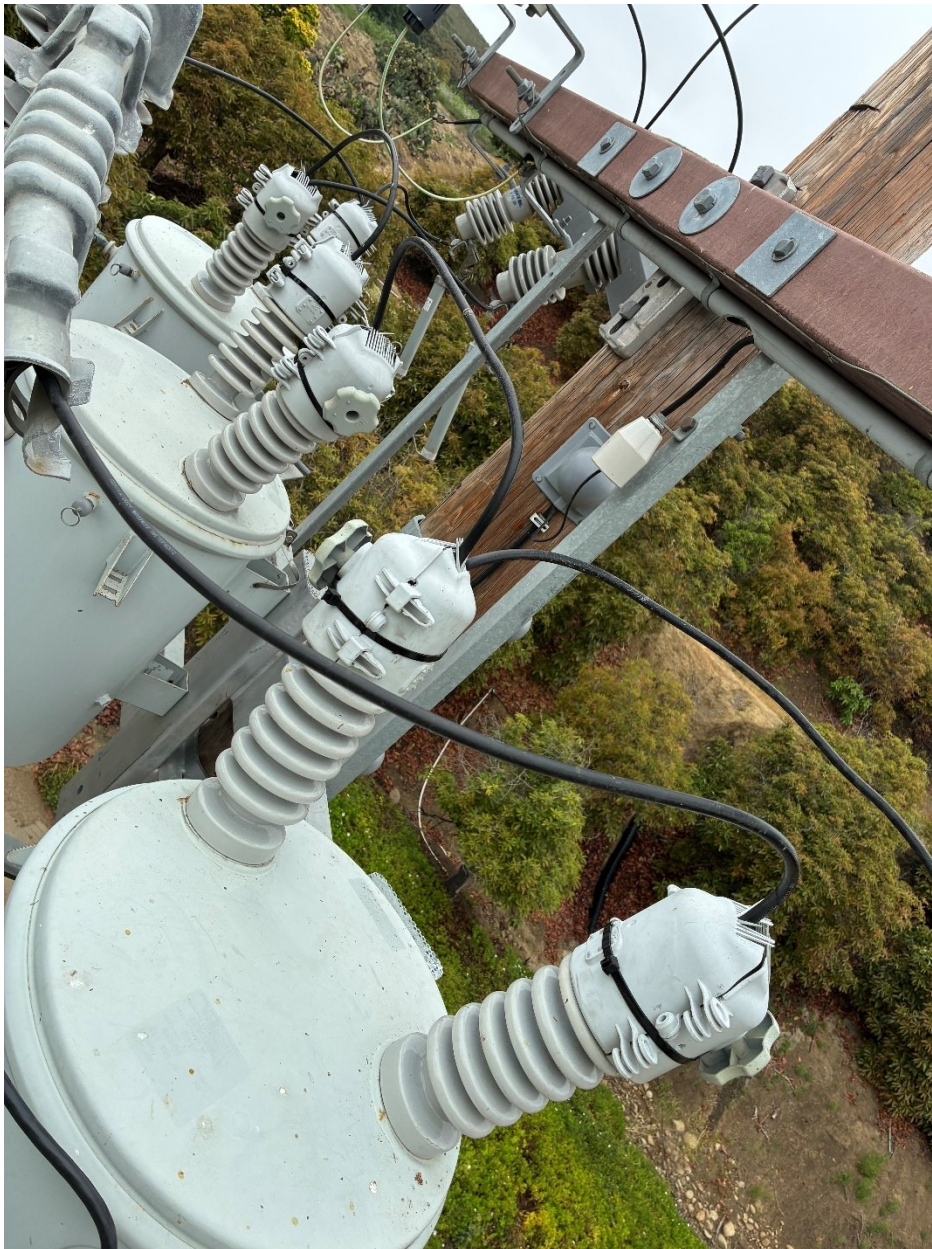
SCE confirms that the open wildlife cover on structure ID 2322471E was remediated on June 12, 2024. During an inspection on June 2, 2025 in response to this Notice, SCE's Field Operations team identified the open wildlife cover issue, likely due to environmental exposure or other external factors leading to the recurrence of the condition. On June 5, 2025, SCE personnel secured the wildlife cover on structure 2322471E once again. Please find the photo evidence below of the most recently completed wildlife cover remediation.
