NOTICE OF VIOLATION

On November 6, 2024, Energy Safety conducted an inspection of PG&E's WMP initiatives in the vicinity of the city of Mile 5.4 Hwy 236 N, Boulder Creek, CA, 95006, USA, California. The inspection report is enclosed herewith. Energy Safety found the following violation(s):

Violation 1. Energy Safety observed that in implementing 2024 WMP initiative 8.1.2.10.5 - Non-Exempt Expulsion Fuses, PG&E failed to complete work on pole ID 142642, Grid Hardening ID 31659221 at coordinates 37.172680516295806, -122.1739655949791. Energy Safety considers this completeness violation to be in the Minor risk category.

INSPECTION REPORT

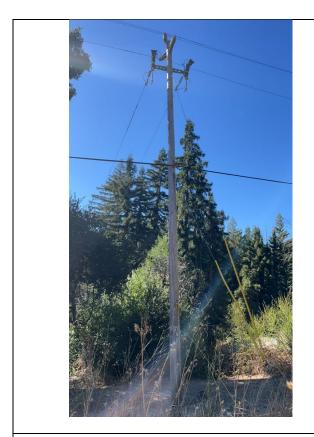
Structure ID: 142642

On pole ID 142642, Grid Hardening ID 31659221 at Mile 5.4 Hwy 236 N, Boulder Creek, CA, 95006, USA, 37.172680516295806, -122.1739655949791, the inspector observed that the hot-end clamp of the cutout jumper is not attached to anything. The inspector's observation is documented in Violation 1 photographs, which are attachments to this report. Photo numbers Item1IA1Img1, Item1IA1Img2 show that the cutout jumper clamp is unattached and hanging freely. PG&E reported that work on WMP initiative 8.1.2.10.5 – Non-Exempt Expulsion Fuses was completed at this location.

- 1. The hot-end clamp of the cutout jumper is not attached to primary nor secondary conductors. The circuit on the fuse side is not attached to the main line which causes an incomplete circuit.
- 2. Replacement of non-exempt fuses was not completed at this location.

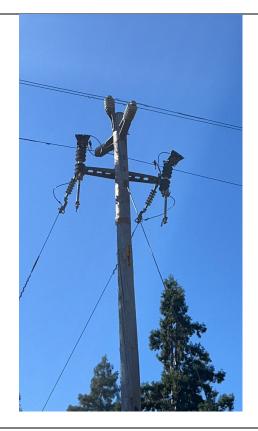
Item1GImg3: View of exempt fuses and Cutout Clamps

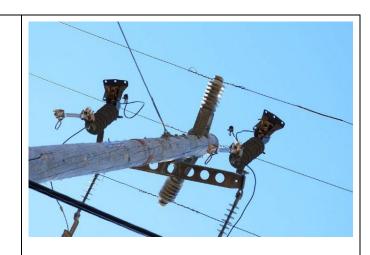
Item1IA1Img1: View of Unsecured Cutout Clamps Suspended in Air

Item1IA1Img2: View of Unsecured Cutout Clamps
Suspended in Air
