**CALIFORNIA UNDERGROUND SAFETY BOARD
INVESTIGATION DIVISION**

INVESTIGATION REPORT

Case No.: N242694

Executive Summary:

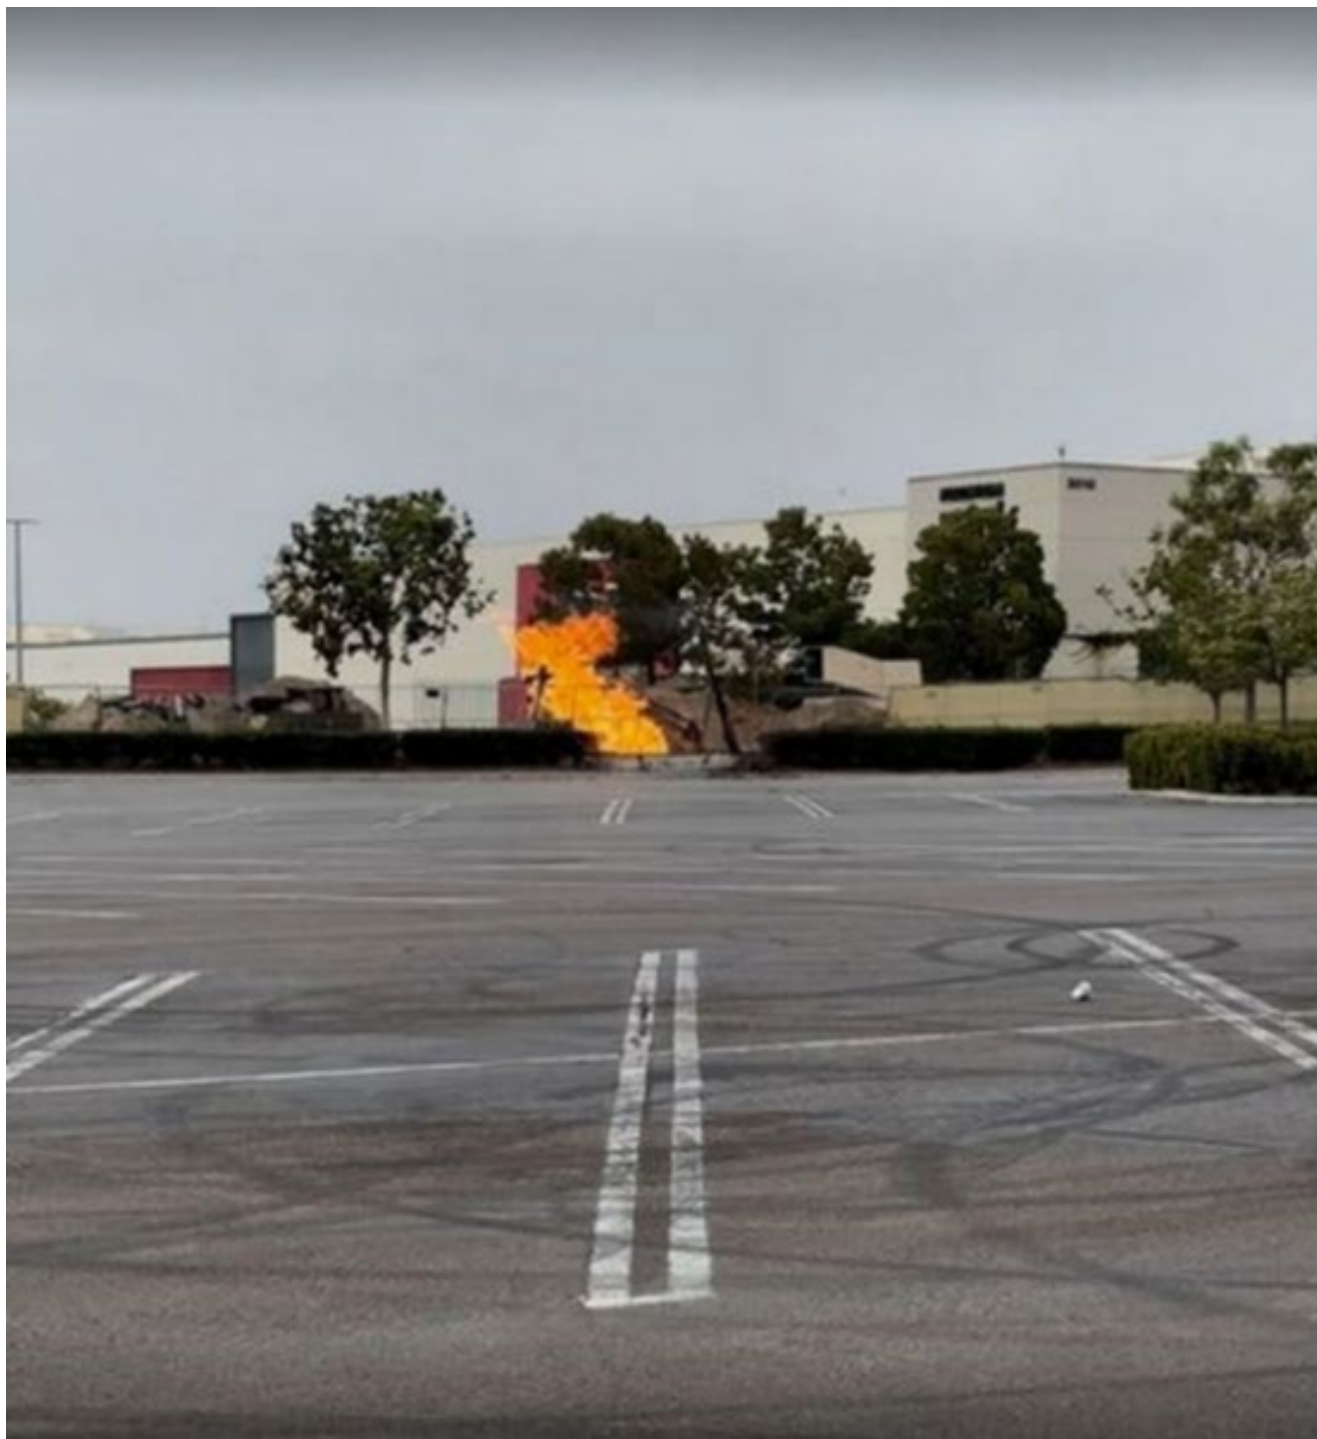
Photo 1 provided by San Diego Gas and Electric depicting the ignition. (Exh. 1.)

When the National City Fire Department (NCFD) arrived at the site, with 3 engines, gas was leaking from the damaged gas line. (Exh. 6.) Before SDG&E was able to stop the flow of gas, FK Design diesel generator (powering lights) ignited the gas. FK Design's bobcat, concrete saw cutter, and other tools were completely burned. (Exh. 2)

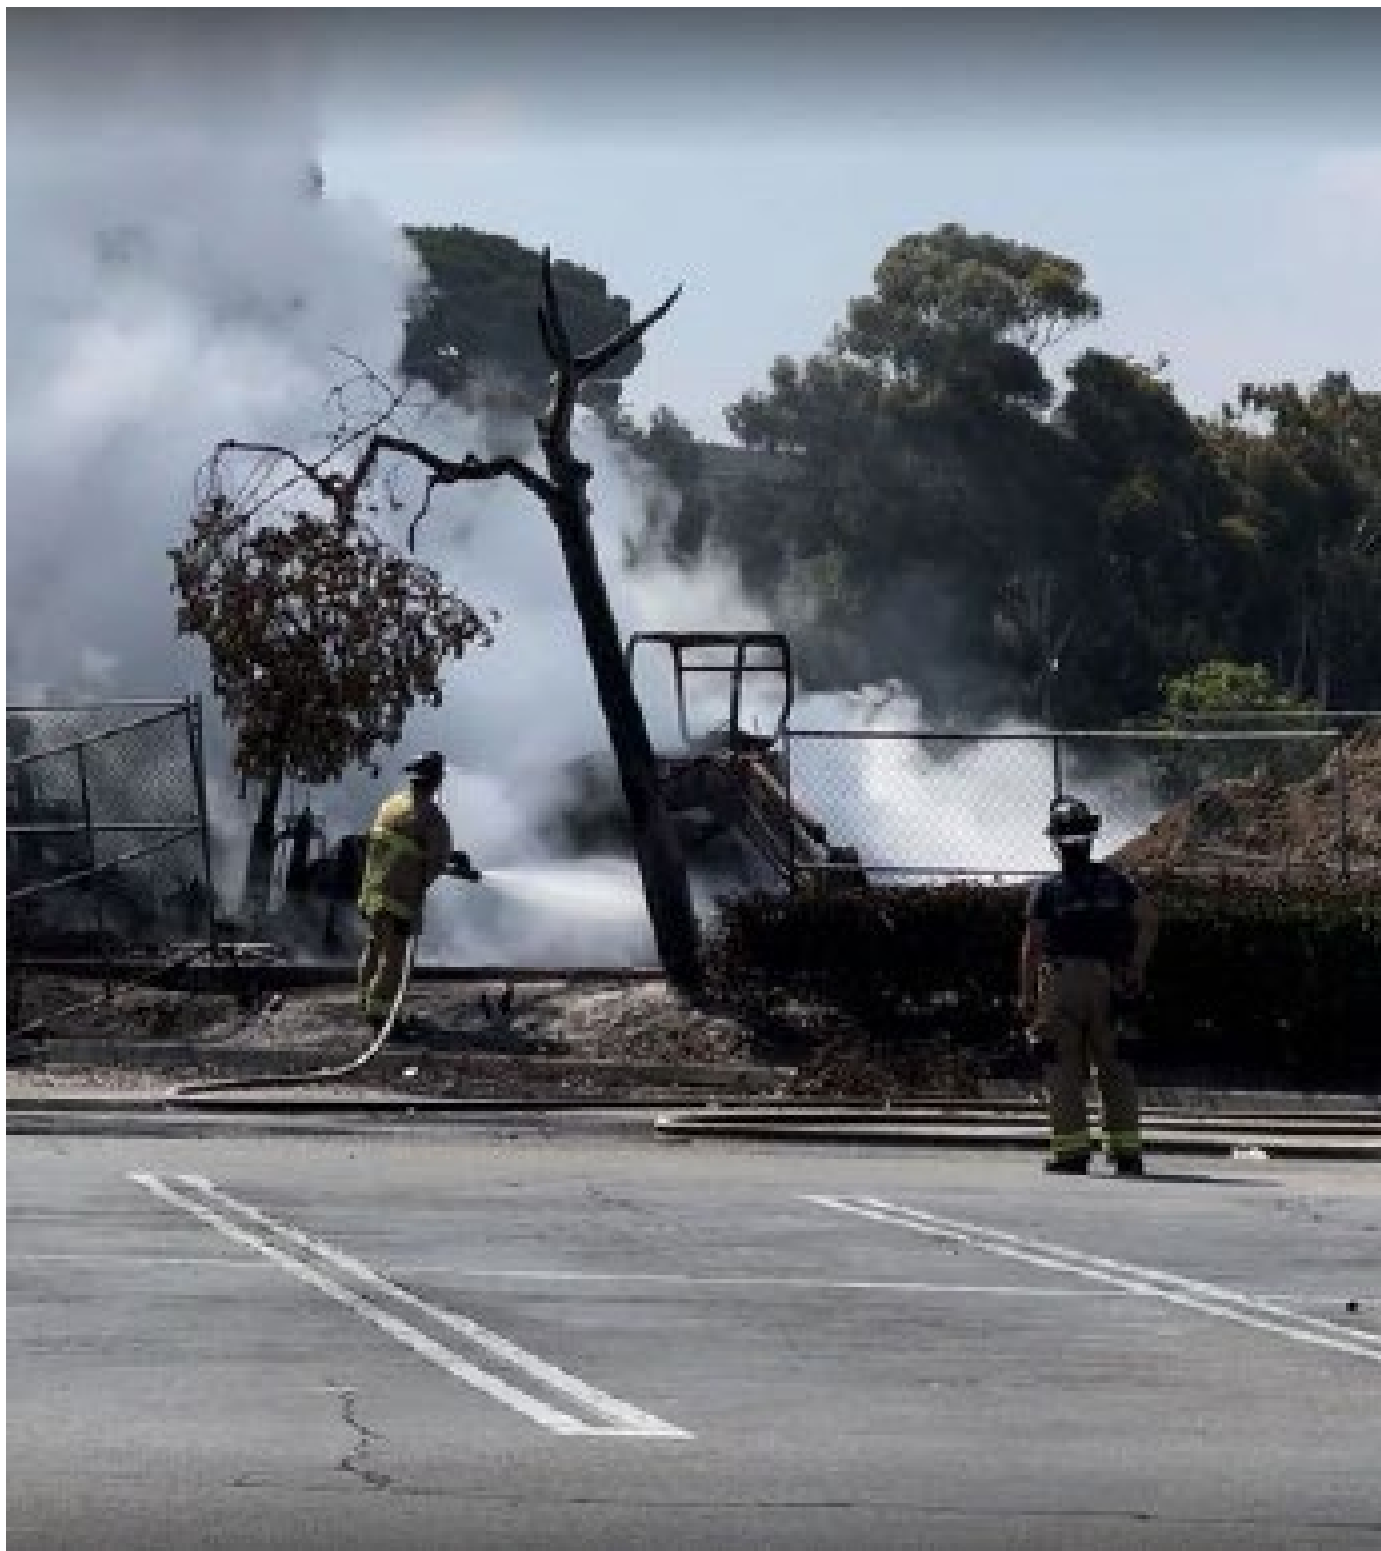
Photo 2 provided by San Diego Gas and Electric shows National City Fire Crew spraying water over equipment damaged by explosion. (Exh. 1).

After damaging the gas line, FK Design and Construction, Inc. called 911. The National City Fire Department evacuated and cordoned off the area. Before SDG&E was able to stop the flow of gas, FK Design and Construction, Inc.'s diesel generator (powering lights) ignited the gas. The fire damaged FK Design and Construction, Inc.'s bobcat and other tools. No one was injured.

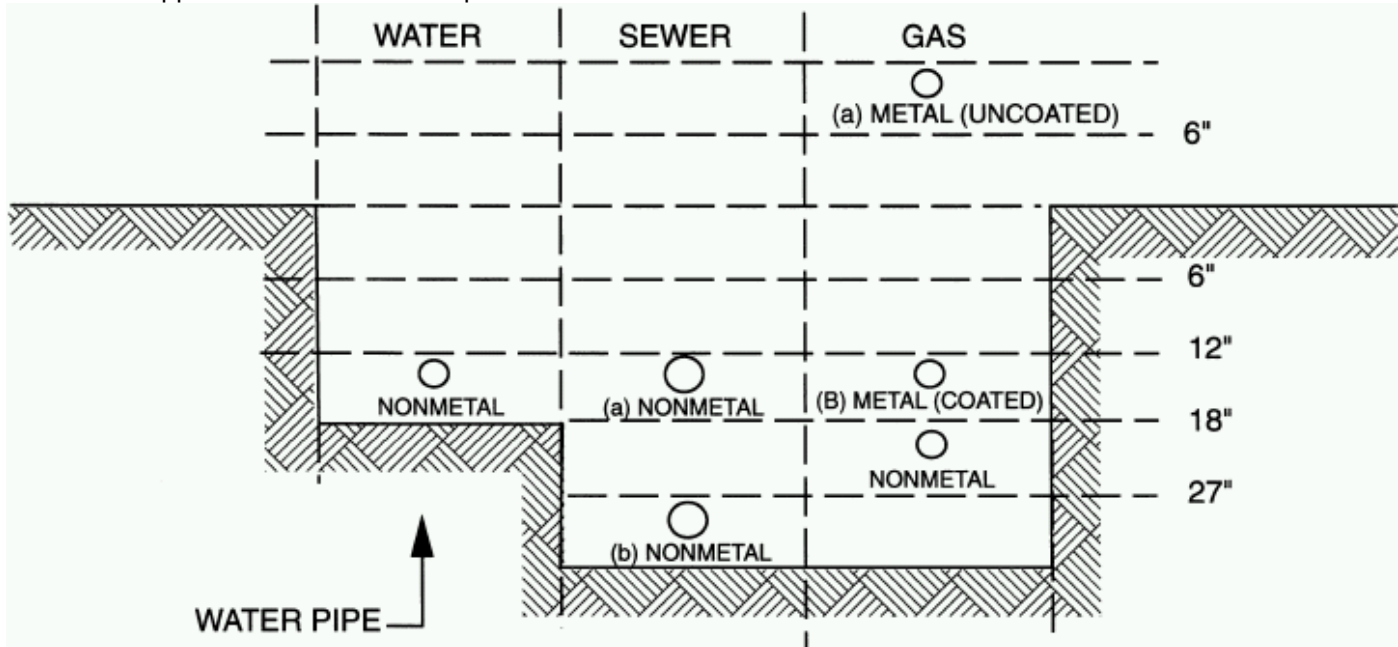
METAL – No burial requirement (recommend 12" to protect from mechanical damage and freezing). For copper pipe joints use **only** nonleaded bearing solders (solders approved for potable water).

NONMETAL – 12" minimum (plastic). Also see sewer Pipe depths, nonmetal (b).

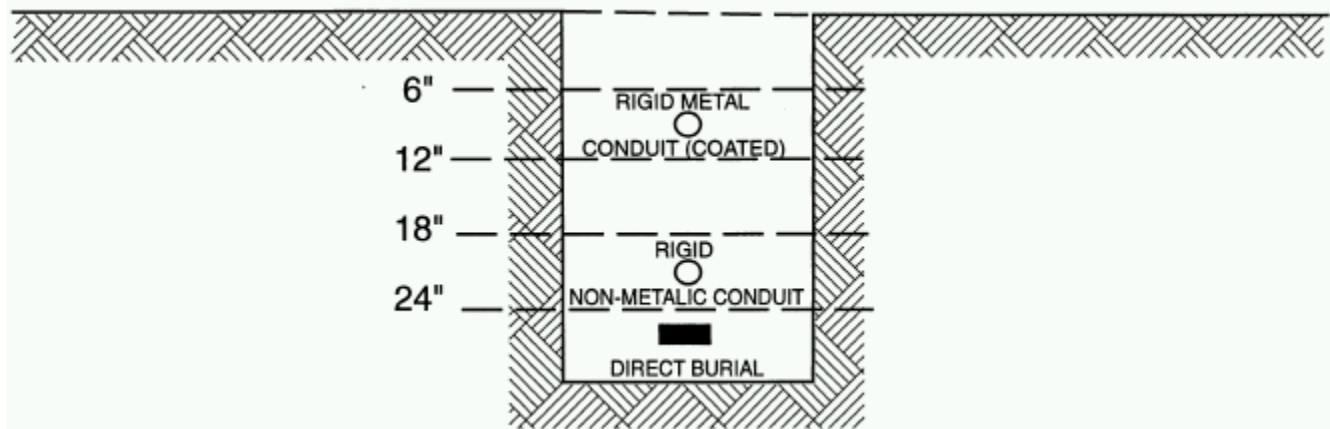
BURIAL DEPTHS FOR ELECTRICAL LINES ON PRIVATE PROPERTY*

ELECTRIC LINE BURIAL DEPTHS
Rigid metal conduit (coated) – 6" minimum
Rigid non-metallic conduit – 18" minimum
Direct burial cable – 24" minimum

National Electric Code Table 300-5 applies. Important exceptions to the above electric line burial depths include:

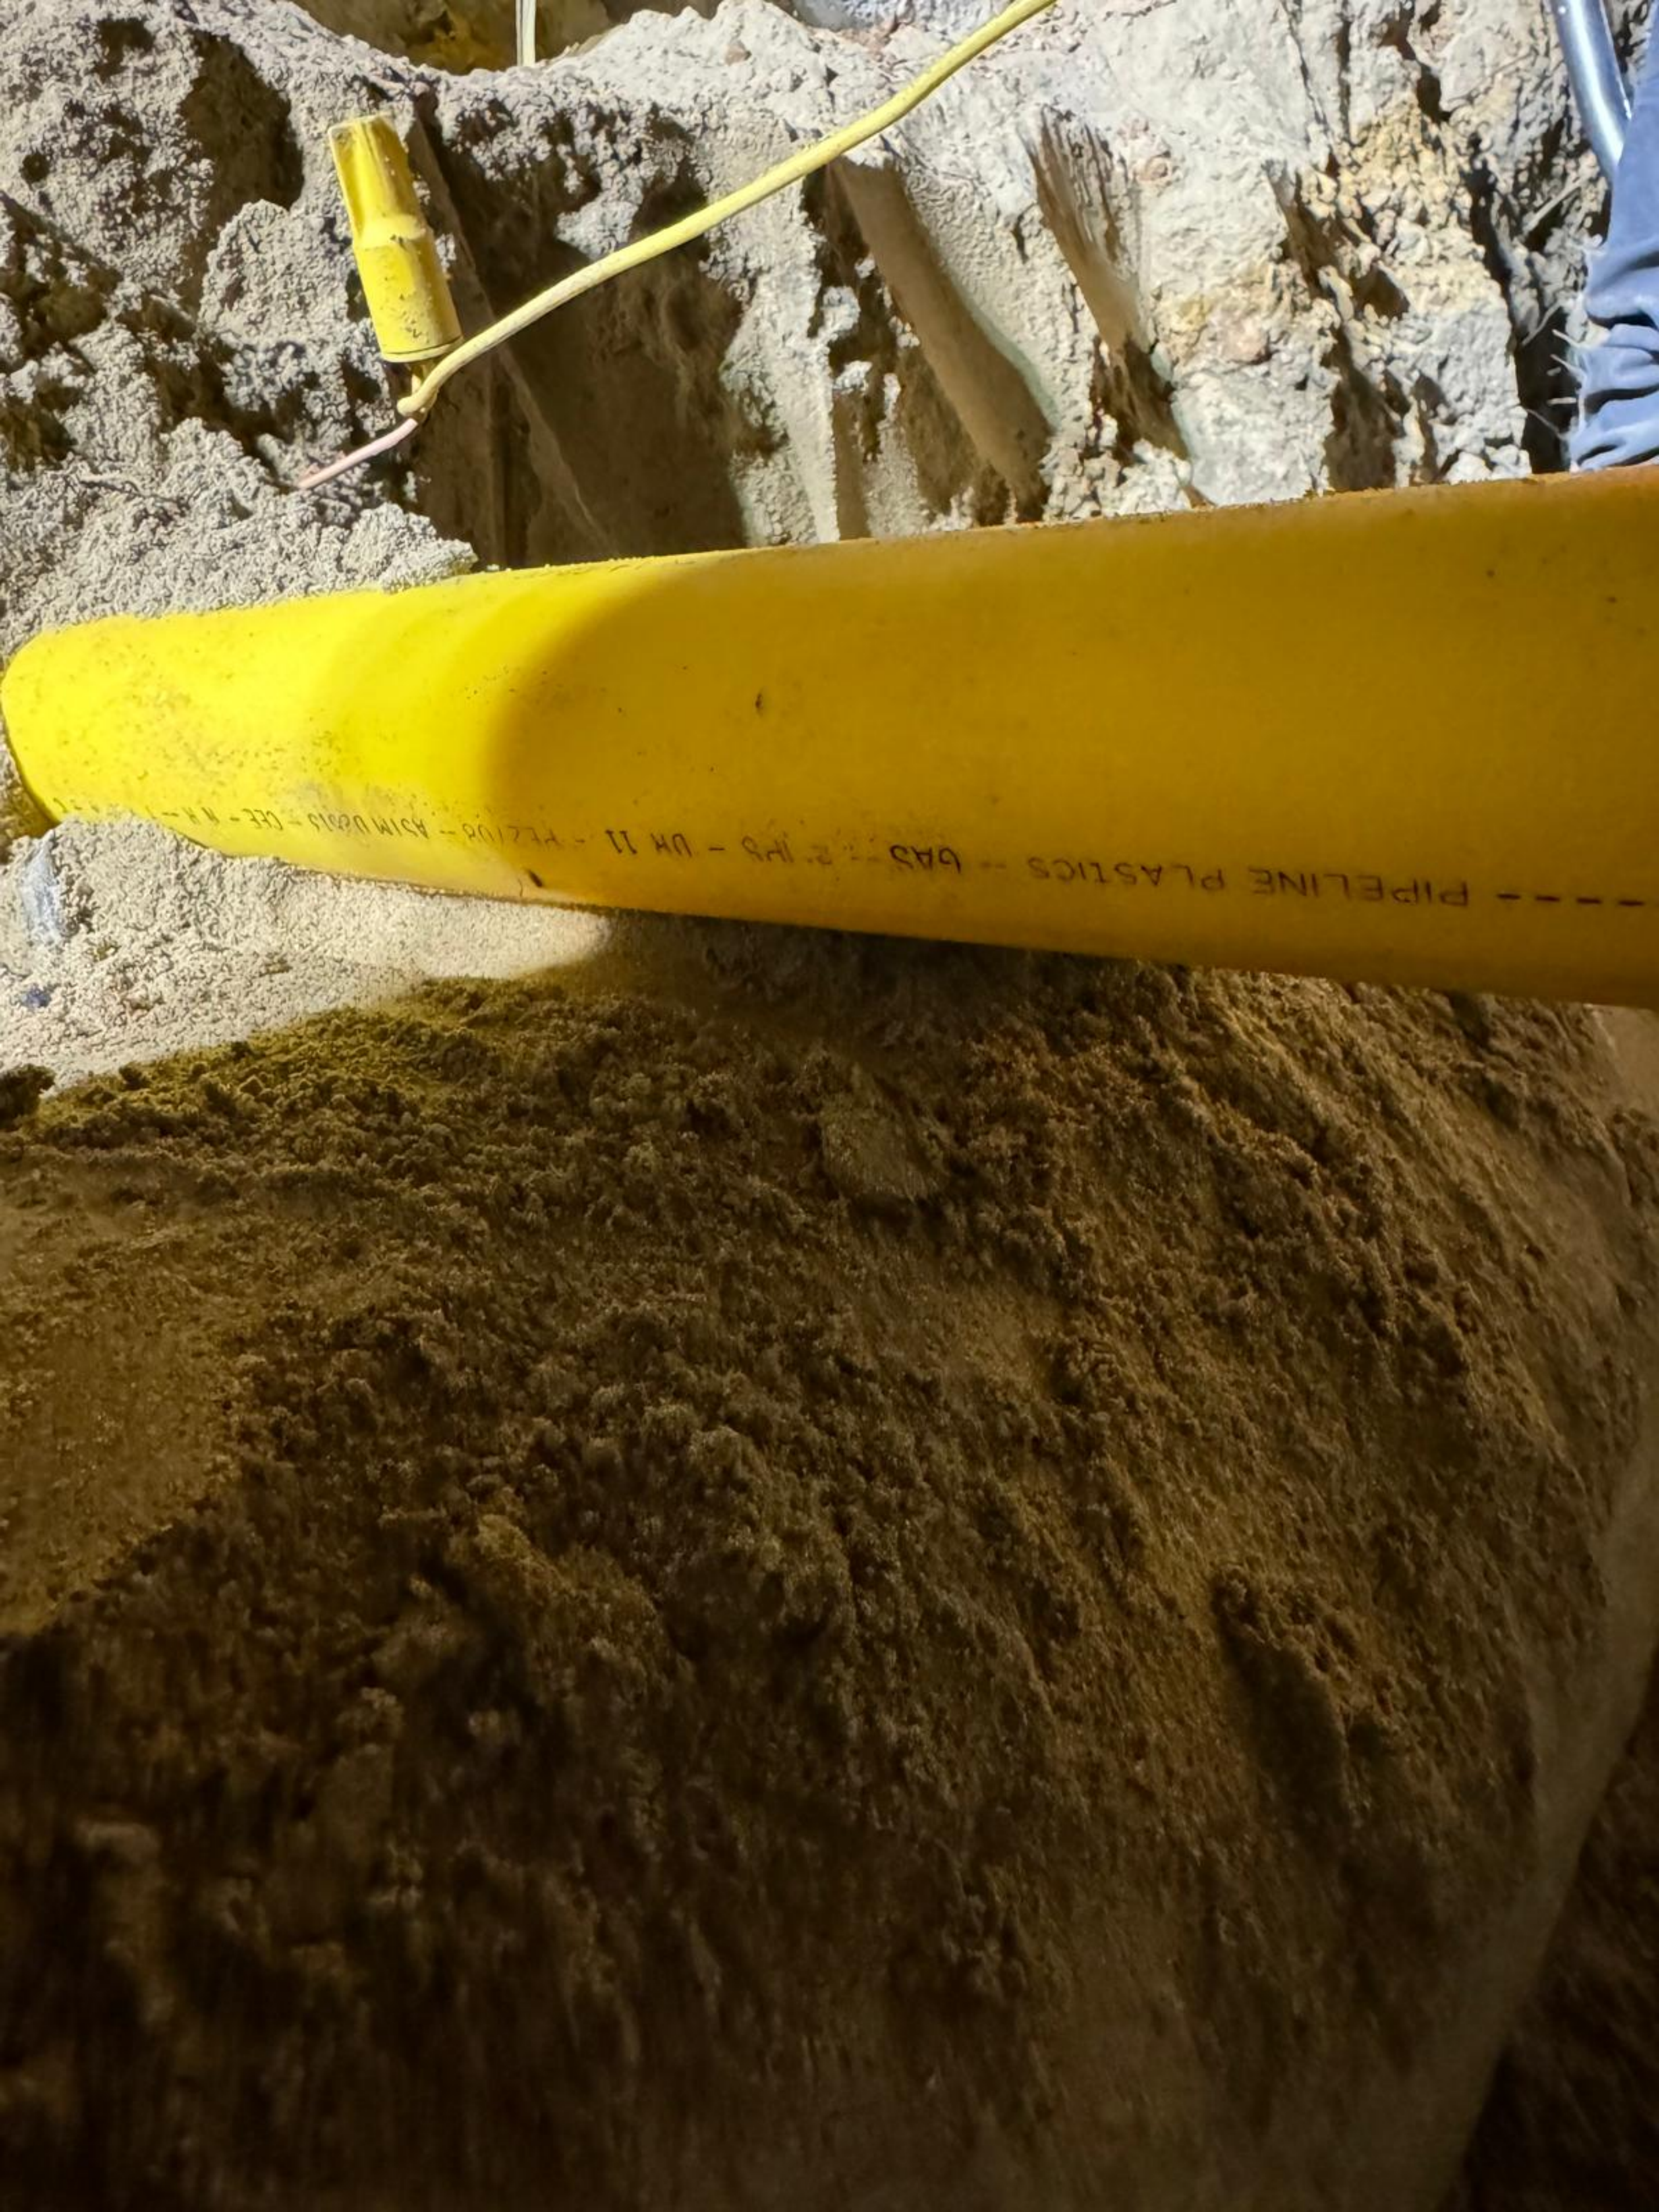
--- PIPELINE PLASTICS --- GAS --- 2" IPS --- UH 11 --- PE210B --- ADIMUGAS --- GE --- H.H. ---
