NOTICE OF VIOLATION

On May 6 and 7, 2025, Energy Safety conducted an inspection of SCE's WMP initiatives in the vicinity of the city of Moreno Valley, California. The inspection report is enclosed herewith. Energy Safety found the following violation(s):

INSPECTION REPORT

Electrical Corporation:	Southern California Edison Company
Report Number:	CAD_SCE_YLO_20250506_1049
Inspector:	Yana Loginova
WMP Year Inspected:	2024
Quarterly Data Report (QDR) Referenced:	Quarter 4 (Q4)
Inspection Selection:	Energy Safety viewed the contents of the Q4 QDR and performed an analysis that resulted in the selection of the WMP initiatives and locations referenced in this report.
Relevant WMP Initiative(s):	8.1.3.1 - Distribution Detailed Inspections and Remediations (IN-1.1)
Date of inspection:	May 6 and 7, 2025
City and/or County of Inspection:	Moreno Valley, Riverside County
Inspection Purpose:	Assess the accuracy of Southern California Edison Company’s QDR data, completeness of its work, compliance with WMP requirements, and compliance with its protocols.

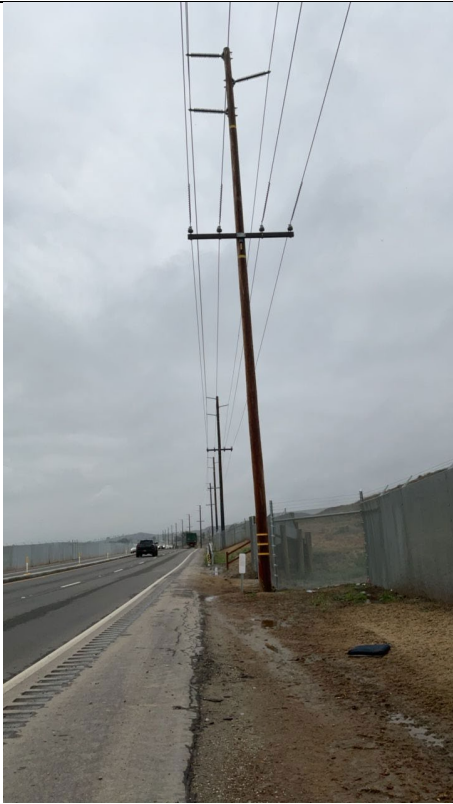
On pole ID 4491292E, Grid Hardening ID 410903711-4491292E at 36000-36030 Gilman Springs Rd, Moreno Valley, CA, 92555, USA, 33.873229702385, -117.048724833795, the inspector observed that no wildlife covers were installed. The inspector's observation is documented in Violation 1 photographs, which are attachments to this report. Photo number Item1IA1Img1 depicts that there are no wildlife covers on the pole. Per information provided by SCE to the Compliance Inbox on June 4, 2025, at 4:13 pm, the remediation of wildlife covers was completed.

1. Southern California Edison Company's 2024 WMP 8.1.3.1 Distribution Detailed Inspections and Remediations work identified that the remediation of wildlife covers was complete at this location.
2. The wildlife covers were not installed.

Item1IA1Img1: View showing no wildlife covers installed

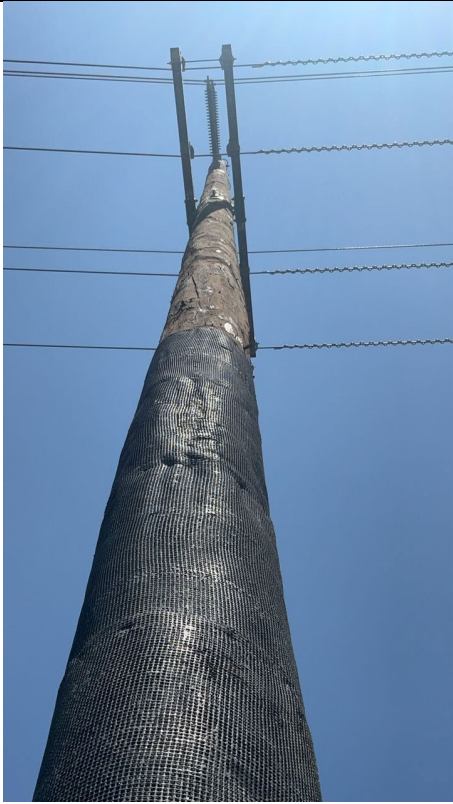
On pole ID 4491275E, Grid Hardening ID 410903702-4491275E at 34574-34810 Gilman Springs Rd, Moreno Valley, CA, 92555, USA, 33.8807560895587, -117.057891499872, the inspector observed that no wildlife covers were installed. The inspector's observation is documented in Violation 3 photographs, which are attachments to this report. Photo numbers Item3IA1Img1 and Item3IA1Img2 depict that there are no wildlife covers on the pole. Per information provided by SCE to the Compliance Inbox on June 4, 2025, at 4:13 pm, the remediation of wildlife covers was completed.

1. Southern California Edison Company's 2024 WMP 8.1.3.1 Distribution Detailed Inspections and Remediations work identified that the remediation of wildlife covers was complete at this location.
2. The wildlife covers were not installed.

Item3IA1Img1: View showing no wildlife covers installed

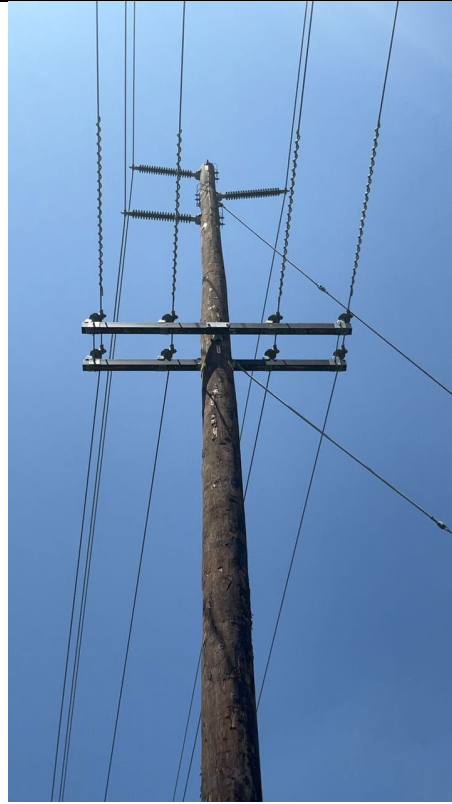
Item3IA1Img2: View showing no wildlife covers installed
