## NOTICE OF VIOLATION

On May 6, 2025, Energy Safety conducted an inspection of SCE's WMP initiatives in the vicinity of the city of Moreno Valley, California. The inspection report is enclosed herewith. Energy Safety found the following violation(s):

# INSPECTION REPORT

Electrical Corporation:	Southern California Edison Company
Report Number:	CAD_SCE_YLO_20250506_1044
Inspector:	Yana Loginova
WMP Year Inspected:	2024
Quarterly Data Report (QDR) Referenced:	Quarter 4 (Q4)
Inspection Selection:	Energy Safety viewed the contents of the Q4 QDR and performed an analysis that resulted in the selection of the WMP initiatives and locations referenced in this report.
Relevant WMP Initiative(s):	8.1.3.1 - Distribution Detailed Inspections and Remediations (IN-1.1)
Date of inspection:	May 6, 2025
City and/or County of Inspection:	Moreno Valley, Riverside County
Inspection Purpose:	Assess the accuracy of Southern California Edison Company’s QDR data, completeness of its work, compliance with WMP requirements, and compliance with its protocols.

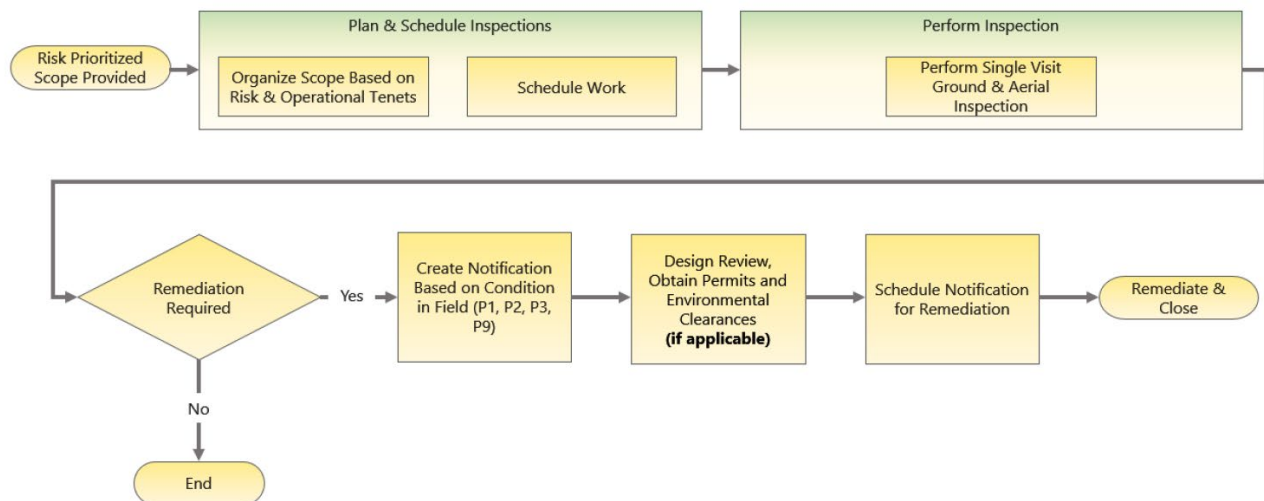
**Figure 8-1a - Distribution Detailed Inspections and Remediations Workflow**

1. "The frequency of [High Fire Risk-Informed inspections] varies by the location-specific risk... within SCE's [High Fire Risk Area] and emergent conditions. Issues identified by inspectors during the detailed inspections are prioritized for remediation to be completed within [General Order 95] compliance timelines. Remediations can be repairs to or replacements of existing assets depending on asset condition. For example, SCE repairs ground molding with that is found to be broken/damaged with an exposed ground wire at the public level. Also, SCE replaces wood guy guards if found to be missing, damaged or outdated."<sup>7</sup>
2. The following is a workflow diagram from SCE's WMP showing the conditions under which SCE will execute remediations under initiative number 8.1.3.1:<sup>8</sup>

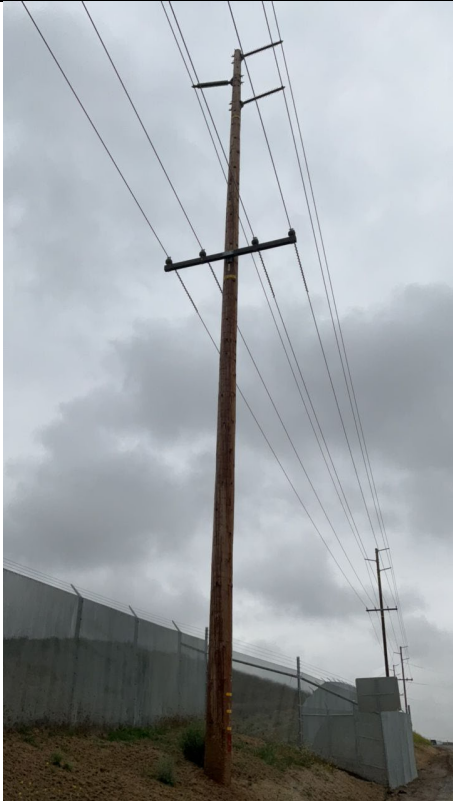
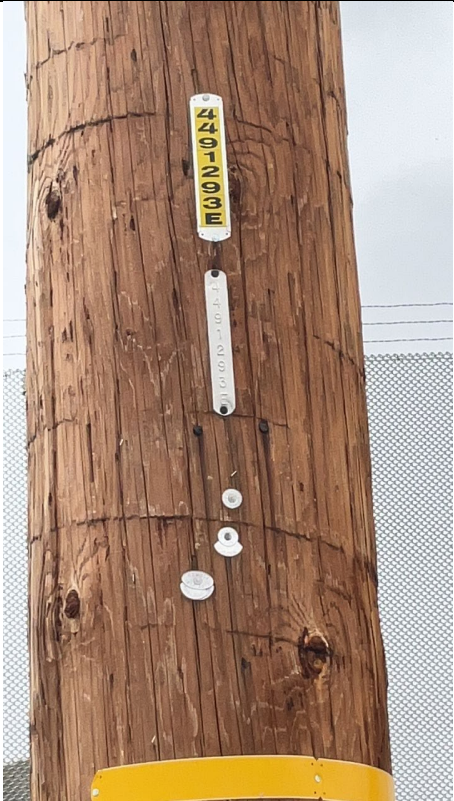
<p>Item1GImg1: Overall pole</p>	<p>Item1GImg2: Pole ID</p>

On pole ID 4491293E, Grid Hardening ID 413415665-4491293E at 36000-36030 Gilman Springs Rd, Moreno Valley, CA, 92555, USA, 33.8727452541626, -117.048218670861, the inspector observed that no wildlife covers were installed. The inspector's observation is documented in Violation 1 photographs, which are attachments to this report. Photo number Item1A1Img1 depicts that there are no wildlife covers on the pole. Per information provided by SCE to the Compliance Inbox on June 4, 2025, at 4:13 pm, the remediation of wildlife covers was completed.

1. Southern California Edison Company's 2024 WMP 8.1.3.1 Distribution Detailed Inspections and Remediations work identified that the remediation of wildlife covers was complete at this location.
2. The wildlife covers were not installed.

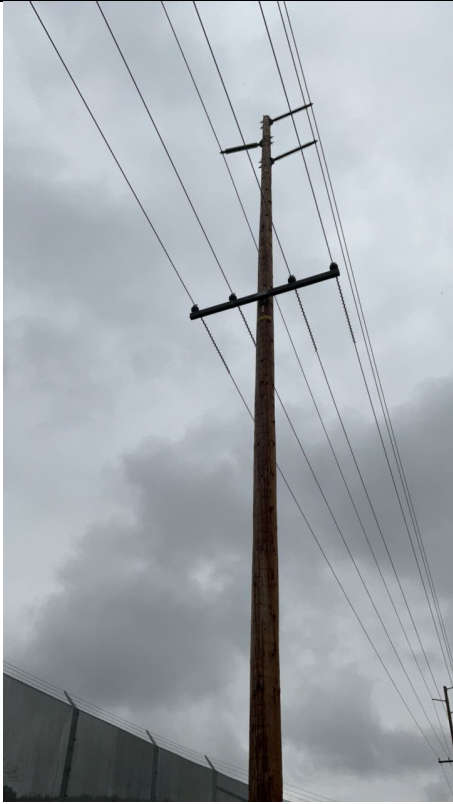
**Item1IA1mg1:** View showing no wildlife covers installed

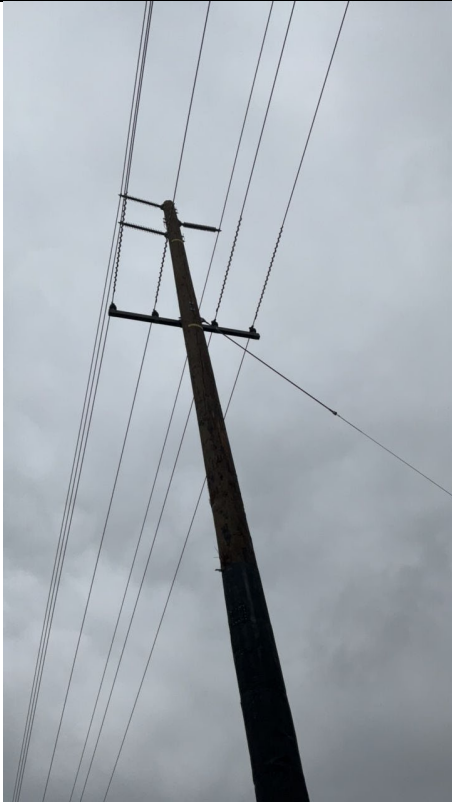
On pole ID 4491289E, Grid Hardening ID 410930023-4491289E at 36000-36030 Gilman Springs Rd, Moreno Valley, CA, 92555, USA, 33.8745356685382, -117.050241481947, the inspector observed that that no wildlife covers were installed. The inspector's observation is documented in Violation 2 photographs, which are attachments to this report. Photo number Item2A1Img1 depicts that there are no wildlife covers on the pole. Per information provided by SCE to the Compliance Inbox on June 4, 2025, at 4:13 pm, the remediation of wildlife covers was completed.

1. Southern California Edison Company's 2024 WMP 8.1.3.1 Distribution Detailed Inspections and Remediations work identified that the remediation of wildlife covers was complete at this location.
2. The wildlife covers were not installed.

**Item2IA1mg1:** View showing no wildlife covers installed
