**SUBJECT:** Southern California Edison Company's Response to Notice of Violation

- NOV CAD SCE ATJ 20250520 1304

## **Finding: Data Accuracy**

Notice	Violation	Structures
NOV_CAD_SCE_ATJ_20250520_1304	1	4864658E

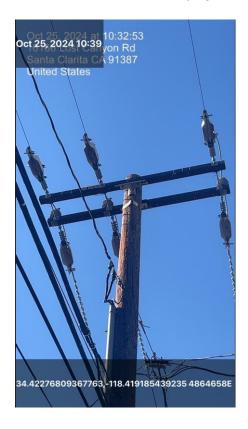
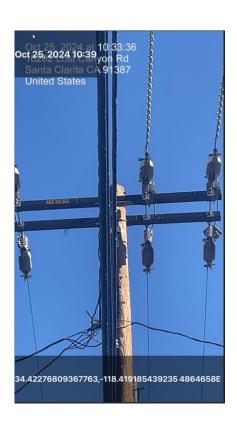
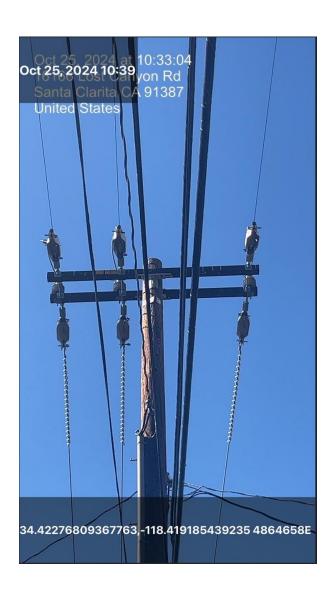
Remediation Photos from 10/25/24 Below

Energy Safety's Notice states that in implementing 2024 WMP initiative 8.1.3.1 - Distribution Detailed Inspections and Remediations (IN-1.1), SCE failed to complete the remediation of rotated dead-end wildlife covers on pole ID 4864658E, Grid Hardening ID 413854385-4864658E at coordinates 34.422765, -118.419019.

SCE confirms that the rotated wildlife dead-end covers on structure ID 4864658E were remediated on October 25, 2024 (see photo evidence below) and that Energy Safety had discovered a recurrence of the issue. During an inspection in response to this Notice, SCE identified that the rotated wildlife dead-end covers were likely due to environmental exposure or other external factors leading to the recurrence of the condition. To remediate the issue, SCE will need to schedule an outage and install different types of nuts.

and bolts to prevent recurrence of the condition. The remediation is planned to be completed by the end of September 2025, and we will provide photo evidence once it has been completed.
