SUBJECT: Southern California Edison Company's Response to Notice of Violation

- NOV_CAD_SCE_YLO_20250506_1049

Finding: Completeness

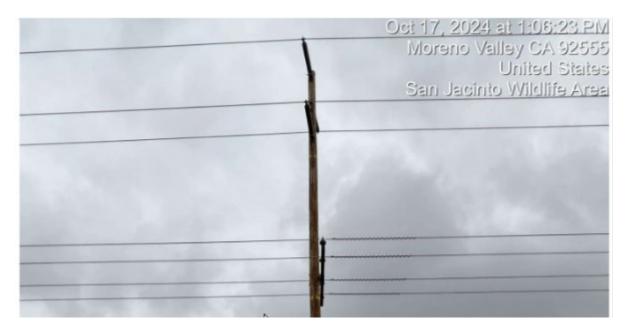
The notification for structure IDs 4491292E, 4491288E, and 4491275E specified the installation of bird guards to address potential avian contact risks. Upon further evaluation, SCE personnel determined that the installation of covered conductor on the center phase would provide a more effective solution. As shown in the photos below, the covered conductor was installed in October 2024 in place of the originally planned bird guards.

Photo 1 – Covered Conductor Installation Structure ID 4491292E

Covered conductor serves the same core function as a bird guard—preventing wildlife contact and mitigating avian related outages—but it does so by fully insulating the energized conductor, rather than shielding a localized jumper connection. This continuous insulation offers enhanced protection by eliminating exposed energized surfaces along the span, thereby exceeding the original scope and intent of the planned bird guard remediation.

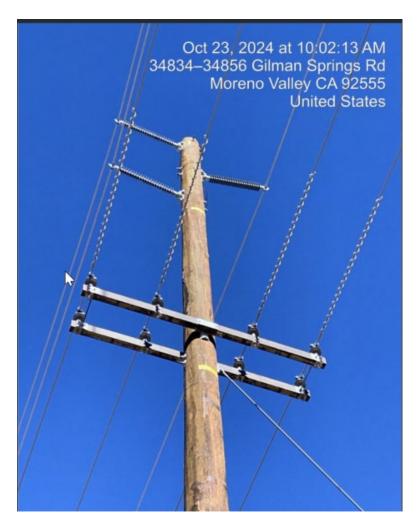
Photo 2 - Covered Conductor Installation Structure ID 4491288E

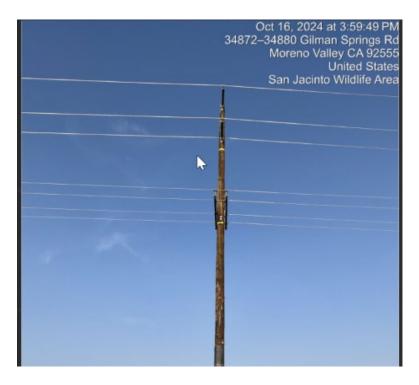
Photo 3 – Covered Conductor Installation Structure ID 4491275E

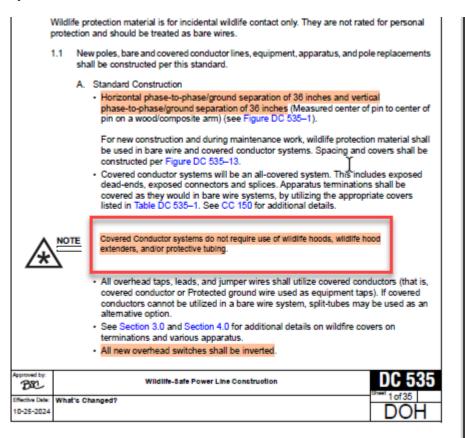
Additionally, per Section DC 535, Sheet 1 of 35 of SCE's Distribution Overhead Construction Standards (DOH), wildlife hoods are not required when covered conductor is used. This standard explicitly recognizes that covered conductor systems eliminate the need for additional wildlife mitigation equipment.

Screenshot – DC 535, Sheet 1 of 35 from SCE's DOH, indicating wildlife hoods are not required with covered conductor
