**SUBJECT:** Southern California Edison Company's Response to Notice of Violation  
NOV\_CAD\_SCE\_LOK\_20250617\_1332

### **Finding: Completeness**

Notice	Violation	Structures
NOV_CAD_SCE_LOK_20250617_1332	1	4210234E

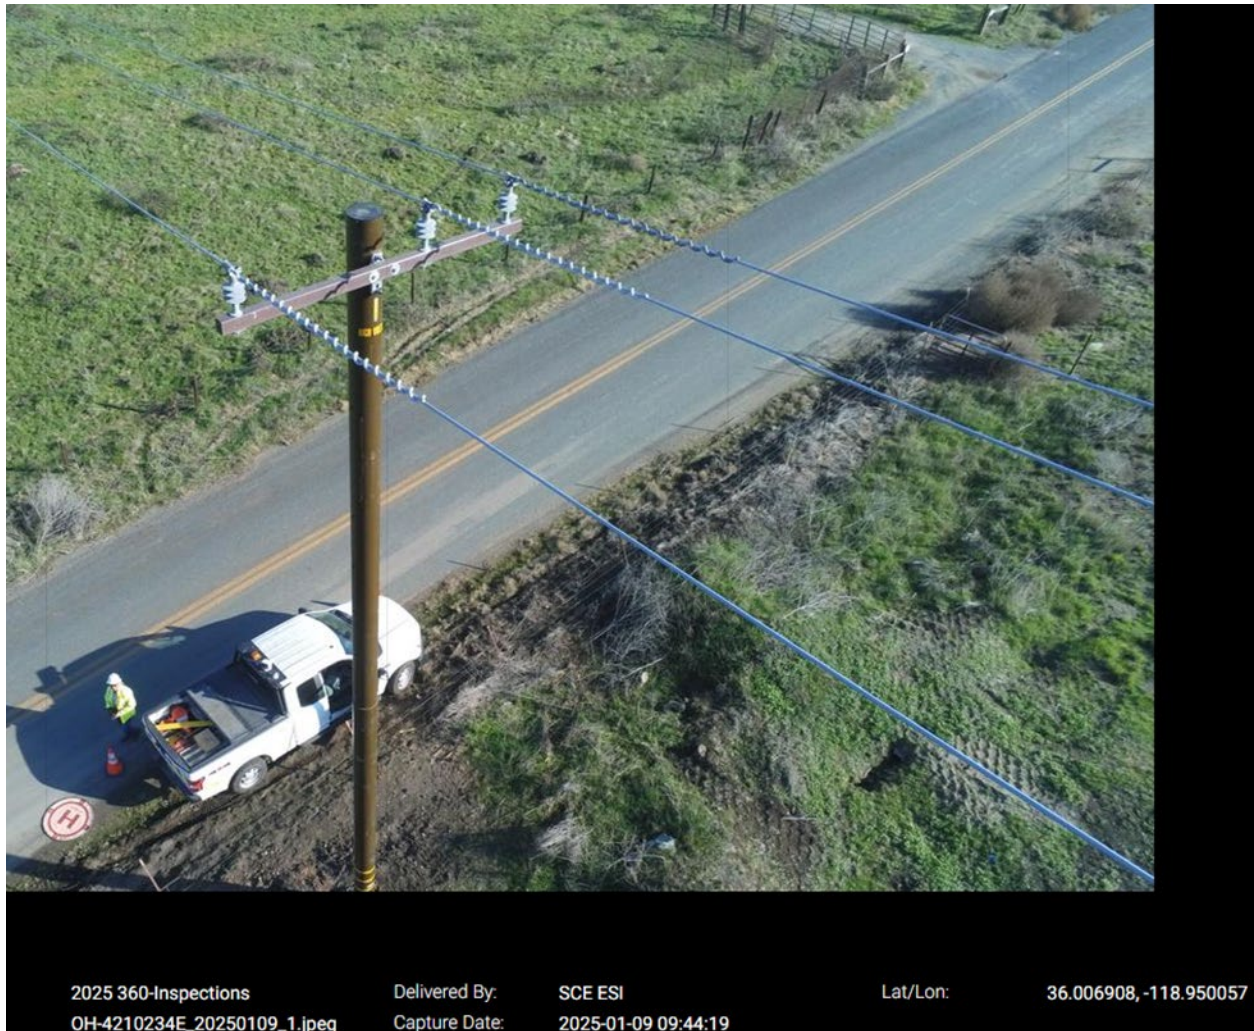
a more comprehensive mitigation. The covered conductor was installed on December 8, 2024, obviating the need for the originally planned bird guard. Please refer to the photo evidence below of the installed covered conductor, as documented during a routine inspection conducted on January 9, 2025.

Covered conductor serves the same core function as a bird guard—preventing wildlife contact and mitigating avian related outages—but it does so by fully insulating the energized conductor, rather than shielding a localized jumper connection. This continuous insulation offers enhanced protection by eliminating exposed energized surfaces along the span, thereby exceeding the original scope and intent of the bird guard remediation.

The notification for structure ID 4210234E specified the installation of a bird guard to address potential avian contact risks. Upon further evaluation, SCE personnel determined that the installation of covered conductor on the center phase would provide

Additionally, per Section DC 535, Sheet 1 of 35 of SCE's Distribution Overhead Construction Standards (DOH), wildlife hoods are not required when covered conductor is installed. This standard explicitly recognizes that covered conductor systems eliminate the need for additional wildlife mitigation equipment.
