## NOTICE OF VIOLATION

On May 21, 2025, Energy Safety conducted an inspection of PacifiCorp's WMP initiatives in the vicinity of the city of Mount Shasta, California. The inspection report is enclosed herewith. Energy Safety found the following violation(s):

Violation 1. Energy Safety observed that in implementing 2024 WMP initiative Distribution Pole Replacement, PC failed to adhere to completeness on pole ID 06240004.289700, Grid Hardening ID 8077847 at coordinates 41.2883908520503, -122.308597826632. Energy Safety considers this completeness violation to be in the Minor risk category.

# INSPECTION REPORT

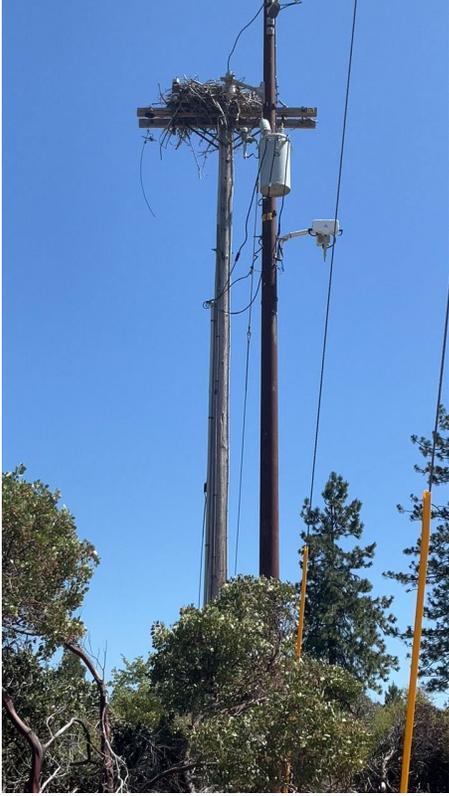
A close-up photograph of a rusted metal utility pole. A yellow identification tag is attached to the pole. The tag has the text "PACIFICORP" at the top, followed by the numbers "06240004" and "289700" on separate lines. The background shows green trees and a clear blue sky.
<p><b>Item1GImg1:</b> Overall pole</p>	<p><b>Item1GImg2:</b> Pole ID</p>

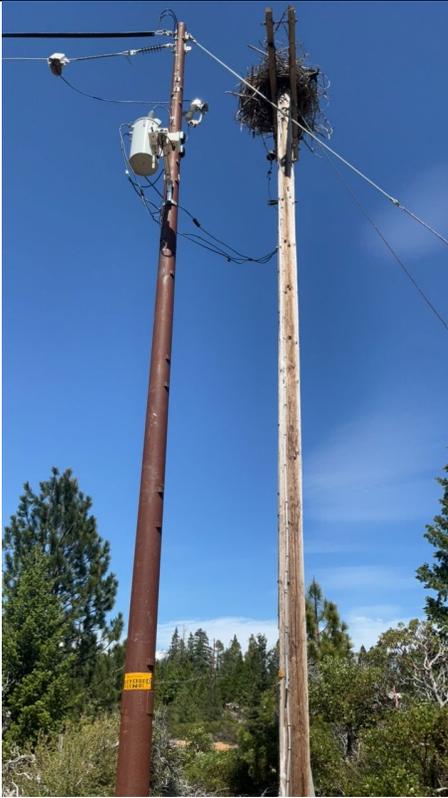
On pole ID 06240004.289700, Grid Hardening ID 8077847 at Volcanic Legacy Scenic Byway, Mount Shasta, CA, 96067, USA, 41.2883908520503, -122.308597826632, the inspector observed that the old pole adjacent to the newly replaced pole remained in use, with an attached riser carrying secondary conductors from the transformer mounted on the new pole. The inspector's observation is documented in Violation 1 photographs, which are attachments to this report. Photo numbers Item1GIimg1, Item1GIimg3, Item1IA1img1, and Item1IA1img2 depict incomplete replacement of a distribution pole. In the 2024 Q3 Quarterly Data Report submission, PC reported that work on WMP initiative 8.1.2.3 - Distribution Pole Replacement and Reinforcement was completed at this location.

**Item1G1mg3:** View of the newly replaced and the old distribution pole

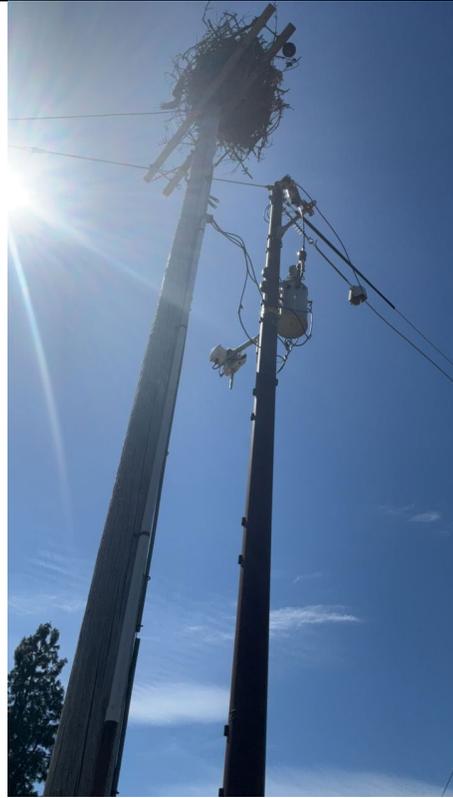
1. A new pole was installed at the inspection location, next to an older pole.
2. The old pole remained in use to support a riser carrying secondary conductors.
3. Because the old pole remained in use to conduct electricity, it was not completely replaced by the new pole next to it.

**Item1IA1mg1:** The newly replaced distribution pole and the old pole still in use as a riser support

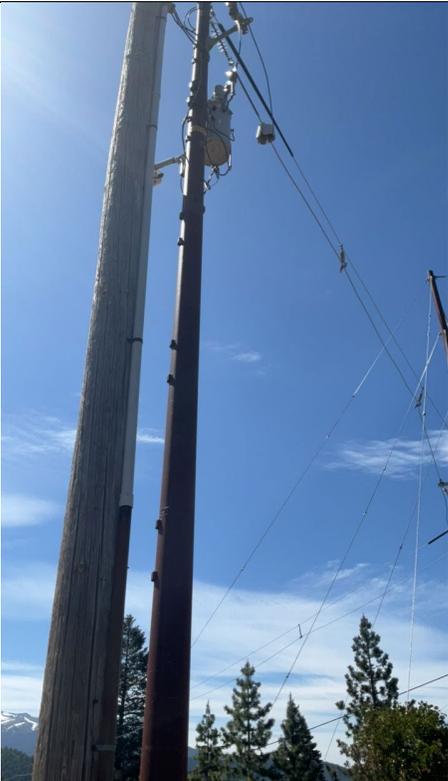
**Item1IA1mg2:** The newly replaced distribution pole and the old pole still in use as a riser support
