## NOTICE OF VIOLATION

On July 10, 2025, Energy Safety conducted an inspection of SCE's WMP initiatives in the vicinity of the city of Temecula, California. The inspection report is enclosed herewith. Energy Safety found the following violation:

# INSPECTION REPORT

## Violation 1

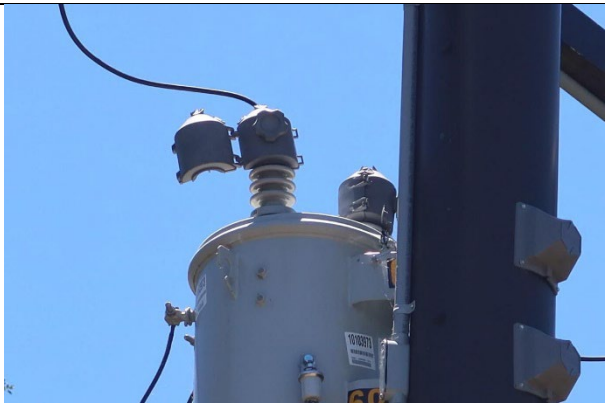
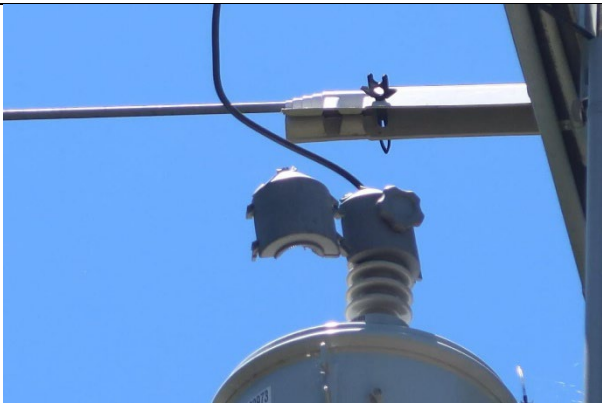
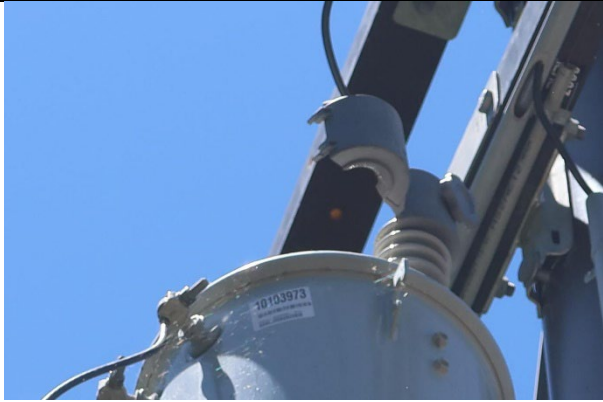
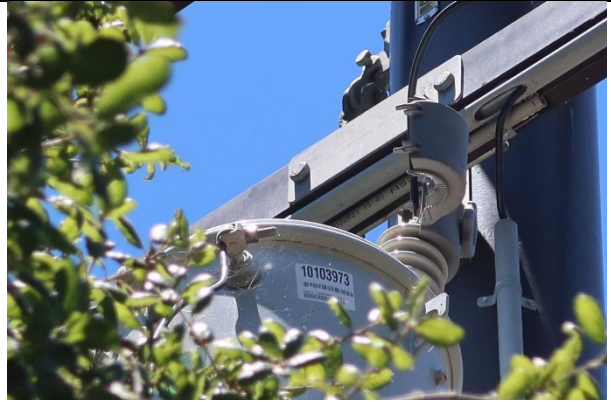
On Pole ID2227580E, Grid Hardening ID 410894941-2227580E at Sandia Creek Dr., Temecula, CA 92590, 33.472045, -117.214765, the inspector observed that the avian protection replacement work was not completed. The inspector's observation is documented in Violation 1 photographs, which are attachments to this report. Photo numbers IA1Img1, IA1Img2, IA1Img3 and IA1Img4 depict that one of the transformer's bushing covers was opened, and transformer's external connecting terminal was exposed. Per information provided by SCE to the Compliance Inbox on August 6, 2025, at 8:32 am, all necessary avian protection was completed on this pole.

1. Southern California Edison Company's 2024 WMP 8.1.3.1 Distribution Detailed Inspections and Remediations work identified that all necessary avian protection was completed at the inspection location.
2. The transformer's bushing cover was opened, and the external connecting terminal was exposed to wildlife; therefore, the avian protection work was incomplete.

IA1img1: Open transformer bushing cover

IA1img2: Open transformer bushing cover

**IA1Img3:** Open transformer bushing cover

**IA1Img4:** Open transformer bushing cover
