SUBJECT: Southern California Edison Company's Response to Notice of Violation

NOV CAD SCE SIS 20250708 1336

Notice	Violation	Structures
NOV_CAD_SCE_SIS_20250708_1336	1	2343288E

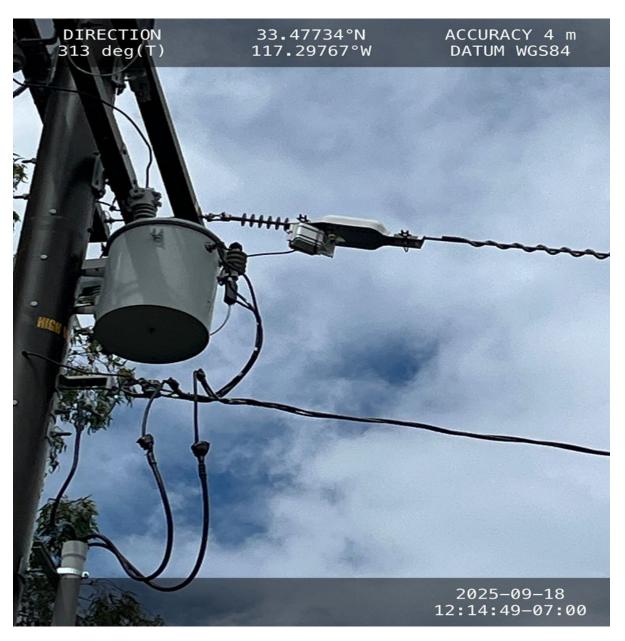
Energy Safety's Notice states that in implementing 2024 WMP initiative 8.1.3.1 - Distribution High Fire Risk-Informed (HFRI) Inspections and Remediations (IN-1.1), SCE failed to complete the remediation of avian protection on Pole ID 2343288E, Grid Hardening ID 413894675-2343288E at coordinates 33.477405, -117.297697.

SCE confirms that the wildlife cover on structure ID 2343288E was remediated on October 7, 2024. During a subsequent inspection in response to this Notice, SCE's Field Operations team identified the previously installed wildlife cover had become dislodged likely due to environmental exposure or other external factors. On September

18, 2025, SCE personnel secured the wildlife cover on structure 2343288E once again. Please find the photo evidence below of the most recently completed wildlife cover remediation.
