Subject: Liberty's Response to Notice of Non-Performance –
NON_ESD_LU_RIB_20250916_1028

Finding: Failure to clear or lop and scatter all slash from the lodgepole pine associated with Vegetation Management ID dd7c3473-870a-4832-b101-a88454914001; minor severity.

Notice	Deficiency #	Location
NON_ESD_LU_RIB_20250916_1028	Deficiency 1	Coordinates 38.872055, -120.001691

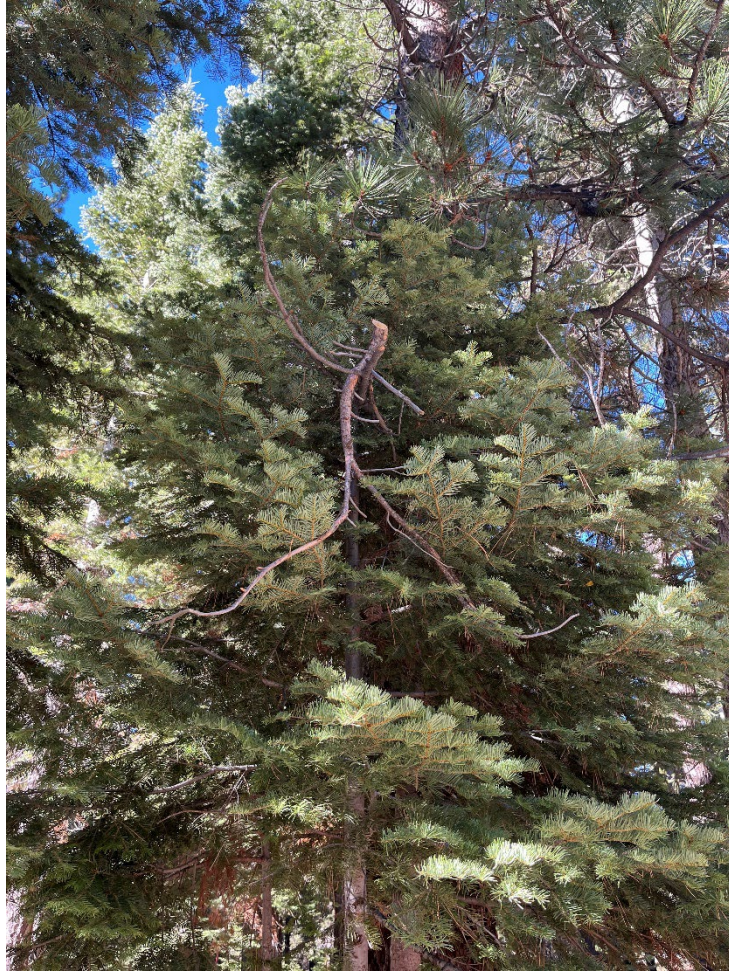
Deficiency 1. Energy Safety observed that in implementing 2025 WMP initiative 8.2.3.4 Fall-In Mitigation, Liberty failed to clear or lop and scatter all slash from the lodgepole pine associated with Vegetation Management ID dd7c3473-870a-4832-b101-a88454914001 at coordinates 38.872055, -120.001691. Additionally, Energy Safety observed a cut lodgepole pine branch hanging from the branches of the surrounding trees directly above the felled log of a lodgepole pine. Energy Safety considers this non-performance to be in the Minor risk category. Liberty must complete a corrective action for this non-performance by 12 months from date of this notice.

Picture 1: Branch in nearby tree
(Vegetation Management ID dd7c3473-870a-4832-b101-a88454914001)

Regarding the branch hanging in a nearby tree, Liberty removed the branch on October 29, 2025. Refer to Picture 1 below for a picture of the branch hanging in the tree and to Pictures 2 and 3 below for pictures after the branch was removed.

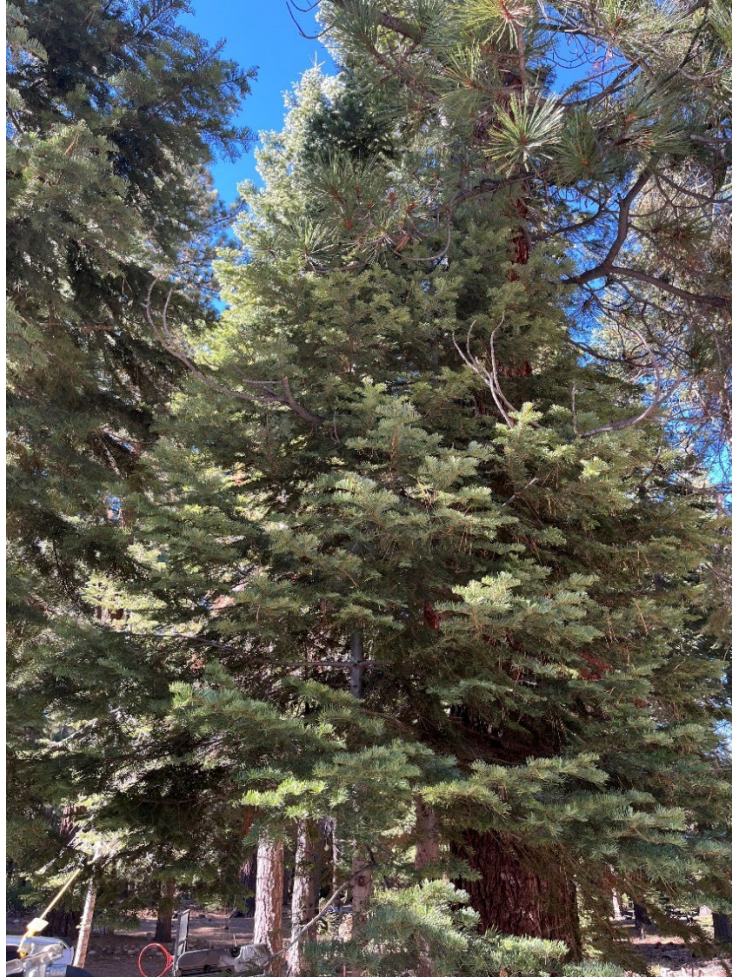
Picture 2: Nearby tree after branch removal
(Vegetation Management ID dd7c3473-870a-4832-b101-a88454914001)

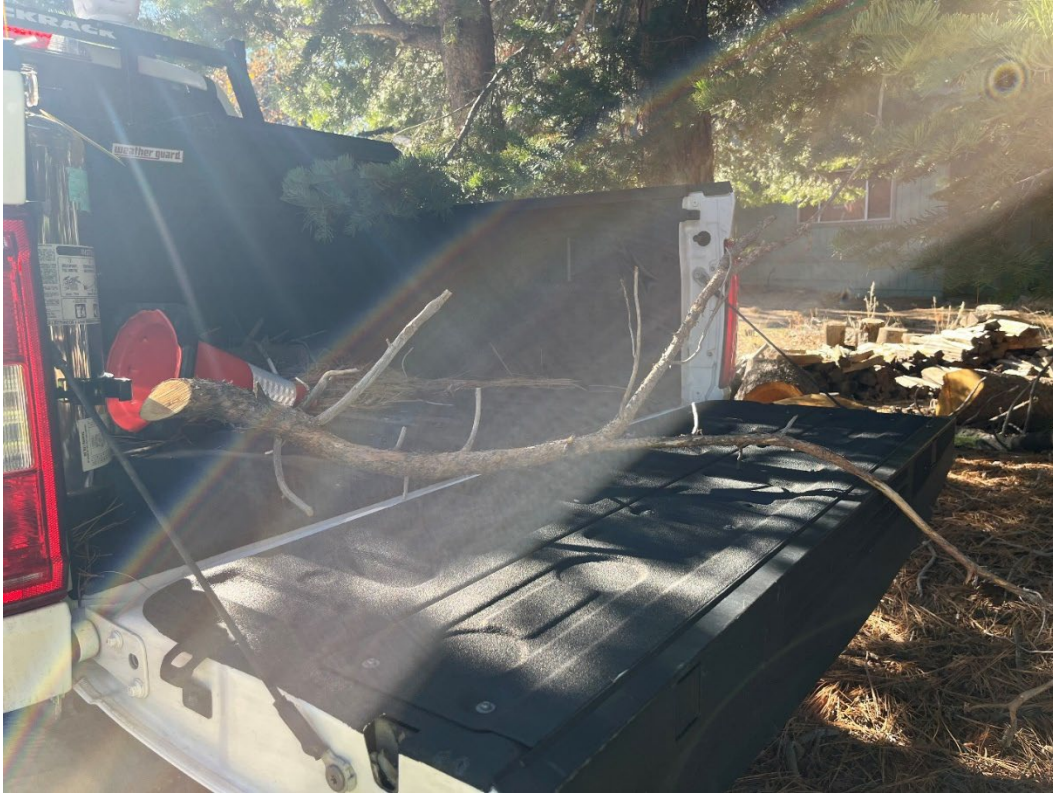
Picture 3: Tree branch after removal
(Vegetation Management ID dd7c3473-870a-4832-b101-a88454914001)
