NOTICE OF NON-PERFORMANCE

INSPECTION REPORT

Electrical Corporation:	Pacific Gas and Electric Company
Report Number:	PAD_PGE_IAG_20260429_1158
Inspector:	Ivan Garcia
WMP Year Inspected:	2025
Quarterly Data Report (QDR) Referenced:	Quarter 4 (Q4)
Inspection Selection:	Energy Safety viewed the contents of the Q4 QDR and performed an analysis that resulted in the selection of the WMP initiatives and locations referenced in this report.
Relevant WMP Initiative(s):	8.1.7.2 – Open Work Orders – Distribution Tags
Date of Inspection:	April 29, 2026
City and/or County of Inspection:	Shingle Springs, El Dorado County
Inspection Purpose:	Assess the accuracy of Pacific Gas and Electric Company's QDR data, completeness of its work, and performance of WMP requirements.

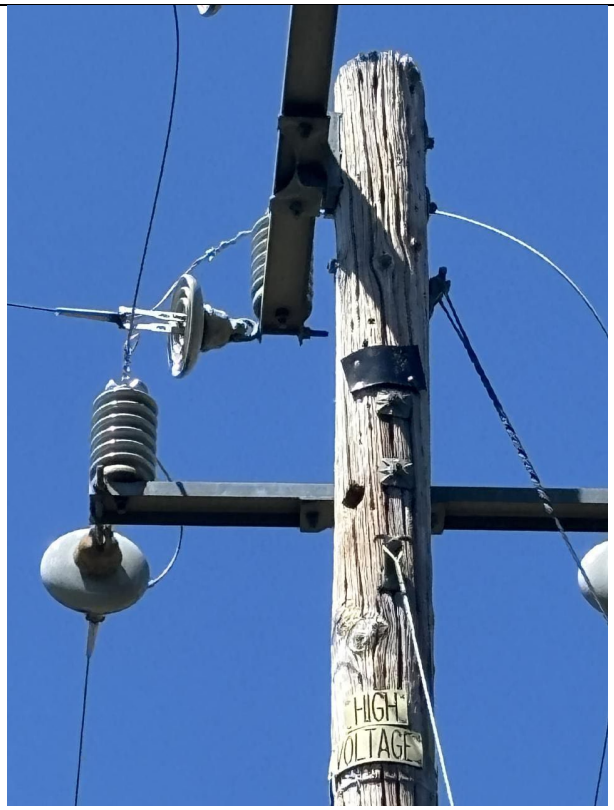
Structure ID: 121300969

On Structure ID I121300969, Grid Hardening ID 119647028 at 3475-3501 Eastview Dr, Shingle Springs, CA, 95682, USA, 38.6737244554636, -120.930135465821, the inspector observed a woodpecker hole greater than one (1) inch in diameter and within two (2) inches of attachment hardware at this location. The inspector's observation is documented in Deficiency 1 photographs, which are attachments to this report. Photo numbers Asset Image 1, Asset Image 2, depict a woodpecker hole present near the attachment hardware and Item1IB1Img1-1, Item1IB1Img1-2, and Item1IB1Img1-3 are references used to evaluate the pole condition. In the 2025 Q4 Quarterly Data Report submission, PG&E reported that work on WMP initiative 8.1.7.2 – Open Work Orders – Distribution Tags was completed at this location.

1. A distribution tag created at the inspection location was cancelled and found not be "non-compelling per updated TD-2305M-JA02, Rev. 14" according to PG&E's distribution tag long text.
2. Inspector observed a woodpecker hole greater than one (1) inch in diameter and within two (2) inches of attachment hardware at this location.
3. Woodpecker holes greater than (1) inch in diameter and within two (2) inches of attachment hardware warrants pole reframe or replacement per PG&E document TD-2305M-JA02, Rev. 14.

General Image 1: Overall Structure	**General Image 2**: Structure ID

Asset Image 1: Woodpecker hole	**Asset Image 2**: Woodpecker hole (secondary view)

Deficiency 1. Energy Safety observed that in implementing 2025 WMP initiative 8.1.7.2 – Open Work Orders – Distribution Tags, PG&E failed to complete work on an open work order – distribution tags on Structure ID 121300969, Grid Hardening ID 119647028 at coordinates 38.6737244554636, -120.930135465821. Energy Safety considers this non-performance to be in the Minor risk category. PG&E must complete a corrective action for this deficiency by 12 months of this notice.[1]
