NOTICE OF NON-PERFORMANCE

INSPECTION REPORT

Electrical Corporation:	Pacific Gas and Electric Company
Report Number:	PAD_PGE_IAG_20260708_1608
Inspector:	Ivan Garcia
WMP Year Inspected:	2025
Quarterly Data Report (QDR) Referenced:	Quarter 4 (Q4)
Inspection Selection:	Energy Safety viewed the contents of the Q4 QDR and performed an analysis that resulted in the selection of the WMP initiatives and locations referenced in this report.
Relevant WMP Initiative(s):	8.1.7.2 – Open Work Orders – Distribution Tags
Date of Inspection:	July 8, 2026
City and/or County of Inspection:	Santa Maria, Santa Barbara County
Inspection Purpose:	Assess the accuracy of Pacific Gas and Electric Company's QDR data, completeness of its work, and performance of WMP requirements.

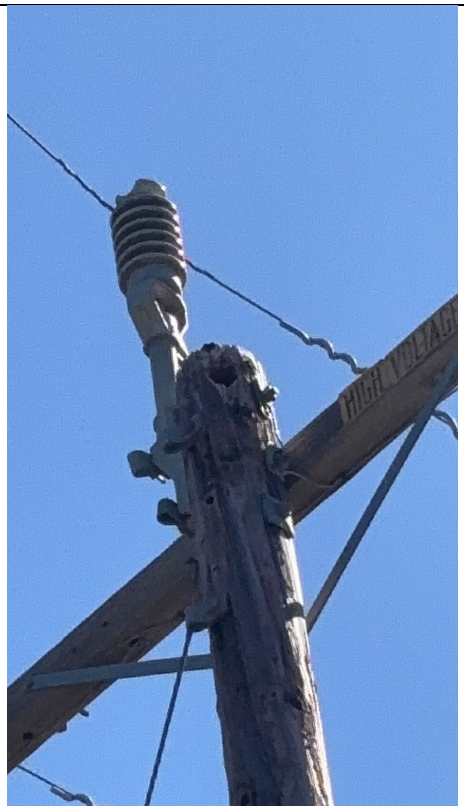
Structure ID: 121143479

On Structure ID 121143479, Grid Hardening ID 123957744 at 9000-9152 Alisos Canyon Rd, Santa Maria, CA, 93455, USA, 34.7471215847129, -120.194272588932, the inspector observed a woodpecker (WP) hole greater than one (1) inch in diameter and within two (2) inches of attachment hardware at this location. The inspector's observation is documented in Deficiency 1 photographs, which are attachments to this report. Photo numbers Asset Image 1 and Asset Image 2 depict a woodpecker hole present near the top of the pole and Item1IB1Img1-1, Item1IB1Img1-2, and Item1IB1Img1-3 are references used to evaluate the pole condition. In the 2025 Q4 Quarterly Data Report submission, PG&E reported that work on WMP initiative 8.1.7.2 – Open Work Orders – Distribution Tags was completed at this location.

1. Distribution tag that had been created for the inspection location was cancelled and found not be "non-compelling per updated TD-2305M-JA02, Rev. 14" according to PG&E's distribution tag long text.
2. Inspector observed a woodpecker hole greater than one (1) inch in diameter and within two (2) inches of attachment hardware at this location.
3. Woodpecker holes greater than one (1) inch in diameter and within two (2) inches of attachment hardware warrants pole reframe or replacement per PG&E document TD-2305M-JA02, Rev. 14.

General Image 1: Overall Structure.	**General Image 2**: Structure ID.

Asset Image 1: WP hole.

Deficiency 1. Energy Safety observed that in implementing 2025 WMP initiative 8.1.7.2 – Open Work Orders – Distribution Tags, PG&E failed to complete work on an open work order – distribution tag on Structure ID 121143479, Grid Hardening ID 123957744 at coordinates 34.7471215847129, -120.194272588932. Energy Safety considers this non-performance to be in the Minor risk category. PG&E must complete a corrective action for this deficiency by 12 months of this notice.[1]
