NOTICE OF NON-PERFORMANCE

INSPECTION REPORT

Electrical Corporation:	PacifiCorp
Report Number:	PAD_PC_IAG_20260520_1029
Inspector:	Ivan Garcia
WMP Year Inspected:	2025
Quarterly Data Report (QDR) Referenced:	Quarter 3 (Q3)
Inspection Selection:	Energy Safety viewed the contents of the Q3 QDR and performed an analysis that resulted in the selection of the WMP initiatives and locations referenced in this report.
Relevant WMP Initiative(s):	8.1.2.12 – Expulsion Fuse Replacements
Date of Inspection:	May 20, 2026
City and/or County of Inspection:	Fort Jones, Siskiyou County
Inspection Purpose:	Assess the accuracy of PacifiCorp's QDR data, completeness of its work, and performance of WMP requirements.

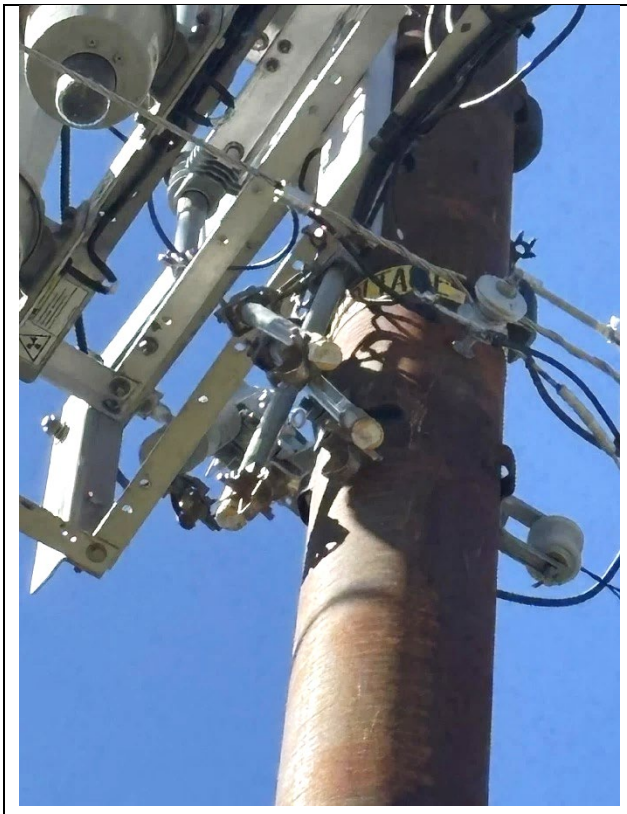
In the 2025 Q3 Quarterly Data Report Submission, PacifiCorp reported that work on WMP initiative 8.1.2.12 – Expulsion Fuse Replacements were completed at Structure ID 06243009.0132501, Grid Hardening ID 7368945 at 41.578971, -122.834518. At this location, the inspector observed three CALFIRE-approved non expulsion fuses that were not installed in the pole's cutouts, but were rather hanging from the pole itself. The inspector's observation is documented in Deficiency 1 photographs, which are attachments to this report. Photo numbers Asset Image 1 and Asset Image 2 depict incomplete installation of CALFIRE-approved non expulsion fuses.

1. Three CALFIRE-approved non expulsion fuses were not installed in the cutouts at the subject pole.
2. Three CALFIRE-approved non expulsion fuses were observed hanging from the subject pole.

Deficiency 1. Energy Safety observed that in implementing 2025 WMP initiative 8.1.2.12 – Expulsion Fuse Replacements, PC failed to complete the installation of California Department of Forestry and Fire Protection (CAL FIRE)-approved non-expulsion fuses on Structure ID 06243009.0132501, Grid Hardening ID 7368945 at coordinates 41.578971, -122.834518. Energy Safety considers this non-performance to be in the Minor risk category. PC must complete a corrective action for this deficiency by 12 months from the date of this notice.[1]
