NOTICE OF DATA INACCURACY

On July 22, 2026, and July 23, 2026, Energy Safety conducted inspections of Southern California Edison Company's 2026 Q1 WMP initiatives in the vicinities of the cities of San Jacinto, Perris, and Hemet, California. The inspection report is enclosed herewith. Energy Safety found the following data inaccuracies:

Exhibit A: Photo Log

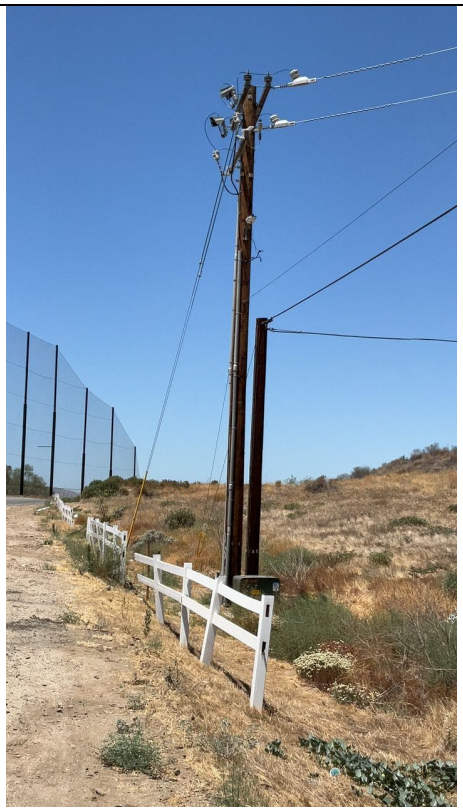
Structure ID: 64655S

Data Inaccuracy Image 1-1: Overall Structure	**Data Inaccuracy Image 1-2**: Structure ID

Data Inaccuracy Image 1-3: No line spacers installed near pole or midspan	**Data Inaccuracy Image 1-4**: No line spacers installed in between two subject poles

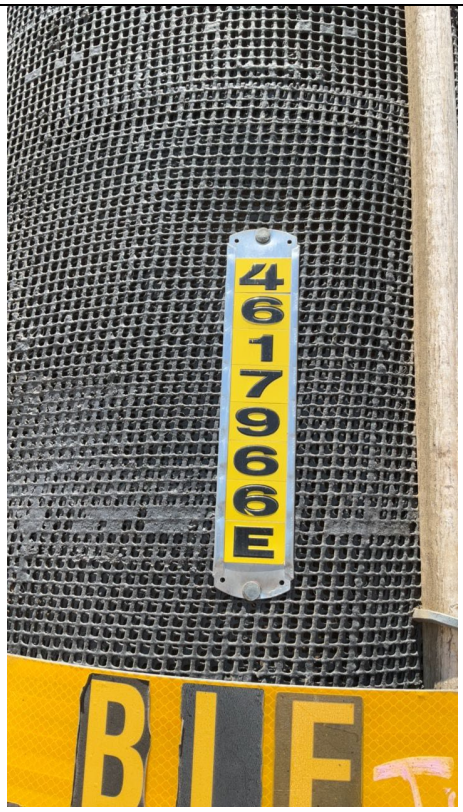
Structure ID: 4617966E

Data Inaccuracy Image 3-1: Overall Structure

Data Inaccuracy Image 3-2: Structure ID

Data Inaccuracy Image 3-3: No line spacers installed between two subject poles.

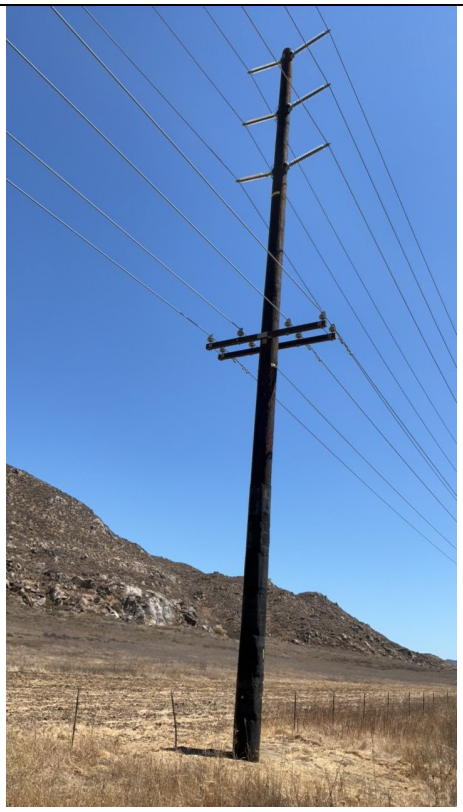
Structure ID: 1804912E

Data Inaccuracy Image 7-1: Overall Structure	**Data Inaccuracy Image 7-2**: Structure ID

Data Inaccuracy Image 7-3: No line spacers installed in between structure IDs 1804912E and 1804913E
