NOTICE OF DATA INACCURACY

INSPECTION REPORT

Electrical Corporation:	Southern California Edison Company
Report Number:	PAD_SCE_SIS_20261007_1023
Date of Inspection:	October 7, 2026
City and/or County of Inspection:	Yucaipa, San Bernardino County
Inspector:	Samuel Isaiah
WMP Year Inspected:	2026
Quarterly Data Report (QDR) Referenced:	Quarter 2 (Q2)
Inspection Selection:	Energy Safety viewed the contents of the Q2 QDR and performed an analysis that resulted in the selection of the WMP initiatives and locations referenced in this report.
Relevant WMP Initiative(s):	8.2.1.1 – WCCP Covered Conductor
Inspection Purpose:	Assess the accuracy of Southern California Edison Company's QDR data, completeness of its work, and performance of WMP requirements.

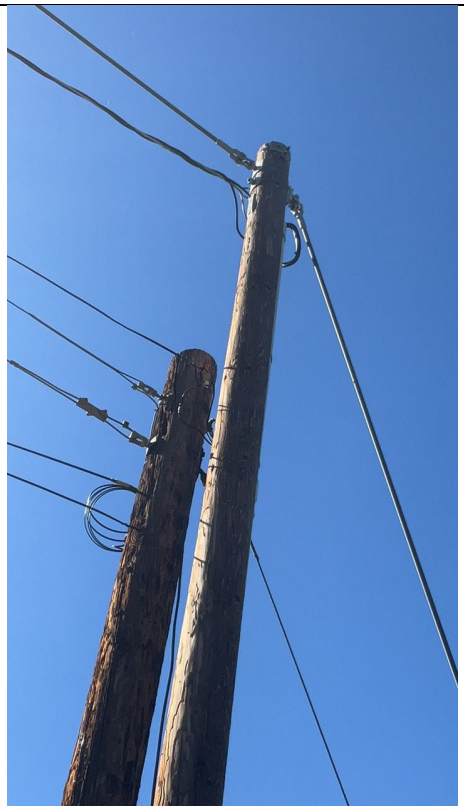
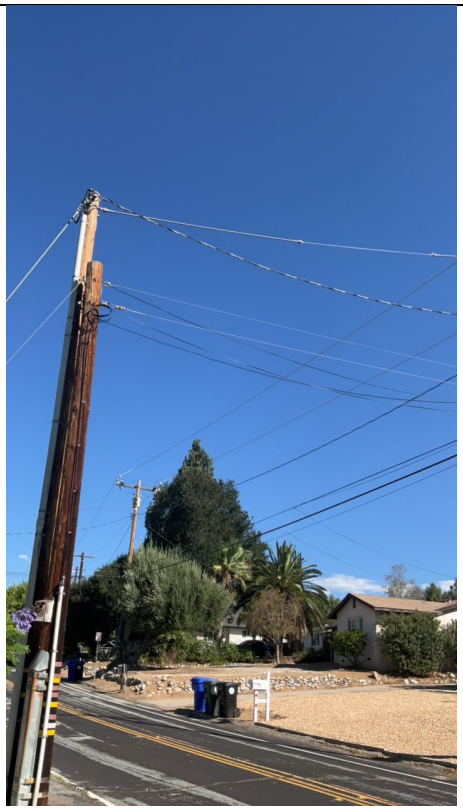
Structure ID: 4680049E

On Structure ID 4680049E, Grid Hardening ID TD2357977-4680049E at 12282 Fremont St, Yucaipa, CA, 92399, USA, coordinates 34.0303981668504, -117.027191402102, the inspector observed that SCE failed to provide accurate data on covered conductor installation initiative. The inspector's observation is documented in Data Inaccuracy 1 photographs, which are attached to this report as Exhibit A.

1. SCE reported in the 2026 Q2 QDR that work on WMP initiative 8.2.1.1 – WCCP Covered Conductor was completed at this location.
2. In 2024, SCE informed Energy Safety that stub pole work does not count toward Covered Conductor WMP totals and would either identify or exclude these points in future QDRs. This data point did not contain an identifier and was not excluded.
3. No covered conductor was observed.

This observation indicates that the data regarding covered conductor was not accurate. Failure to rectify this data inaccuracy prior to the submission of any performance assessments, such as annual reports, may result in a notice of non-performance.

Asset Image 1: No covered conductor observed	**Asset Image 2**: No covered conductor observed

Within 30 days from the issuance date of this NODI, SCE should provide a response advising Energy Safety of corrective actions taken or planned to remedy the identified data inaccuracy or inaccuracies.
