NOTICE OF DATA INACCURACY

INSPECTION REPORT

Electrical Corporation:	Southern California Edison Company
Report Number:	PAD_SCE_SIS_20261007_1026
Date of Inspection:	October 7, 2026
City and/or County of Inspection:	Yucaipa, San Bernardino County
Inspector:	Samuel Isaiah
WMP Year Inspected:	2026
Quarterly Data Report (QDR) Referenced:	Quarter 2 (Q2)
Inspection Selection:	Energy Safety viewed the contents of the Q2 QDR and performed an analysis that resulted in the selection of the WMP initiatives and locations referenced in this report.
Relevant WMP Initiative(s):	8.2.1.1 – WCCP Covered Conductor
Inspection Purpose:	Assess the accuracy of Southern California Edison Company's QDR data, completeness of its work, and performance of WMP requirements.

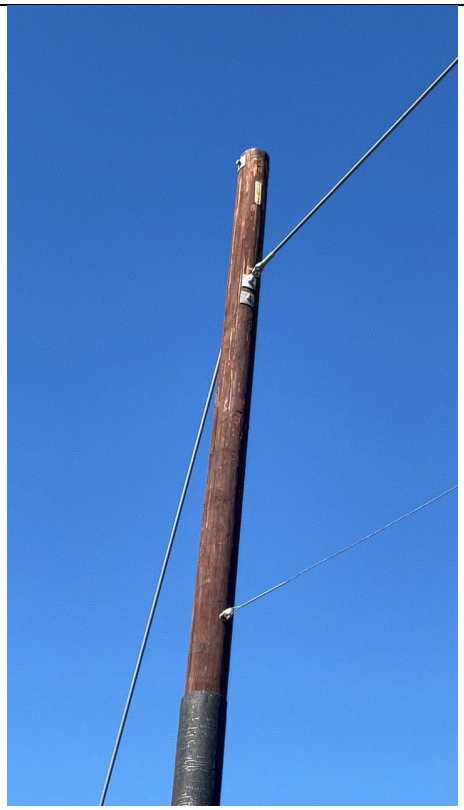
On Structure ID 5806823E, Grid Hardening ID TD2357977-5806823E at 12298 Fremont St, Yucaipa, CA, 92399, USA, coordinates 34.0299719993623, -117.026951999965, the inspector observed that SCE failed to provide accurate data on covered conductor installation initiative. The inspector's observation is documented in Data Inaccuracy 1 photographs, which are attached to this report as Exhibit A.

1. SCE reported in the 2026 Q2 QDR that work on WMP initiative 8.2.1.1 – WCCP Covered Conductor was completed at this location.
2. In 2024, SCE informed Energy Safety that stub pole work does not count toward Covered Conductor WMP totals and would either identify or exclude these points in future QDRs. This data point did not contain an identifier and was not excluded.
3. No covered conductor was observed.

This observation indicates that the data regarding covered conductor was not accurate. Failure to rectify this data inaccuracy prior to the submission of any performance assessments, such as annual reports, may result in a notice of non-performance.

Asset Image 1: No covered conductor observed	**Asset Image 2**: No covered conductor observed

Within 30 days from the issuance date of this NODI, SCE should provide a response advising Energy Safety of corrective actions taken or planned to remedy the identified data inaccuracy or inaccuracies.
