NOTICE OF DATA INACCURACY

INSPECTION REPORT

Electrical Corporation:	Southern California Edison Company
Report Number:	PAD_SCE_SIS_20261007_1021
Date of Inspection:	October 7, 2026
City and/or County of Inspection:	Yucaipa, San Bernardino County
Inspector:	Samuel Isaiah
WMP Year Inspected:	2026
Quarterly Data Report (QDR) Referenced:	Quarter 2 (Q2)
Inspection Selection:	Energy Safety viewed the contents of the Q2 QDR and performed an analysis that resulted in the selection of the WMP initiatives and locations referenced in this report.
Relevant WMP Initiative(s):	8.2.1.1 – WCCP Covered Conductor
Inspection Purpose:	Assess the accuracy of Southern California Edison Company's QDR data, completeness of its work, and performance of WMP requirements.

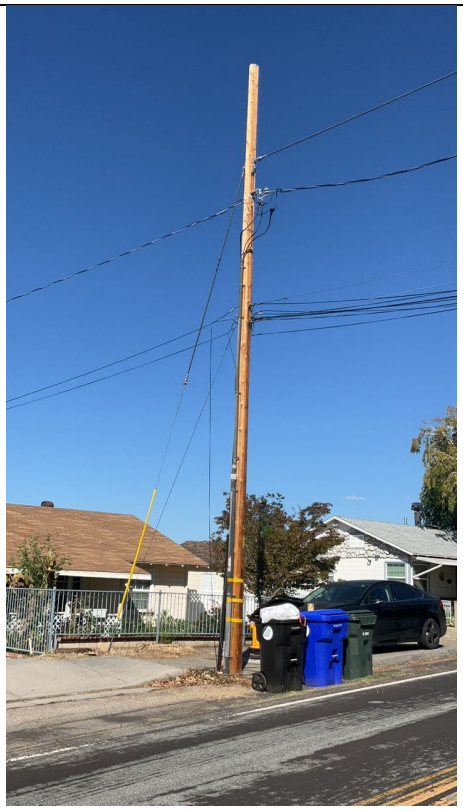
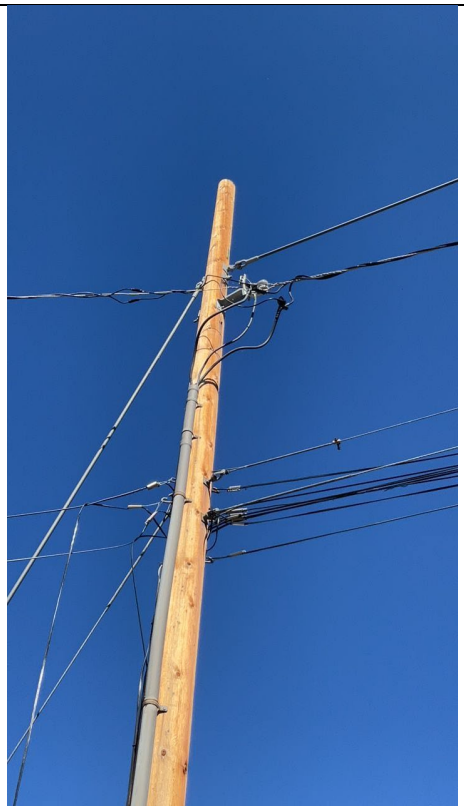
Data Inaccuracy 1

Data Inaccuracy 1. On Structure ID 4332416E, Grid Hardening ID TD2357977-4332416E at coordinates 34.0306693483214, -117.027275723204, the inspector observed that no covered conductor was installed at the specified location.

1. SCE reported in the 2026 Q2 QDR that work on WMP initiative 8.2.1.1 – WCCP Covered Conductor was completed at this location.
2. In 2024, SCE informed Energy Safety that stub pole work does not count toward Covered Conductor WMP totals and would either identify or exclude these points in future QDRs. This data point did not contain an identifier and was not excluded.
3. No covered conductor was observed.

This observation indicates that the data regarding covered conductor was not accurate. Failure to rectify this data inaccuracy prior to the submission of any performance assessments, such as annual reports, may result in a notice of non-performance.

Asset Image 1: No covered conductor observed	**Asset Image 2**: No covered conductor observed

Within 30 days from the issuance date of this NODI, SCE should provide a response advising Energy Safety of corrective actions taken or planned to remedy the identified data inaccuracy or inaccuracies.
