NOTICE OF DATA INACCURACY

INSPECTION REPORT

Electrical Corporation:	Southern California Edison Company
Report Number:	PAD_SCE_SIS_20261007_0959
Date of Inspection:	October 7, 2026
City and/or County of Inspection:	Yucaipa, San Bernardino County
Inspector:	Samuel Isaiah
WMP Year Inspected:	2026
Quarterly Data Report (QDR) Referenced:	Quarter 2 (Q2)
Inspection Selection:	Energy Safety viewed the contents of the Q2 QDR and performed an analysis that resulted in the selection of the WMP initiatives and locations referenced in this report.
Relevant WMP Initiative(s):	8.2.1.1 – WCCP Covered Conductor
Inspection Purpose:	Assess the accuracy of Southern California Edison Company's QDR data, completeness of its work, and performance of WMP requirements.

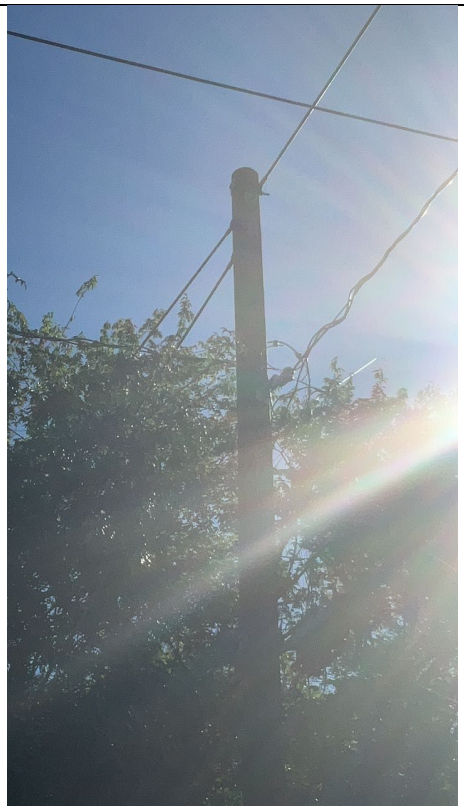
Structure ID: 4332414E

On Structure ID 4332414E, Grid Hardening ID TD2357977-4332414E at 35595 Avenue D, Yucaipa, CA, 92399, USA, coordinates 34.029614437502, -117.028147232709, the inspector observed that SCE failed to provide accurate data on covered conductor installation initiative. The inspector's observation is documented in Data Inaccuracy 1 photographs, which are attached to this report as Exhibit A.

1. SCE reported in the 2026 Q2 QDR that work on WMP initiative 8.2.1.1 – WCCP Covered Conductor was completed at this location.
2. In 2024, SCE informed Energy Safety that stub pole work does not count toward Covered Conductor WMP totals and would either identify or exclude these points in future QDRs. This data point did not contain an identifier and was not excluded.
3. No covered conductor was observed.

This observation indicates that the data regarding covered conductor was not accurate. Failure to rectify this data inaccuracy prior to the submission of any performance assessments, such as annual reports, may result in a notice of non-performance.

Asset Image 1: No covered conductor observed	**Asset Image 2**: No covered conductor observed

Within 30 days from the issuance date of this NODI, SCE should provide a response advising Energy Safety of corrective actions taken or planned to remedy the identified data inaccuracy or inaccuracies.
