NOTICE OF NON-PERFORMANCE

INSPECTION REPORT

Electrical Corporation:	Southern California Edison Company
Report Number:	NON_PAD_SCE_YLO_20260826_1436
Inspector:	Yana Loginova
WMP Year Inspected:	2026
Quarterly Data Report (QDR) Referenced:	Quarter 1 (Q1)
Inspection Selection:	Energy Safety viewed the contents of the Q1 QDR and performed an analysis that resulted in the selection of the WMP initiatives and locations referenced in this report.
Relevant WMP Initiative(s):	8.3.1 Distribution High Fire Risk-Informed (HFRI) Inspections - Ground and Aerial (IN-1.1)
Date of Inspection:	August 26, 2026
City and/or County of Inspection:	Chino Hills, San Bernardino County
Inspection Purpose:	Assess the accuracy of Southern California Edison Company's QDR data, completeness of its work, and performance of WMP requirements.

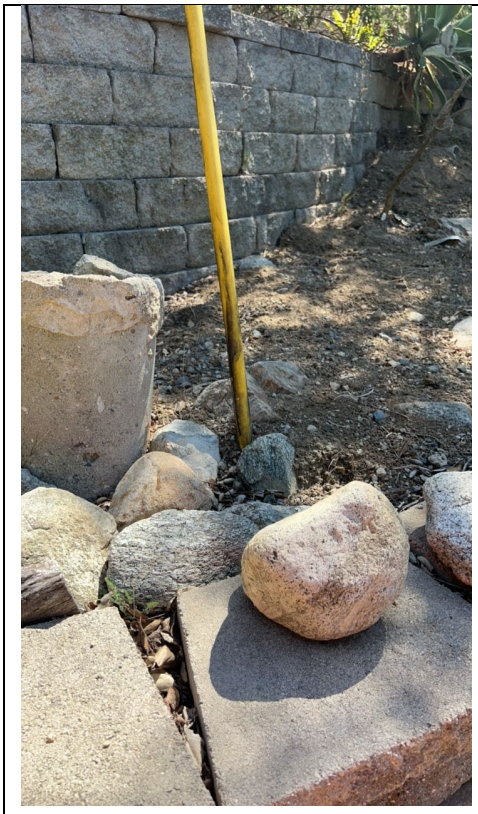
At this location, the inspector observed that anchor was buried. The inspector's observation is documented in Deficiency 1 photographs, which are attachments to this report. Photo numbers Asset Image 1, Asset Image 2, Asset Image 3, and Asset Image 4, depict buried anchor.

1. Southern California Edison Company reported that work related to a buried anchor at the location was completed under SCE's 2026 WMP initiative number 8.3.1 - Distribution High Fire Risk-Informed (HFRI) Inspections.
2. The anchor was found buried at the inspection location.

Deficiency 1. Energy Safety observed that in implementing 2026 WMP initiative 8.3.1 Distribution High Fire Risk-Informed (HFRI) Inspections - Ground and Aerial (IN-1.1), SCE failed to complete the remediation of buried anchor in a customer's backyard garden on Structure ID 517907E, Grid Hardening ID 413658337-517907E at coordinates 33.9570795865286, -117.767951189578. Energy Safety considers this non-performance to be in the Minor risk category. SCE must complete a corrective action for this deficiency by 12 months from the date of this notice.[1]
