CALIFORNIA UNDERGROUND SAFETY BOARD
INVESTIGATION DIVISION

INVESTIGATION REPORT

Date: August 25, 2026
Case No.: C250710002

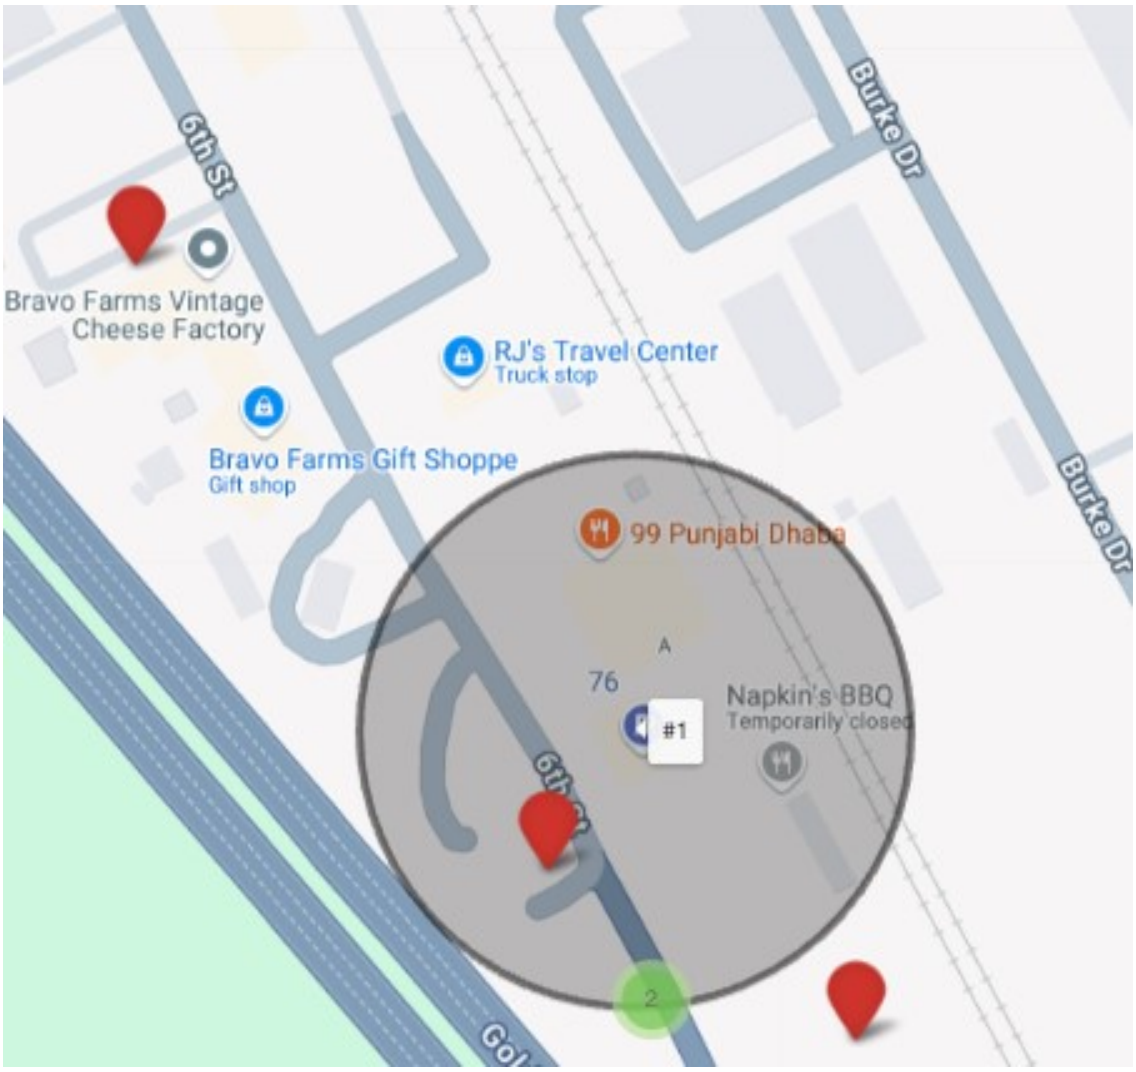
Attached is a screenshot from Google Maps of the approximate location of the billboard for reference.
