## NOTICE OF NON-PERFORMANCE

# INSPECTION REPORT

| Report Number: | PAD_PGE_AXS_20251118_1057 |

## Deficiency 1

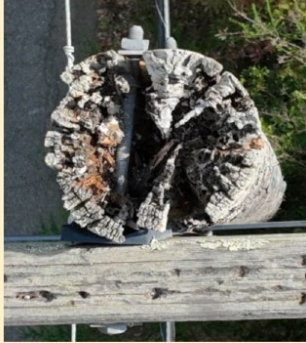
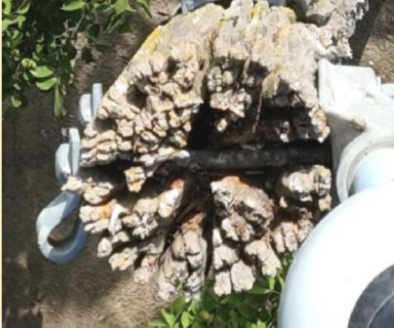
| DECAY OF POLE OVER TIME – AERIAL VIEW | |

| DECAY OF POLE OVER TIME – AERIAL VIEW | |
|---|---|
| At this Location: Pole top decayed.<br> | |
| Write EC Notification: Yes<br>FDA= Pole Decayed/Rotten/Replace | Write EC Notification: Yes<br>FDA= Pole Decayed / Rotten / Replace |

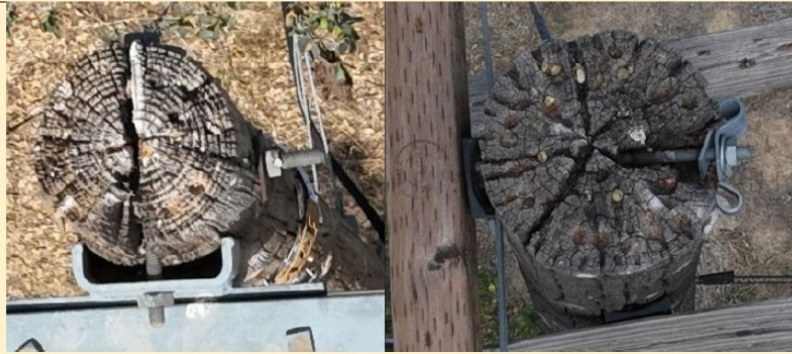
# DECAY OF POLE OVER TIME – AERIAL VIEW

At this Location: Pole top decayed.

FDA= Pole Decayed/Rotten/Replace
