NOV_SCE ATJ_20220406-01

NOTICE OF VIOLATION

Report Name: SCE_ATJ_20220406-01

On April 6, 2022, I performed a walking inspection of Southern California Edison (SCE) covered conductor installations, 2021 WMP initiative number 7.3.3.3.1, in the Tule River Reservation in Springwater, California. I also observed the overall vegetation management within the area. Detailed findings from this field inspection are laid out in Section II below.

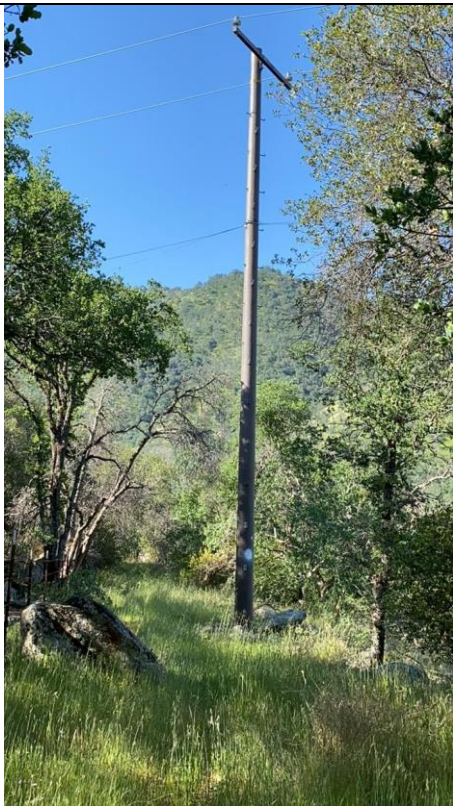
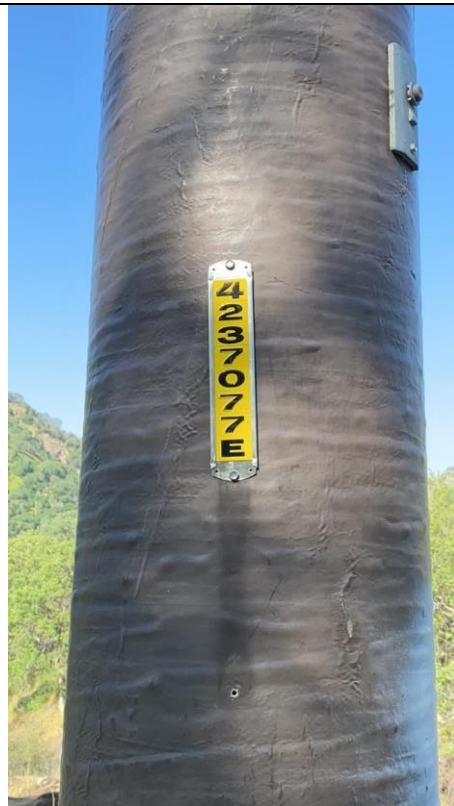
Structure ID: 4237077E

| Item | Structure ID | HFTD | Initiative Number | Violation Type | Severity | Violation Description |
|---|---|---|---|---|---|---|
| 1 | 4237077E | Non-HFTD | 7.3.3.3.1 | Adherence to Protocol | Minor | Failure to install vibration dampers on a span |

Per SCE's DDS and DOH, when installing covered conductor, vibration dampers must also be installed.¹ Energy Safety staff found that vibration dampers were not installed at multiple structures where covered conductor was completed. The structures missing vibration dampers where covered conductor was installed are identified in Table 2 above. On November 19, 2021, SCE submitted a memo to Energy Safety titled, "Interim Deviation from Standards on Vibration Damper for Covered Conductor" (hereafter, "Memo").² This Memo was dated August 18, 2021, and indicates that due to supply chain issues, SCE will suspend the installation of vibration dampers until December 31, 2021. On March 25, 2022, SCE sent an earlier version of that Memo that was dated May 18, 2021.³ However, Energy Safety finds that SCE is still in violation of its protocols requiring the installation of vibration dampers as part of covered conductor installations.

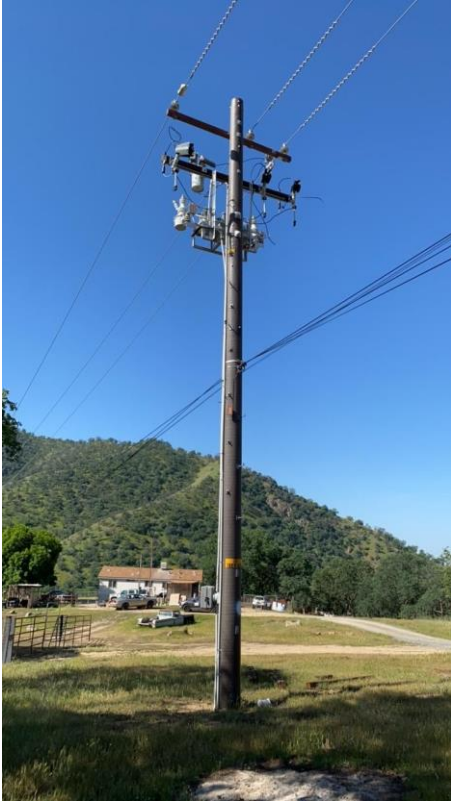
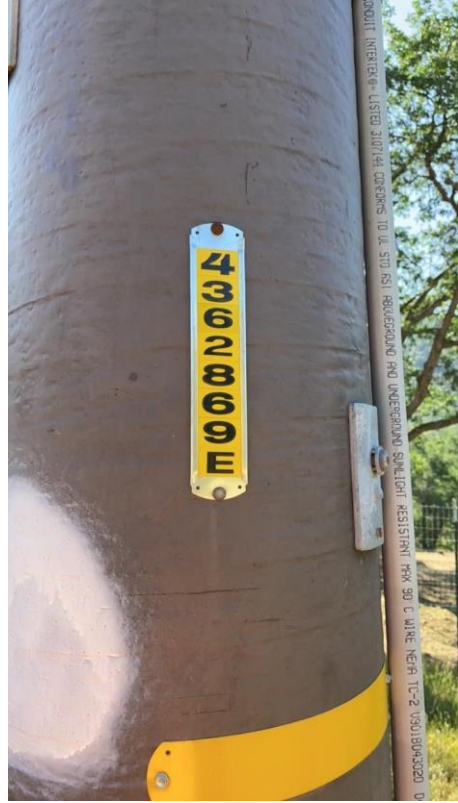
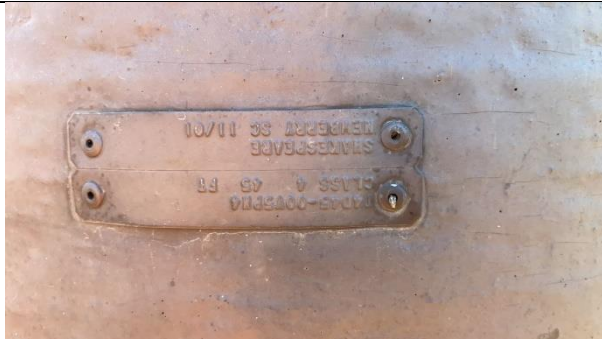
Structure ID: 4362869E

| Item | Structure ID | HFTD | Initiative Number | Violation Type | Severity | Violation Description |
|---|---|---|---|---|---|---|
| 2 | 4362869E | Tier 2 | 7.3.3.3.1 | Adherence to Protocol | Minor | Wildlife terminator/pothead covers found on ground |

In accordance with SCE's protocols for covered conductor installation, DOH CC 180, "If conductor is exposed, install bolted wedge connector cover" and "If overhead equipment is located at a pole transition from bare wire to covered conductor, the equipment is considered part of the covered conductor system." During the inspection, Energy Safety found one instance where a pothead cover fell off the conductor and lying next to the pole. The structure where this protocol was not followed is

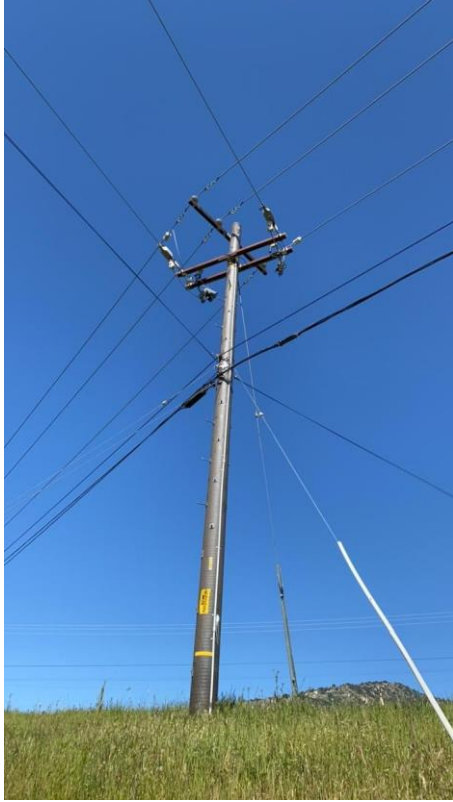
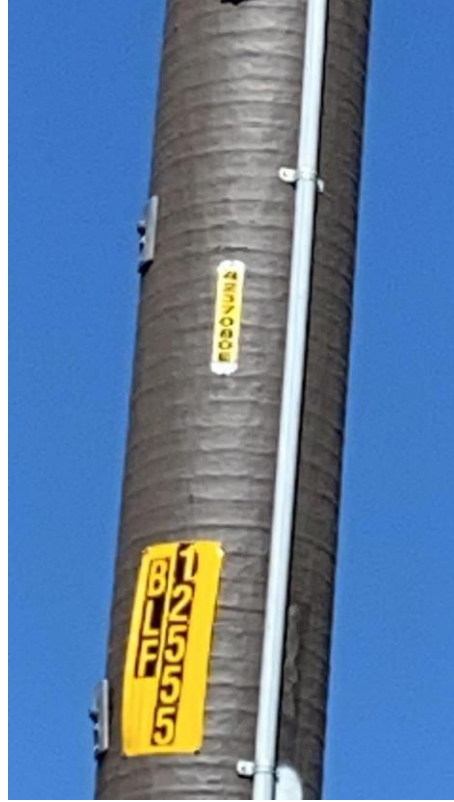
Structure ID: 4237080E

| Item | Structure ID | HFTD | Initiative Number | Violation Type | Severity | Violation Description |
|---|---|---|---|---|---|---|
| 3 | 4237080E | Tier 2 | 7.3.3.3.1 | Adherence to Protocol | Minor | Failure to install vibration dampers on a span |

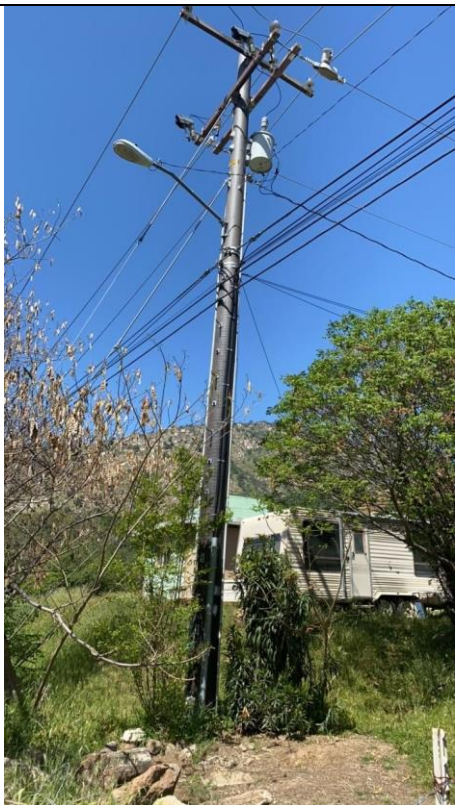
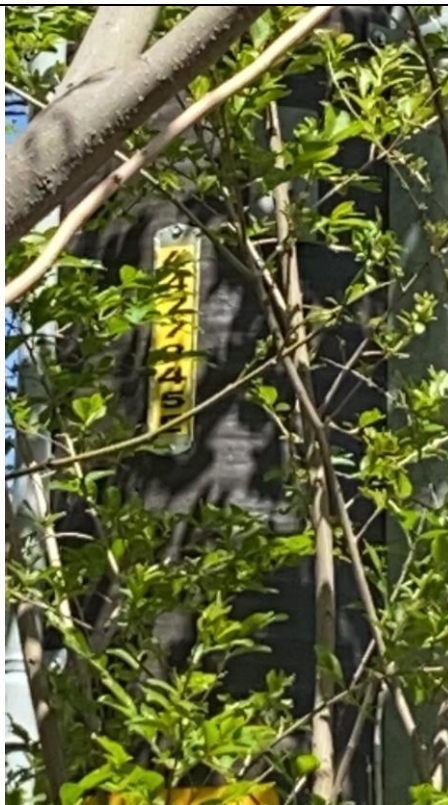
Structure ID: 4477345E

| Item | Structure ID | HFTD | Initiative Number | Violation Type | Severity | Violation Description |
|---|---|---|---|---|---|---|
| 4 | 4477345E | Tier 2 | 7.3.3.3.1 | Adherence to Protocol | Minor | Failure to install vibration dampers on a span |
| 5 | 4477345E | Tier 2 | 7.3.3.3.1 | Adherence to Protocol | Minor | Failure to install anti-rotational clip on dead end cover |

Energy Safety discovered two dead-end covers that were missing anti-rotational devices. Per SCE's DOH, Table DC 535-1: Wildlife Protection Material, SCE requires that anti-rotation clips be used with Dead-End Clamp Covers.⁴ Structures where this protocol was not followed are noted in Table 2 above.

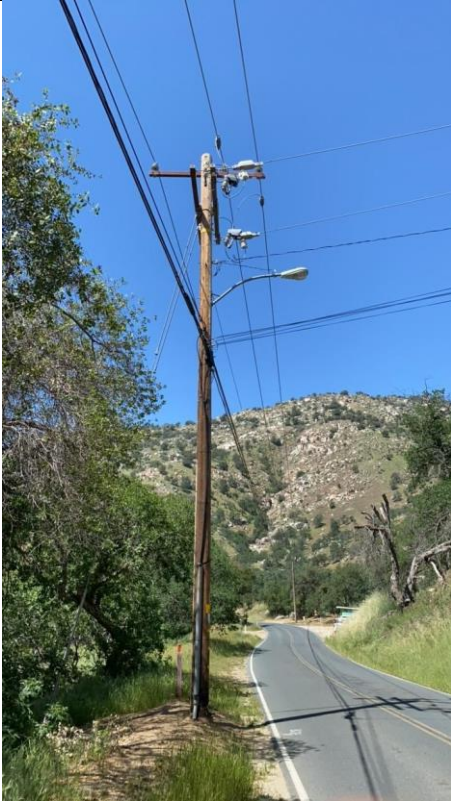
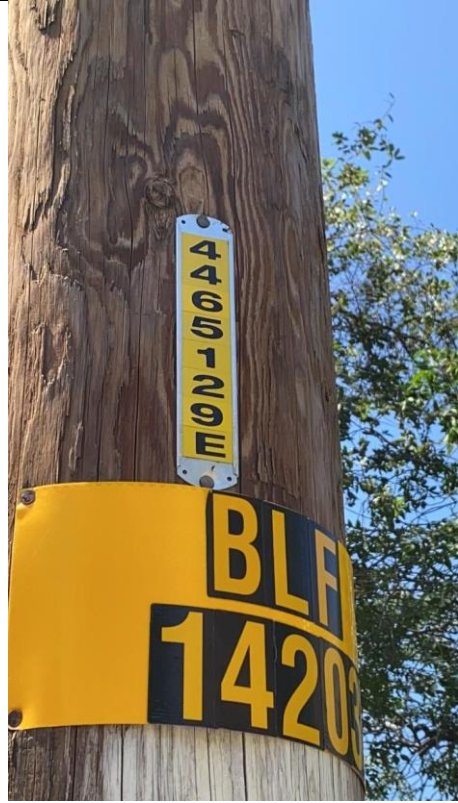
Structure ID: 4465129E

| Item | Structure ID | HFTD | Initiative Number | Violation Type | Severity | Violation Description |
|---|---|---|---|---|---|---|
| 6 | 4465129E | Tier 2 | 7.3.3.3.1 | Adherence to Protocol | Minor | Failure to install vibration dampers on a span |
| 7 | 4465129E | Tier 2 | 7.3.3.3.1 | Adherence to Protocol | Minor | Failure to install anti-rotational clip on dead end cover |

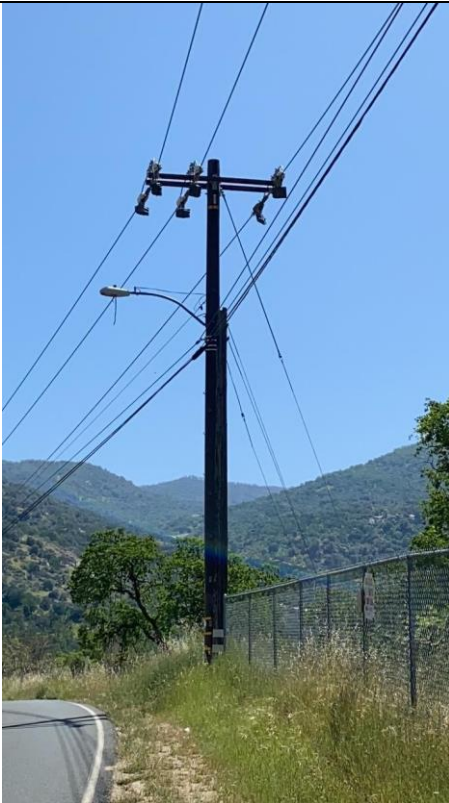
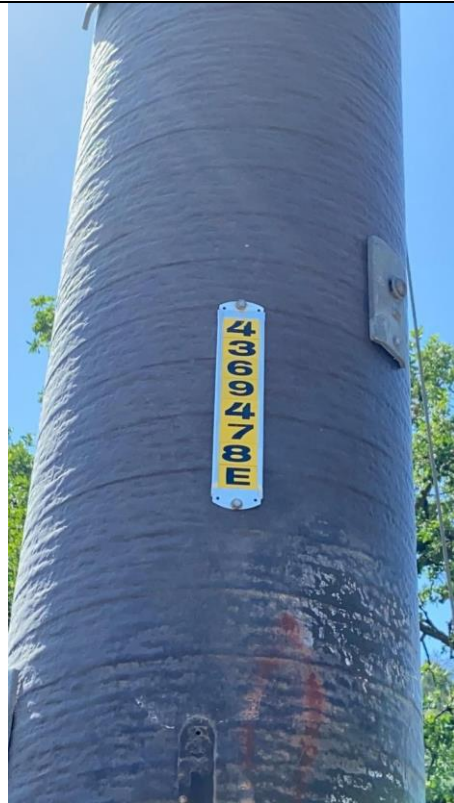
Structure ID: 4369478E

| Item | Structure ID | HFTD | Initiative Number | Violation Type | Severity | Violation Description |
|---|---|---|---|---|---|---|
| 8 | 4369478E | Tier 2 | 7.3.3.3.1 | Adherence to Protocol | Minor | Failure to install vibration dampers on a span |

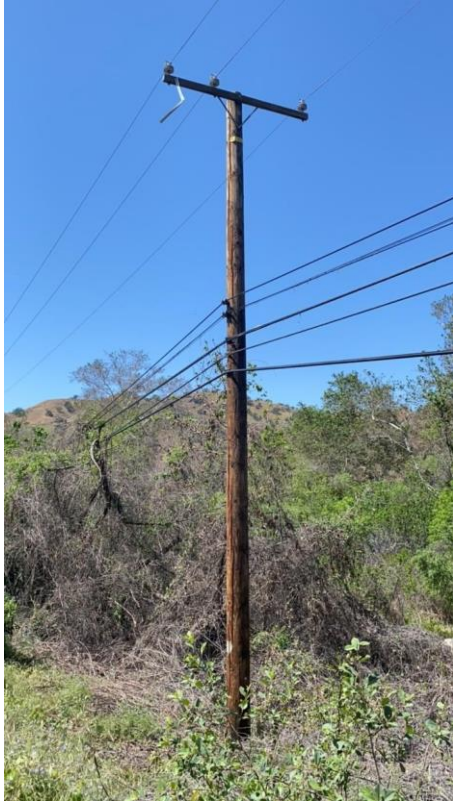
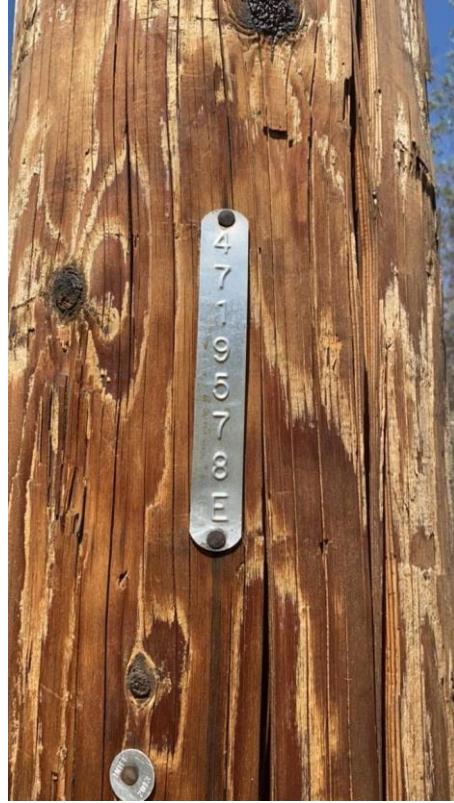
Structure ID: 4719578E

| Item | Structure ID | HFTD | Defect Type | Severity | Defect Description |
|---|---|---|---|---|---|
| 1 | 4719578E | Tier 2 | Cold End Hardware | Minor | Triangular wildlife Guard loose/detaching from crossarm |

In addition to the violations discovered during WMP inspections of SCE's covered conductor installations, Energy Safety discovered a triangular wildlife guard that was dislodged and falling off a crossarm. The structure where this was found is identified in Table 3 above.
