NOTICE OF VIOLATION

INSPECTION REPORT

Electrical Corporation:	Southern California Edison Company
Report Number:	CAD_SCE_ATJ_20250520_1304
Inspector:	Anthony Trujillo
WMP Year Inspected:	2024
Quarterly Data Report (QDR) Referenced:	Quarter 4 (Q4)
Inspection Selection:	Energy Safety viewed the contents of the Q4 QDR and performed an analysis that resulted in the selection of the WMP initiatives and locations referenced in this report.
Relevant WMP Initiative(s):	8.1.3.1 - Distribution Detailed Inspections and Remediations (IN-1.1)
Date of inspection:	May 20, 2025
City and/or County of Inspection:	Canyon Country, Los Angeles County
Inspection Purpose:	Assess the accuracy of Southern California Edison’s QDR data, completeness of its work, compliance with WMP requirements, and compliance with its protocols.

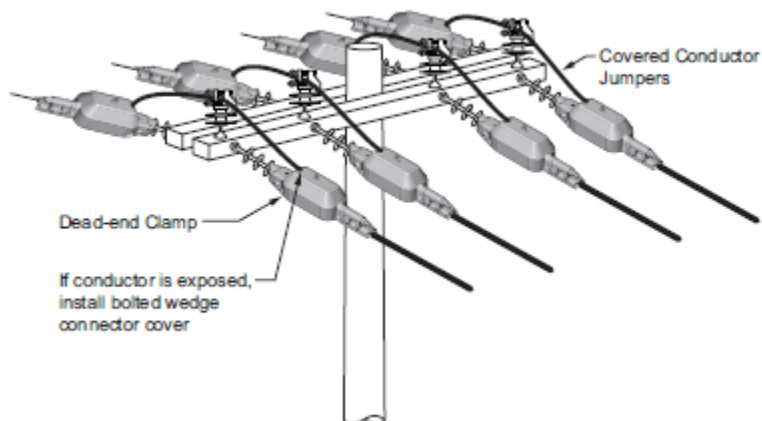
Figure CC 150-2: 4-Wire Covered Conductor Double Dead-end Construction

1. The body of the dead-end cover is commonly referred to as the Canoe. Proper installation of the canoe is when the opening at the bottom faces the ground indicated by the following photos: ⁹

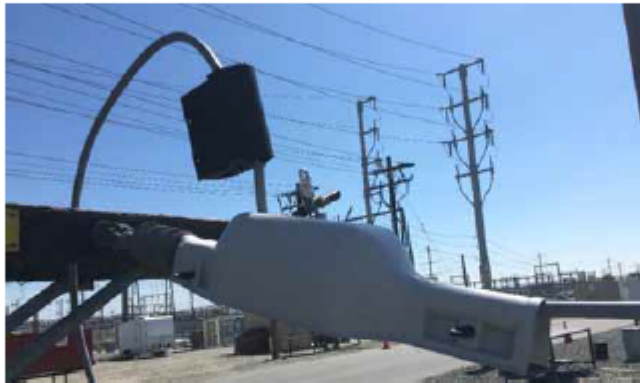
Figure CC 150-3: Connector Cover Installed at Dead-End Tap

Connectors shall be covered with an appropriately sized connector cover (see [DC 535](#)).
