NOTICE OF NON-PERFORMANCE

INSPECTION REPORT

Electrical Corporation:	Southern California Edison Company
Report Number:	PAD_SCE_YLO_20251119_1039_2
Inspector:	Yana Loginova
WMP Year Inspected:	2025
Quarterly Data Report (QDR) Referenced:	Quarter 2 (Q2)
Inspection Selection:	Energy Safety viewed the contents of the Q2 QDR and performed an analysis that resulted in the selection of the WMP initiatives and locations referenced in this report.
Relevant WMP Initiative(s):	8.1.3.1 - Distribution Detailed Inspections and Remediations (IN-1.1)
Date of inspection:	November 19, 2025
City and/or County of Inspection:	Calimesa, Riverside County
Inspection Purpose:	Assess the accuracy of Southern California Edison Company's QDR data, completeness of its work, and performance of requirements.

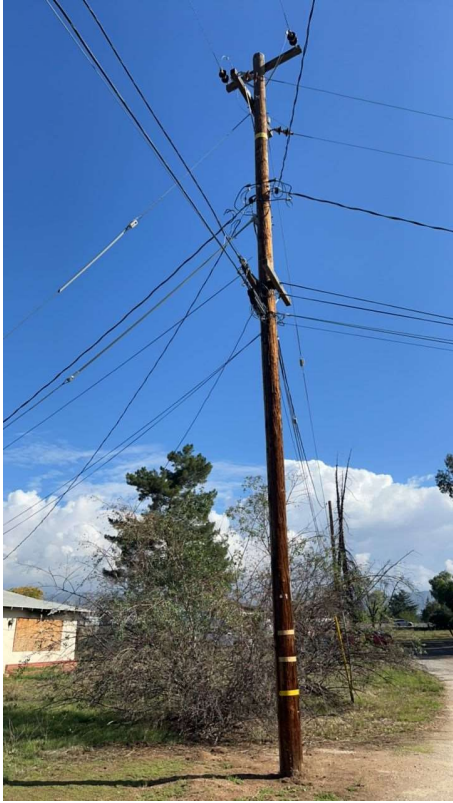
On Pole ID 2114637E, Grid Hardening ID 413113623-2114637E at 991 7th Pl, Calimesa, CA, 92320, USA, 34.001276074715, -117.065463685533, the inspector observed that a down guy was loose. The inspector's observation is documented in Deficiency 1 photographs, which are attachments to this report. Photo numbers IA1Img1, IA1Img2 and IA1Img3 depict a loose down guy.

1. Southern California Edison Company's 2025 WMP initiative number 8.1.3.1 Distribution Detailed Inspections and Remediations work identified that remediation of slack in down guys was complete at this location.
2. One down guy had slack during the inspection.

Deficiency 1. Energy Safety observed that in implementing 2025 WMP initiative 8.1.3.1 - Distribution High Fire Risk-Informed (HFRI) Inspections and Remediations (IN-1.1), SCE failed to complete the remediation of slack in down guys on Pole ID 2114637E, Grid Hardening ID 413113623-2114637E at coordinates 34.001276074715, -117.065463685533. Energy Safety considers this non-performance to be in the Minor risk category. SCE must complete corrective action for this deficiency by 12 months from date of this notice.¹
