## **NOTICE OF NON-PERFORMANCE**

# INSPECTION REPORT

Electrical Corporation:	PacifiCorp
Report Number:	PAD_PC_BKA_20251007_1414
Inspector:	Babak Kaviani
WMP Year Inspected:	2025
Quarterly Data Report (QDR) Referenced:	Quarter 2 (Q2)
Inspection Selection:	Energy Safety viewed the contents of the Q2 QDR and performed an analysis that resulted in the selection of the WMP initiatives and locations referenced in this report.
Relevant WMP Initiative(s):	8.1.2.12 – Expulsion Fuse Replacements
Date of Inspection:	October 7, 2025
City and/or County of Inspection:	Yreka, Siskiyou County
Inspection Purpose:	Assess the accuracy of PacifiCorp’s QDR data, completeness of its work, and performance of requirements.

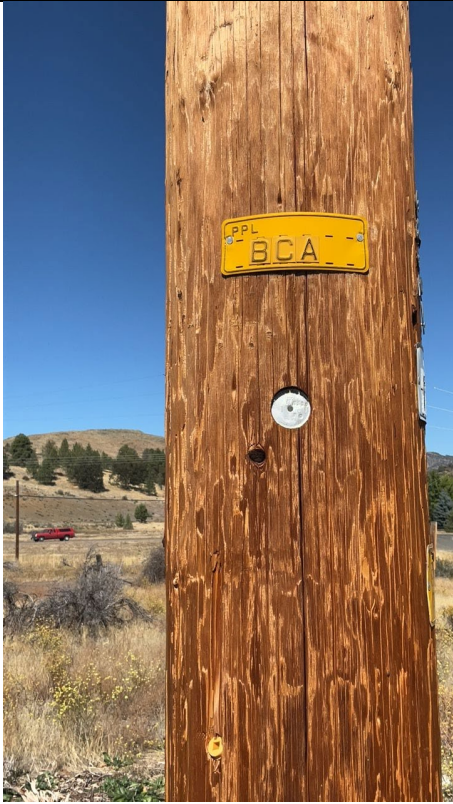
**G1mg3:** Structure ID

On Pole ID 20/7X, Grid Hardening ID 7112939 at 41.7383054840344, -122.615714, the inspector observed that CAL FIRE-approved non-expulsion fuses were not installed. The inspector's observation is documented in Deficiency 1 photographs, which are attachments to this report. Photo numbers IA1Img1, IA1Img2, IA1Img3, and IA1Img4 depict incomplete installation of CAL FIRE-approved non-expulsion fuses. In the 2025 Q2 Quarterly Data Report submission, PC reported that work on WMP initiative 8.1.2.12 – Expulsion Fuse Replacements were completed at this location.

1. CAL FIRE-approved non-expulsion fuses were not installed at the subject pole.
2. The inspector observed solid blade disconnects on the subject pole.
3. No reclosers, sectionalizers, or voltage regulators were observed at the subject pole.
