Final Independent Evaluator Annual Report
on Compliance

Bureau Veritas North America, Inc.
Horizon West Transmission, LLC

June 29, 2021

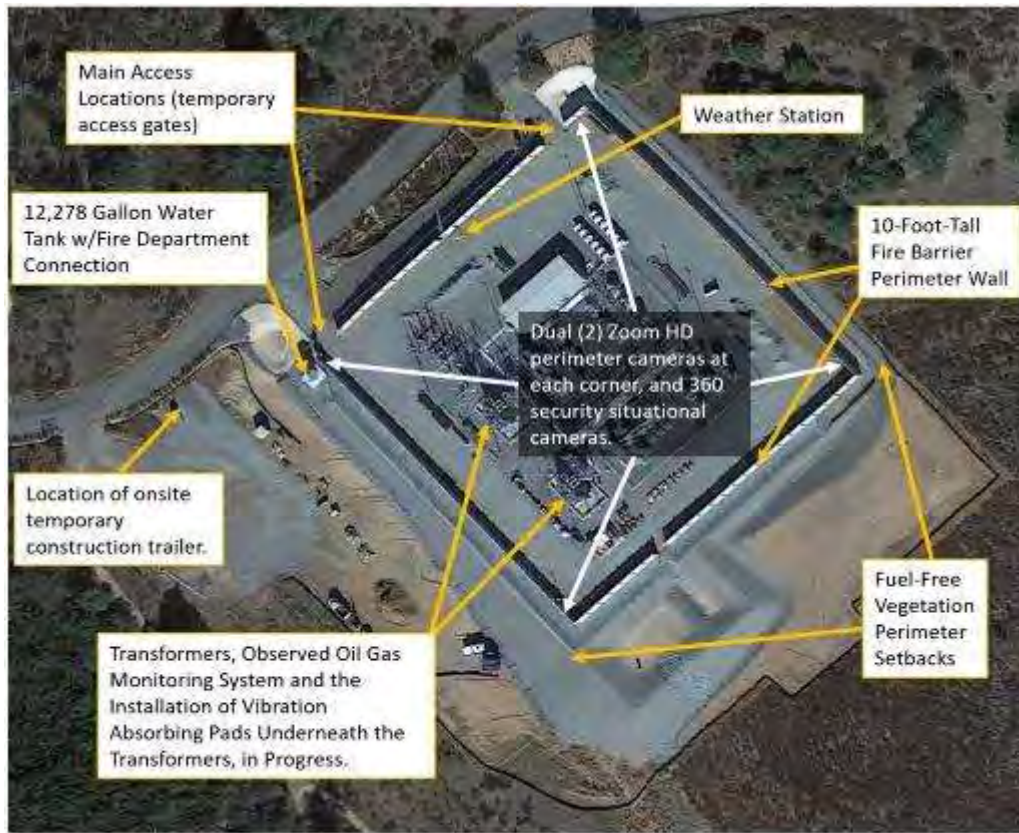
Figure 1. HWT Suncrest Facility Major Components

The following graphic represents the significant components currently being installed, or which are in the process of installation, at the Facility as relevant to 2020 WMP upgrades to be assessed for further evaluation:

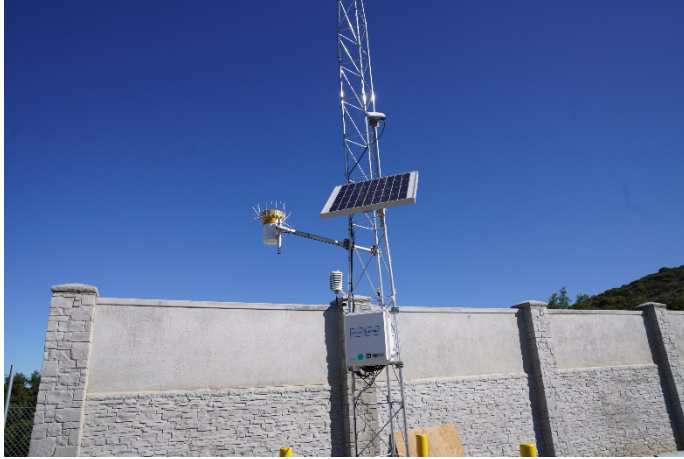
268 **Weather Station, Exterior, View North**

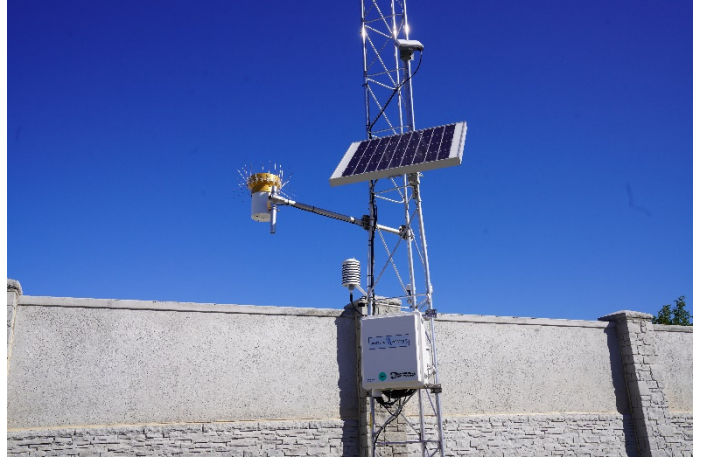
269 **Weather Station, Exterior, View North, Close up**

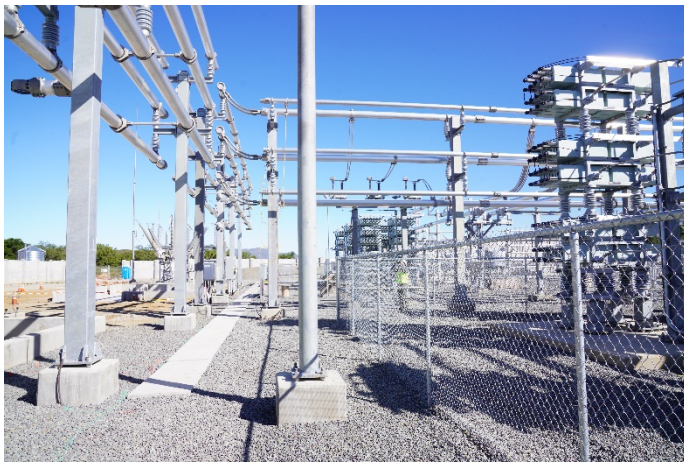
270 **Capacitor banks, View Northwest**

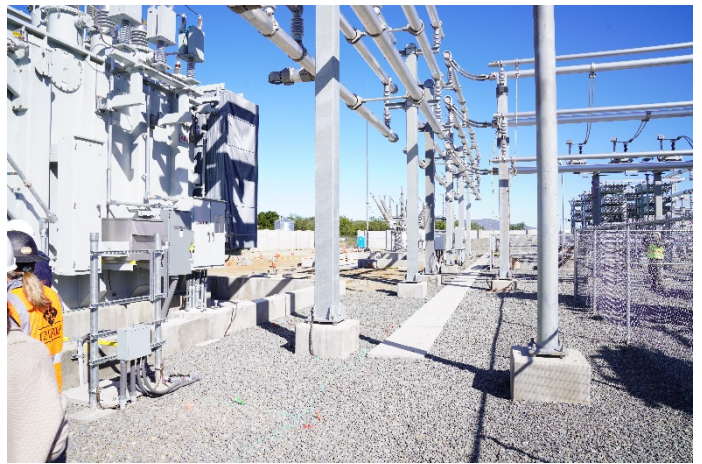
271 **Transformer and Capacitors banks, View Northwest**

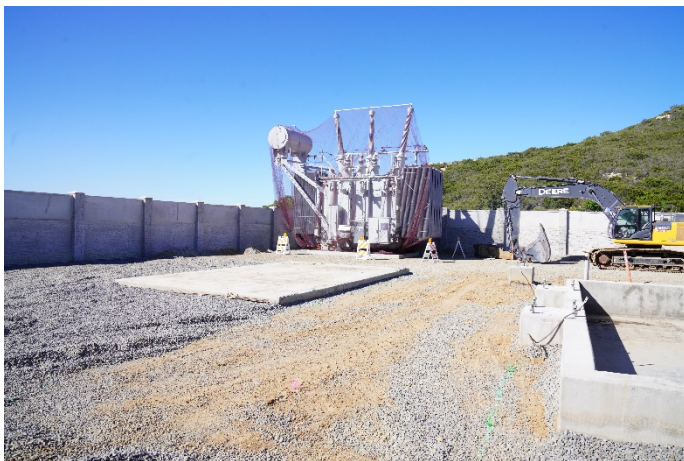
272 **Spare Tx under netting (500-kV) View Southwest**

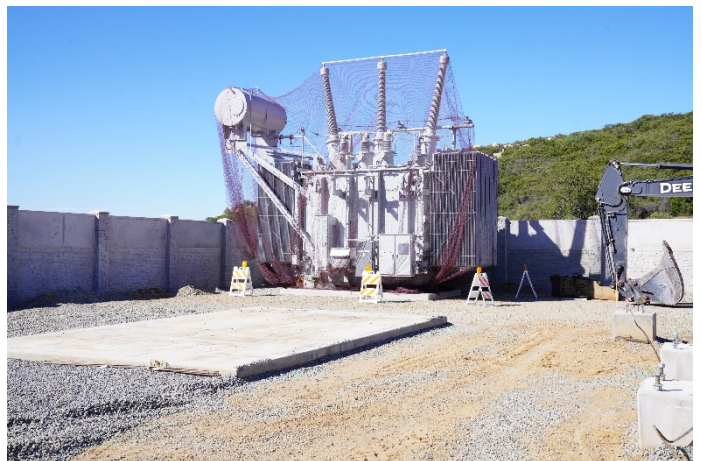
273 **Spare Tx under netting (500-kV) View Southwest, close up**

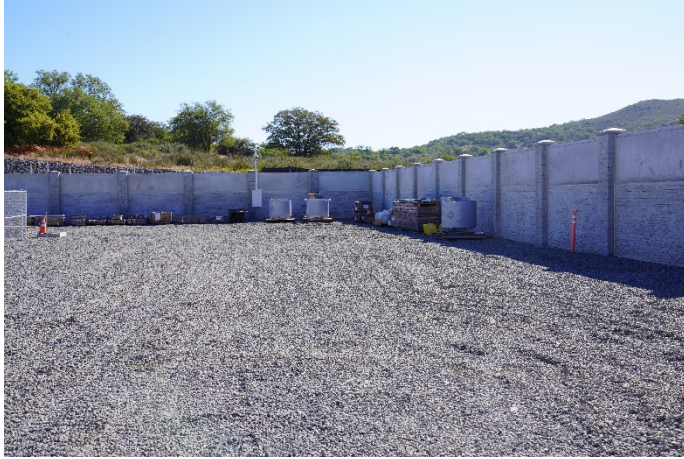
274 **Capacitor bank reactors, View North**

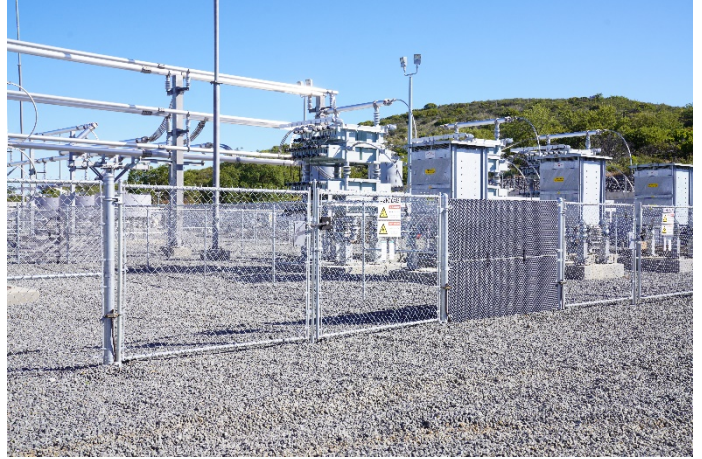
275 **Capacitor banks, View North**

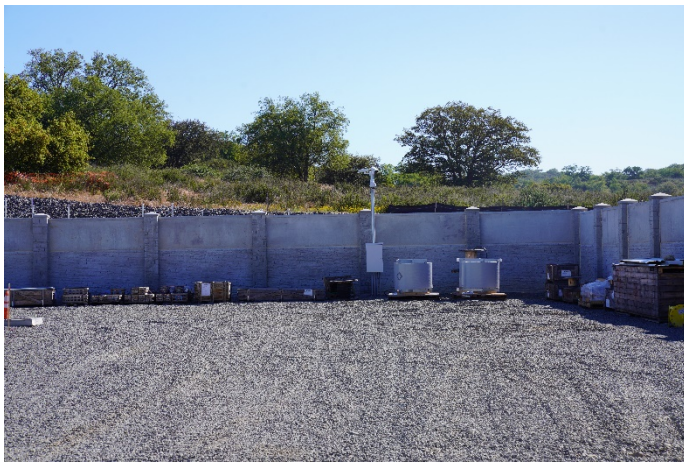
276 **Cameras, reactors, View South, close up**

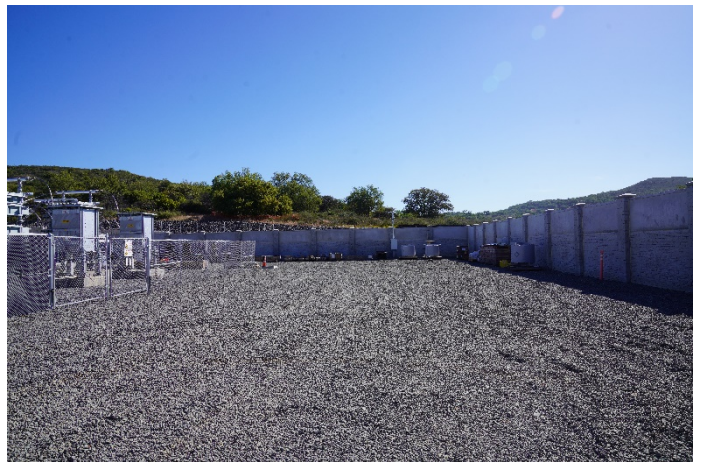
277 **Capacitors Reactors, View South, Wide view**

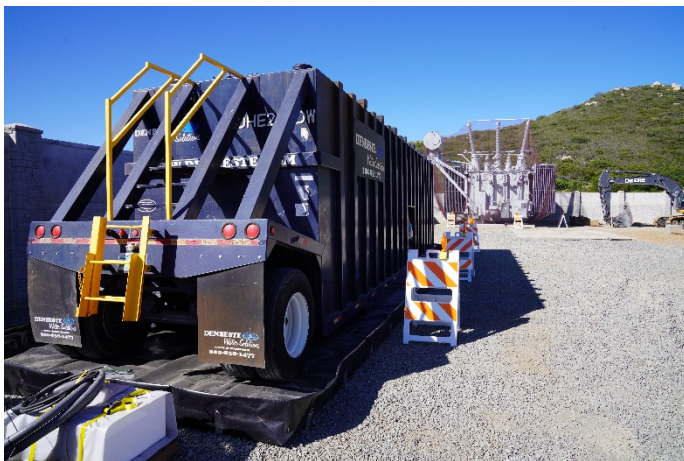
278 **Denbeste Water Solutions trailer, View Southwest**

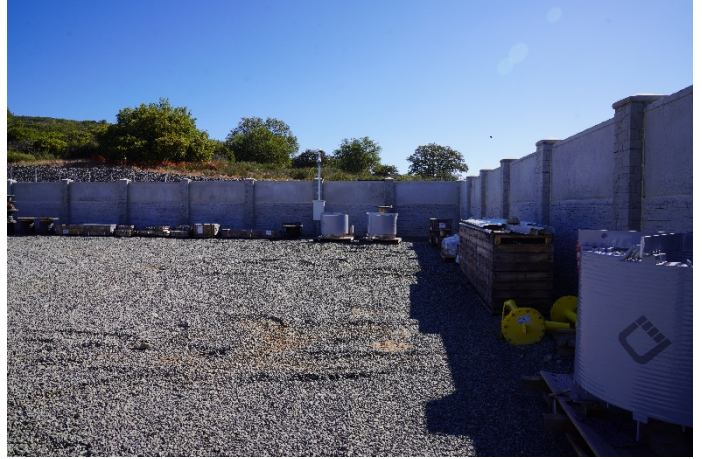
281 Capacitor bank reactors, View North

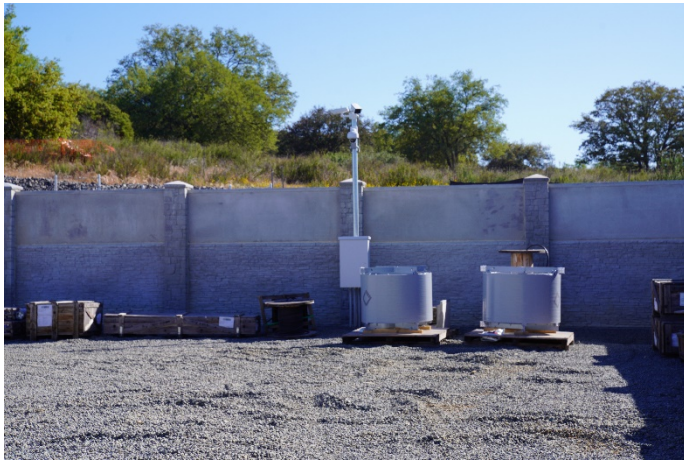
282 Cameras, reactors, View South, close up

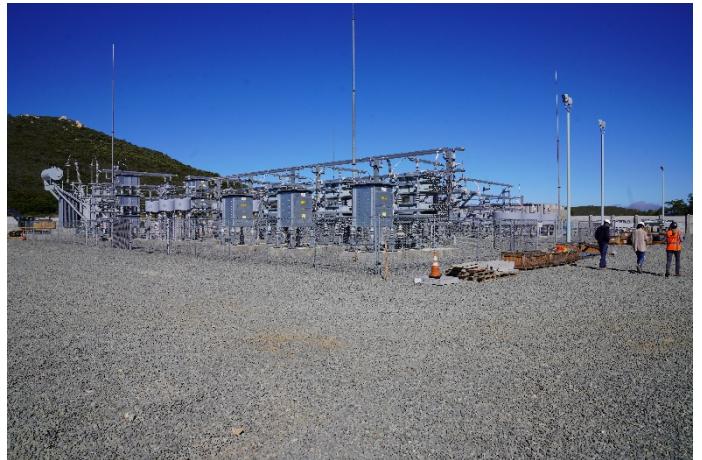
283 Tx, Reactors, Resistors, View Northwest

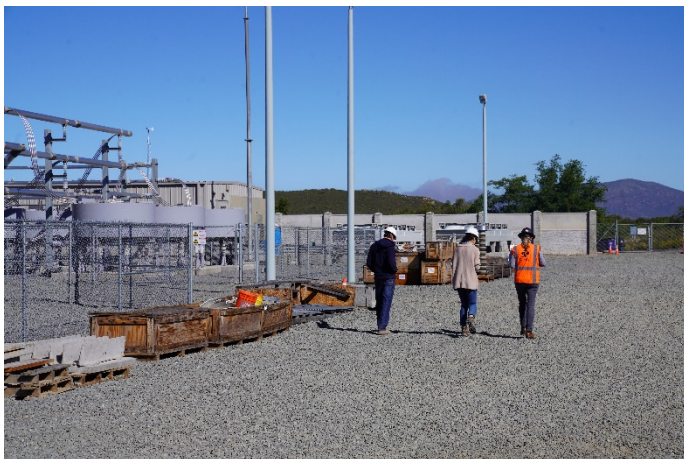
284 Reactors, Control Building, View North

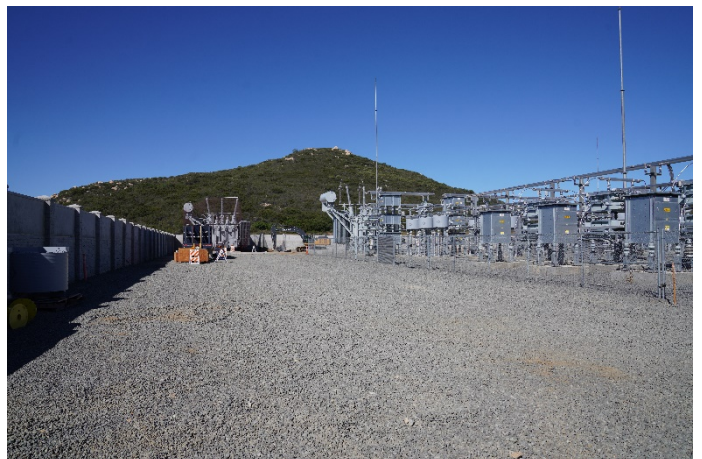
285 Tx, Reactors, Resistors, View West, Wide view

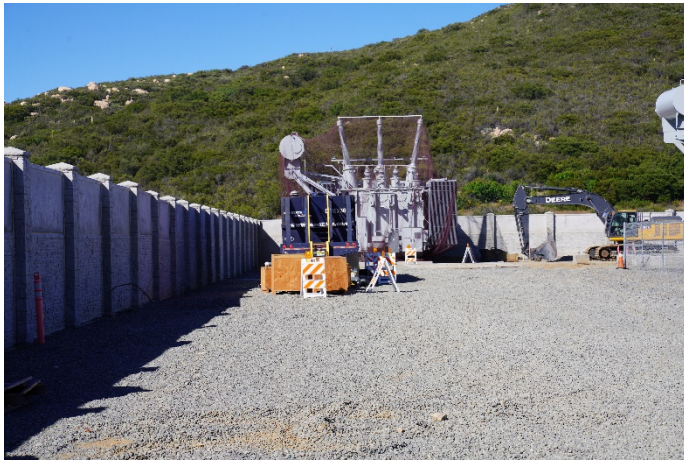
286 Denbeste trailer, Spare Tx, View West

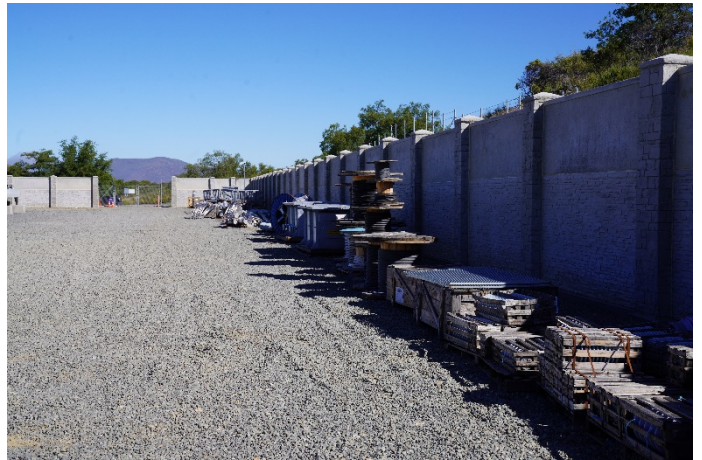
287 Interior East wall, View North

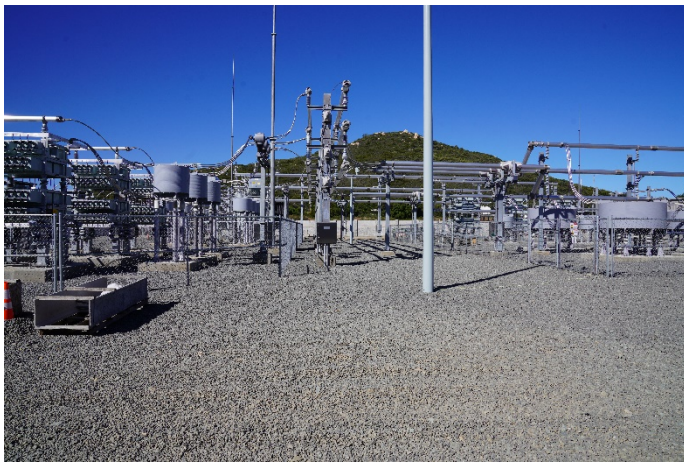
288 Capacitor banks & Reactors, Reactors

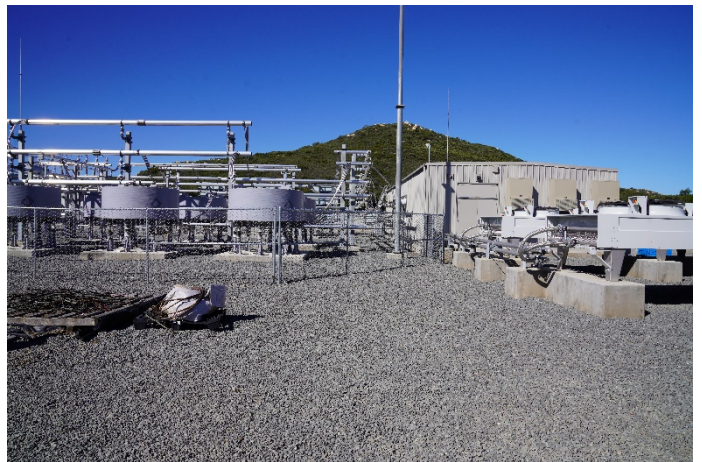
289 Reactors, Control House, View Southwest

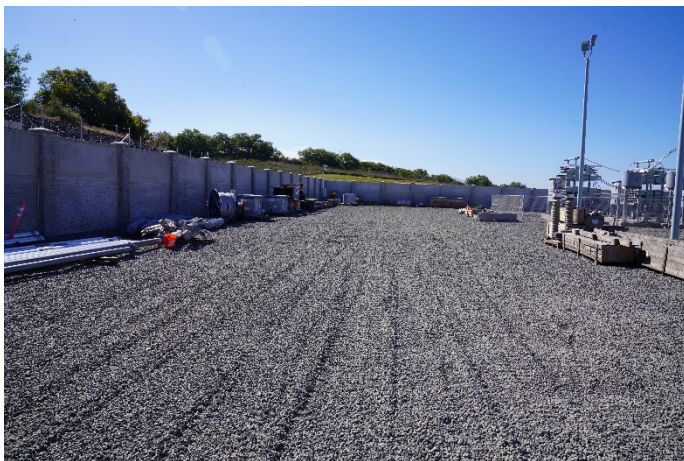
290 East Wall, Interior, View South

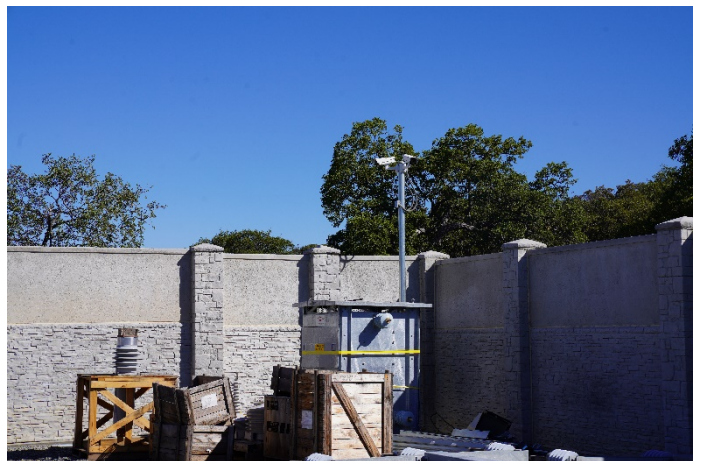
291 Cameras, Interior Northeast corner

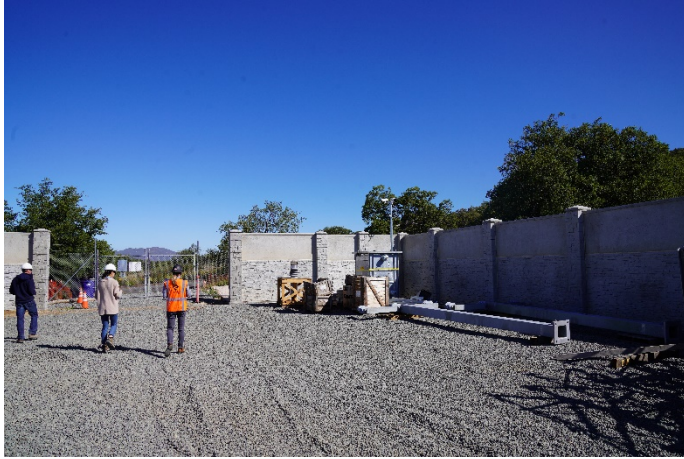
292 North Wall, Interior, Gate, View North

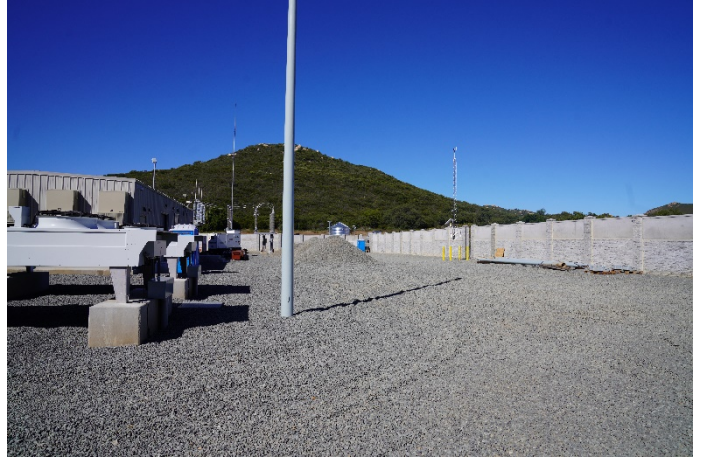
293 North Wall, Control House, View Southwest

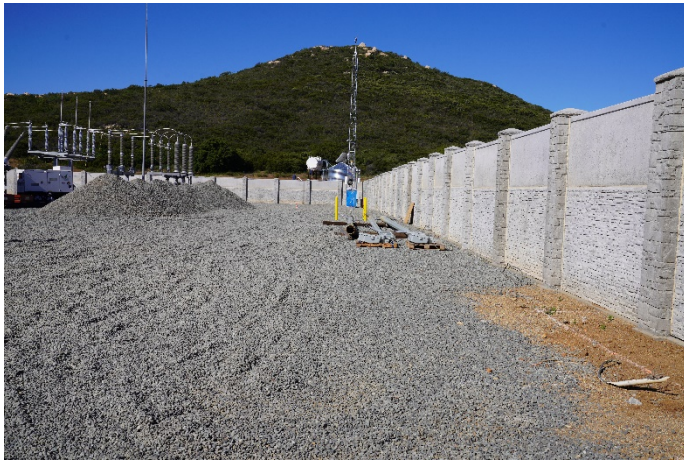
294 500-kV Cable risers, Interior North Wall, View West

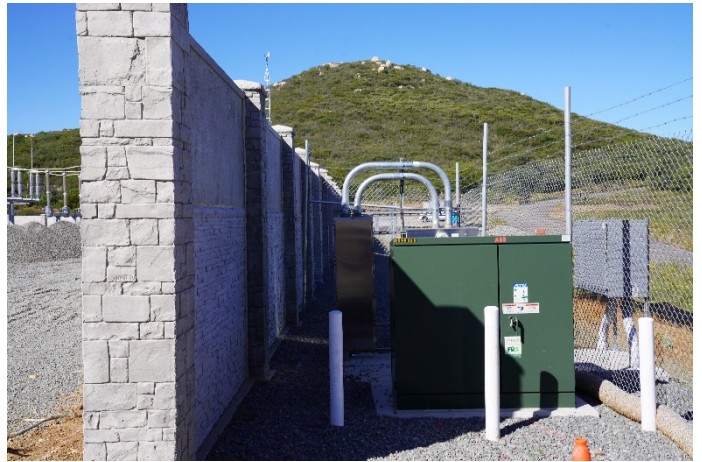
295 North Wall, Exterior, Station transformers, View West

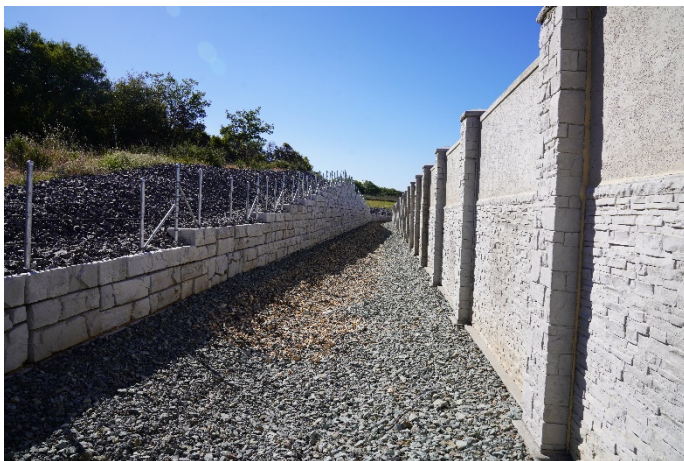
296 East Wall, Exterior, View South

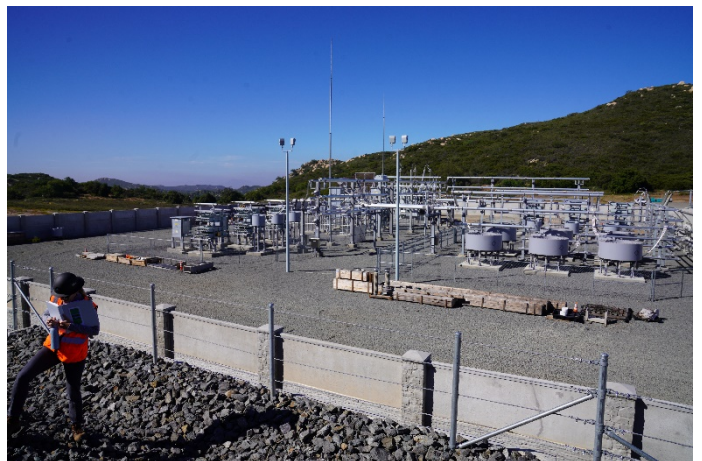
297 Reactors, Capacitor banks, Elevated view West

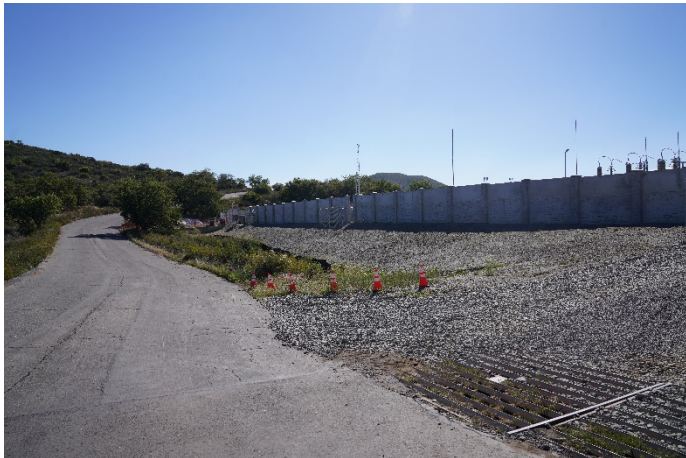
302 West Wall, Exterior, View East

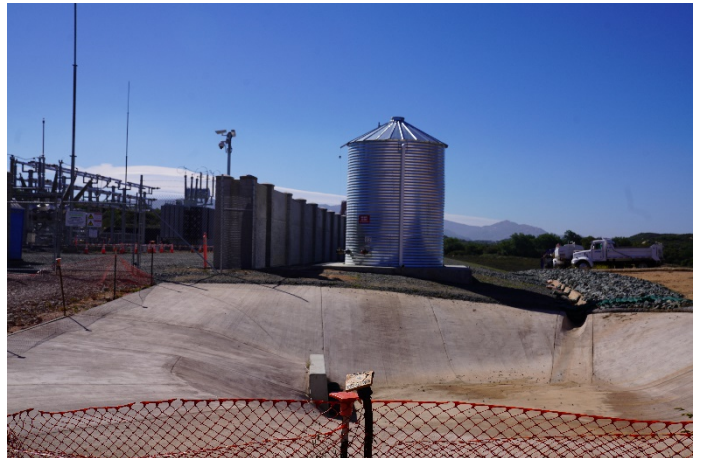
303 Fire Department Water Tank, West, Exterior, View South

HWT provided a Fire Protection Plan accepted and approved by San Diego County Fire Authority (SDCFA). An item that was not identified as installing a 12,278-gallon water storage tank with a concrete foundation is installed at the substation's northwest corner. The local Fire Authority Having Jurisdiction has reviewed the installation of the tank - see Photo 3 of this assessment.

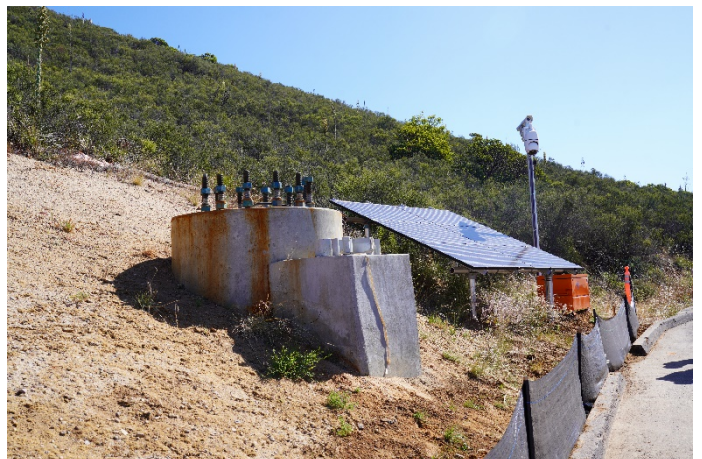
325 Foundation for single steel pole, security camera

Exterior to the Facility, it was observed that a small ground photovoltaic array that supports an exterior camera has approximately 3 feet of dry vegetation directly below the array as demonstrated in Figure 7 and requires fuel mitigation.

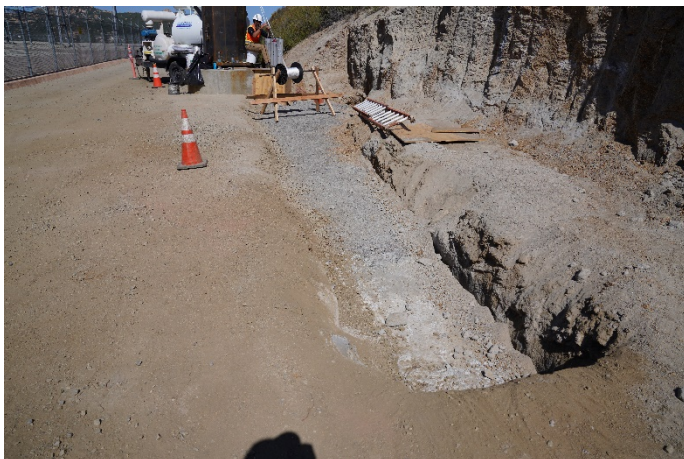
344 Steel riser pole base with worker installing pull cord in conduit, concrete covered trench

At the time of the field visit, the new 230 kV cable pole, immediately adjacent to the substation fence, was installed, and the trench and conduit work to the new cable pole. The original cable pole has been removed, and its foundation is intact, as well as the mast-mounted camera and ground-mounted solar panel and control box. A construction crew was onsite performing tasks to prepare for cable installation for the new underground section.
