NOTICE OF VIOLATION

Energy Safety Inspection Report

Report Name: ATJ_SCE_20211207-01

Utility: Southern California Edison

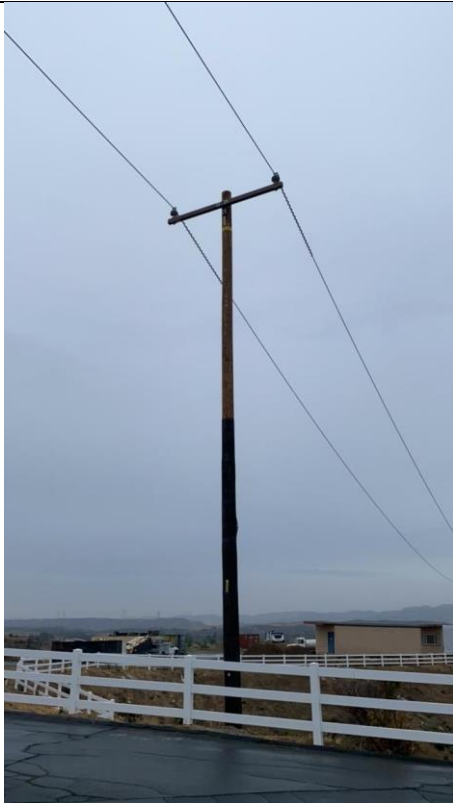
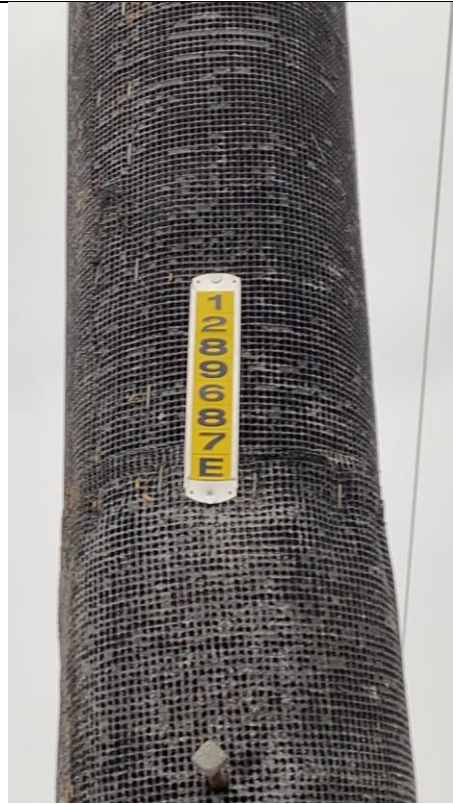
Structure ID: 1289687E

Item	Structure ID	HFTD	Initiative Number	Violation Type	Severity	Violation Description
1	1289686E	Tier 2	7.3.3.3.1	Data Accuracy	Minor	Wrong pole ID provided. Provided pole ID is 1289686E. Actual pole ID is 4941451E
2	4467330E	Tier 2	7.3.3.3.1	Data Accuracy	Minor	Pole submitted to Energy Safety as covered conductor work completed. Covered conductor not installed at this pole. Covered conductor starts at next pole
3	4556899E	Tier 2	7.3.3.3.1	Adherence to Protocol	Minor	Failure to install vibration dampers on a span
4	4554799E	Tier 2	7.3.3.3.1	Adherence to Protocol	Minor	Failure to install vibration dampers on a span
5	4554798E	Tier 2	7.3.3.3.1	Adherence to Protocol	Minor	Failure to install vibration dampers on a span
6	4554796E	Tier 2	7.3.3.3.1	Adherence to Protocol	Minor	Failure to install vibration dampers on a span
7	4554794E	Tier 2	7.3.3.3.1	Adherence to Protocol	Minor	Failure to install vibration dampers on a span

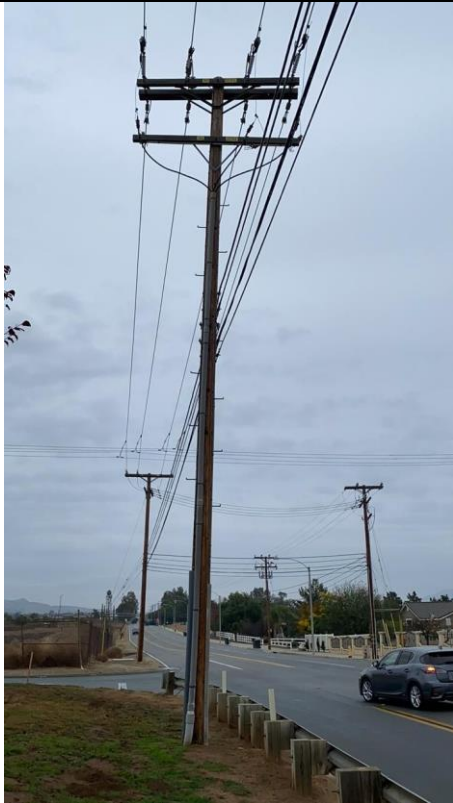
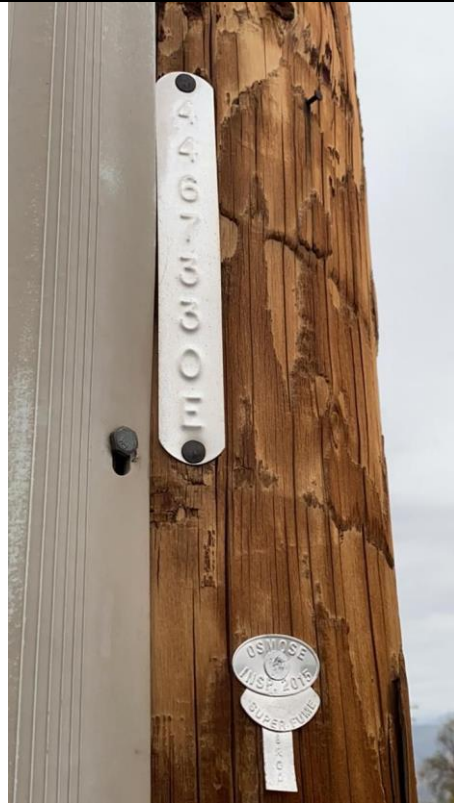
Structure ID: 4467330E

1. Violation 1: Per SCE’s 2021-Q1 quarterly data report (QDR), covered conductor was installed on pole 4467330E. This structure was reported in covered conductor initiative (2021 WMP initiative number 7.3.3.3.1) with a status of “complete.” However, upon inspection, SCE did not install covered conductor at this pole. Covered conductor work starts at next pole. Energy Safety considers this data accuracy violation to be in the Minor risk category.
2. Violation 2: At poles numbered 1289686E, 1789149E, and 4475177E the pole ID did not match the ID provided by SCE in its QDR spatial data. Energy Safety considers this data accuracy violation to be in the Minor risk category.
3. Violation 3: Per SCE’s Distribution Design Standards (DDS), section DDS-10, page 10-82, “for the 336 (30/7) ACSR covered conductor, vibration dampers shall be installed on every

span in both light loading and heavy loading areas.” SCE’s Distribution Overhead Construction Standards (DOH), section CC 190, page 1 of 11, indicates vibration dampers are required when installing covered conductor. Poles numbered 4556899E, 4554785E, 4554799E, 4554798E, 4554796E, 4554794E, 4545339E, 4554790E, 4554788E, 4554787E, 1026956E, 1407366E, 1789149E, and 4475177E had covered conductor installed but failed to install vibration dampers. Energy Safety considers this violation for failure of adhering to protocol to be in the Minor risk category.

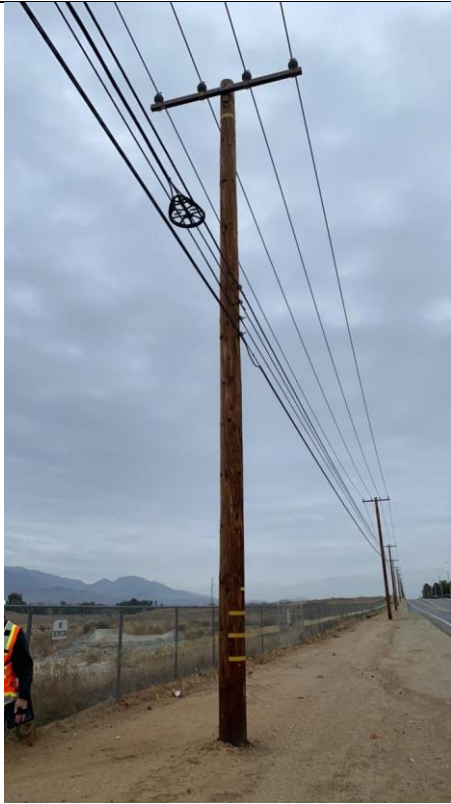
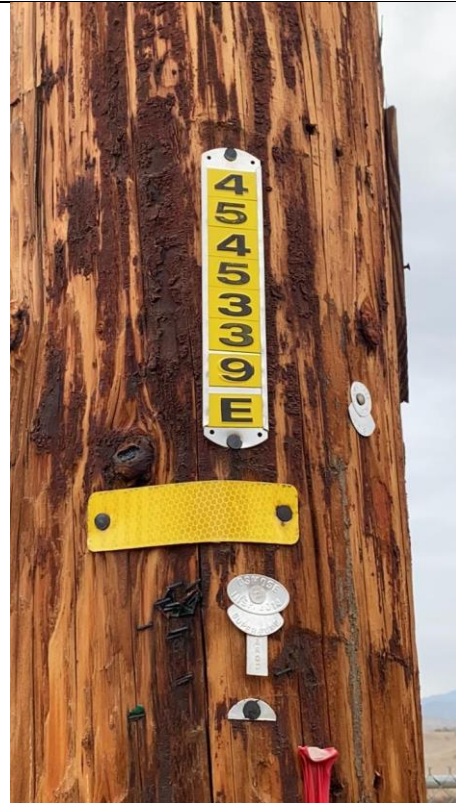
Structure ID: 4545339E

8	4545339E	Tier 2	7.3.3.3.1	Adherence to Protocol	Minor	Failure to install vibration dampers on a span
9	4554790E	Tier 2	7.3.3.3.1	Adherence to Protocol	Minor	Failure to install vibration dampers on a span
10	4554788E	Tier 2	7.3.3.3.1	Adherence to Protocol	Minor	Failure to install vibration dampers on a span
11	4554787E	Tier 2	7.3.3.3.1	Adherence to Protocol	Minor	Failure to install vibration dampers on a span
12	4554787E	Tier 2	7.3.3.3.1	Completeness	Minor	Failure to remove guy anchor
13	4554785E	Tier 2	7.3.3.3.1	Adherence to Protocol	Minor	Failure to install vibration dampers on a span

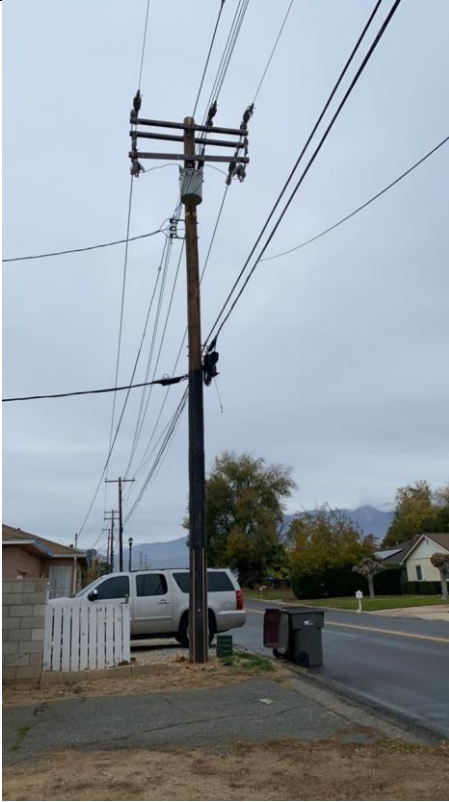
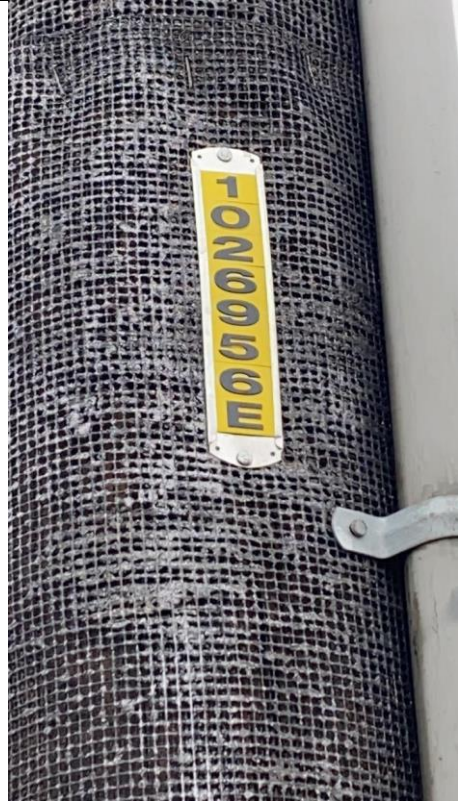
Structure ID: 1026956E

Item	Structure ID	HFTD	Initiative Number	Violation Type	Severity	Violation Description
14	1026956E	Non-HFTD	7.3.3.3.1	Adherence to Protocol	Minor	Failure to install vibration dampers on a span
15	1407366E	Non-HFTD	7.3.3.3.1	Adherence to Protocol	Minor	Failure to install vibration dampers on a span
16	1789149E	Tier 2	7.3.3.3.1	Data Accuracy	Minor	Wrong Pole ID reported. Provided pole ID is 1789149E. Actual pole ID is 4775181E
17	1789149E	Tier 2	7.3.3.3.1	Adherence to Protocol	Minor	Failure to install vibration dampers on a span
18	1789149E	Tier 2	7.3.3.3.1	Adherence to Protocol	Minor	Covered conductor covering is frayed
19	1789149E	Tier 2	7.3.3.3.1	Adherence to Protocol	Minor	Loose dead-end clamp
20	4475177E	Non-HFTD	7.3.3.3.1	Adherence to Protocol	Minor	Failure to install vibration dampers on a span
21	4475177E	Non-HFTD	7.3.3.3.1	Data Accuracy	Minor	Wrong Pole ID reported. Provided pole ID is 4475177E. Actual pole ID is 4775177E

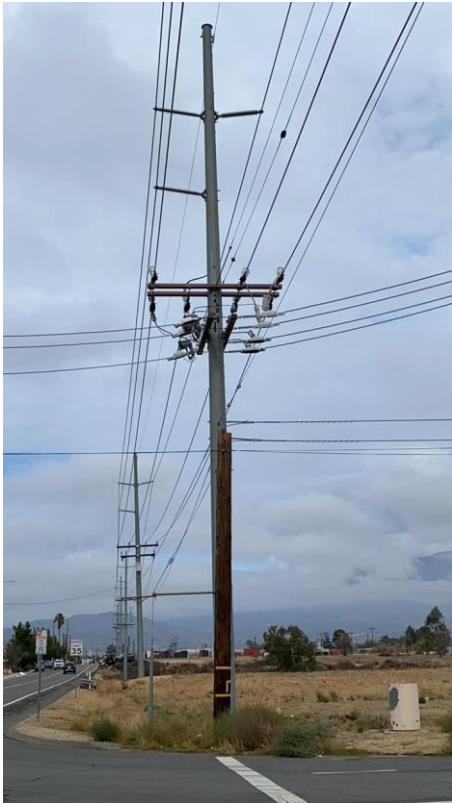
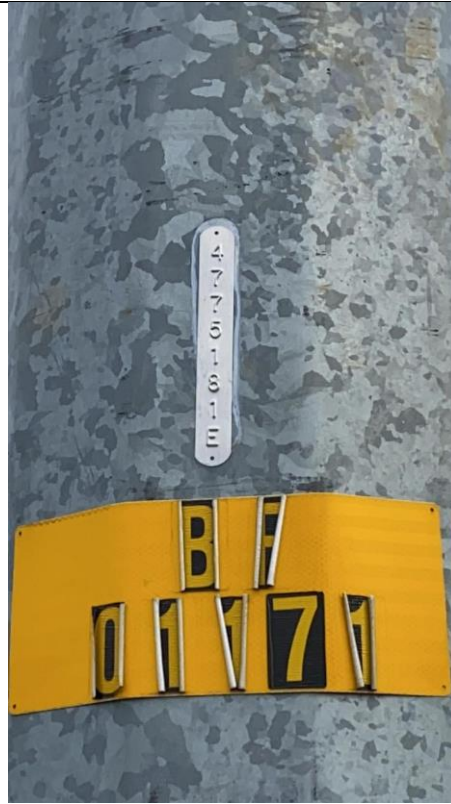
Structure ID: 1789149E

Energy Safety discovered a dead-end clamp that was loosely attached to the covered conductor. Per SCE DOH, "Dead-ends shall be covered with a dead-end clamp in covered conductor systems. Covering dead-ends will ensure that stripped portions of the covered conductor at the dead-end will be protected from contact that could lead to phase-to-phase or phase-to-ground faults."³ The structure where this violation was observed is noted in Table 2 above.

Item16IA4Img1: Loose dead-end clamp

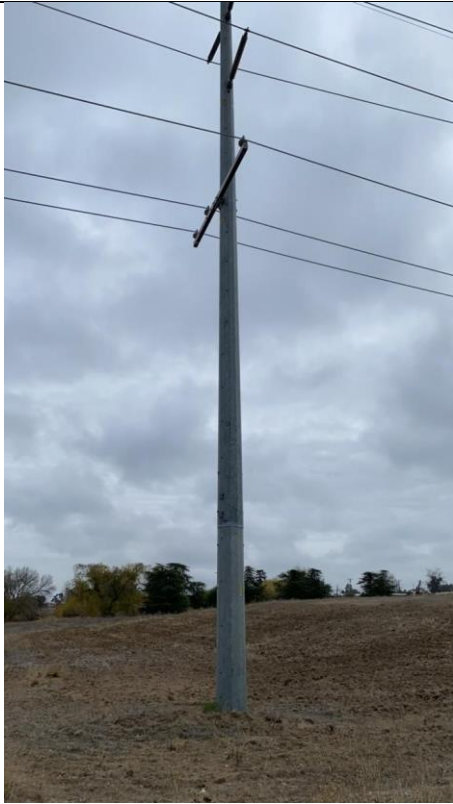
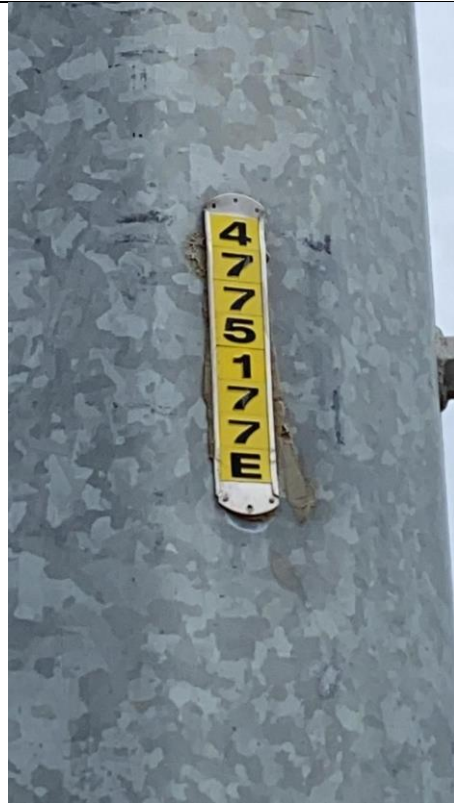
Structure ID: 4475177E

Item17IA1mg1: No vibration dampers
