NOV_SCE_ATJ_ 20211209-01

NOTICE OF VIOLATION

Energy Safety Inspection Report

Report Name: ATJ_SCE_20211209-01

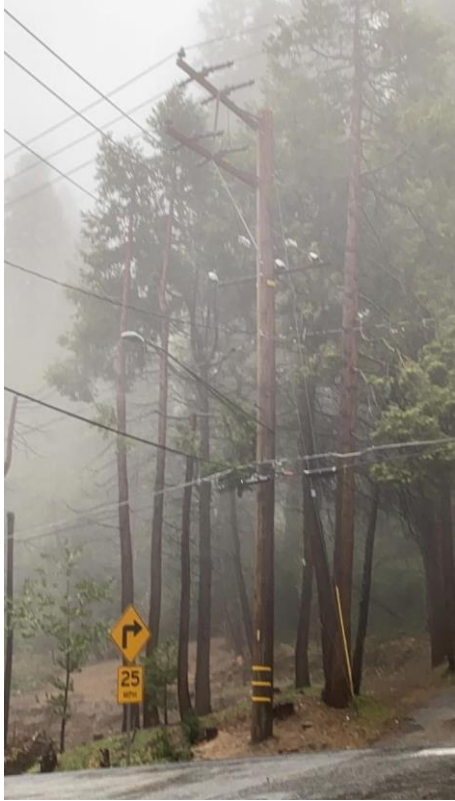
| <p>Item1Gimg1: Overall pole</p> | <p>Item1Gimg2: Pole ID</p> |

| Item | Structure ID | HFTD | Initiative Number | Violation Type | Severity | Violation Description |
|---|---|---|---|---|---|---|
| 2 | 687838E | Tier 3 | 7.3.3.3.1 | Completeness | Moderate | Failure to install covered conductor |

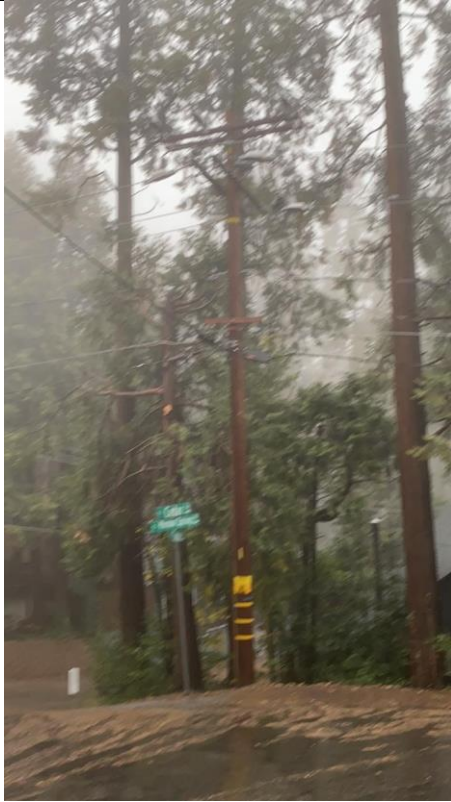
Item3GImg1: Overall pole

| Item | Structure ID | HFTD | Initiative Number | Violation Type | Severity | Violation Description |
|---|---|---|---|---|---|---|
| 3 | 4931111E | Tier 3 | 7.3.3.3.1 | Adherence to Protocol | Minor | Failure to install vibration dampers on a span |
| 4 | 4931111E | Tier 3 | 7.3.3.3.1 | Adherence to Protocol | Minor | Improperly installed fuse cover |
| 5 | 4931111E | Tier 3 | 7.3.3.3.1 | Adherence to Protocol | Minor | Failure to install fiberglass guy strain insulator |
| 6 | 4931111E | Tier 3 | 7.3.3.3.1 | Adherence to Protocol | Minor | Failure to install bolted wedge connector cover on center phase |

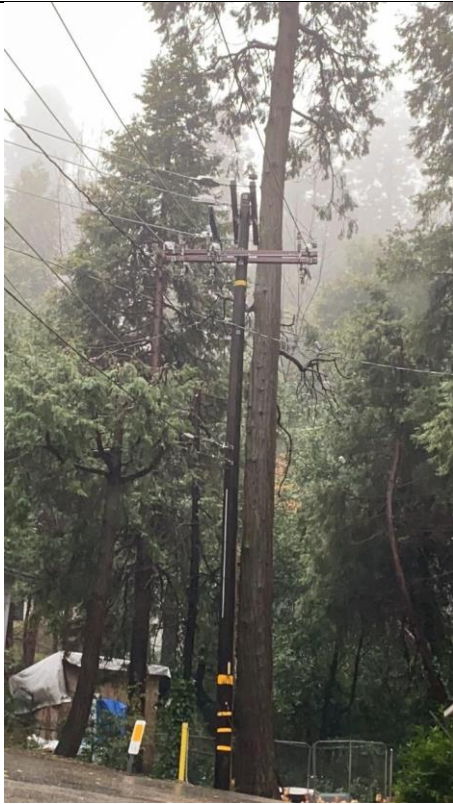
Item4GImg1: Overall pole

| Item | Structure ID | HFTD | Initiative Number | Violation Type | Severity | Violation Description |
|---|---|---|---|---|---|---|
| 8 | F16868Y | Tier 3 | 7.3.3.3.1 | Adherence to Protocol | Minor | Failure to install vibration dampers on a span |
| 9 | F16868Y | Tier 3 | 7.3.3.3.1 | Adherence to Protocol | Minor | Failure to install fiberglass guy strain insulator |

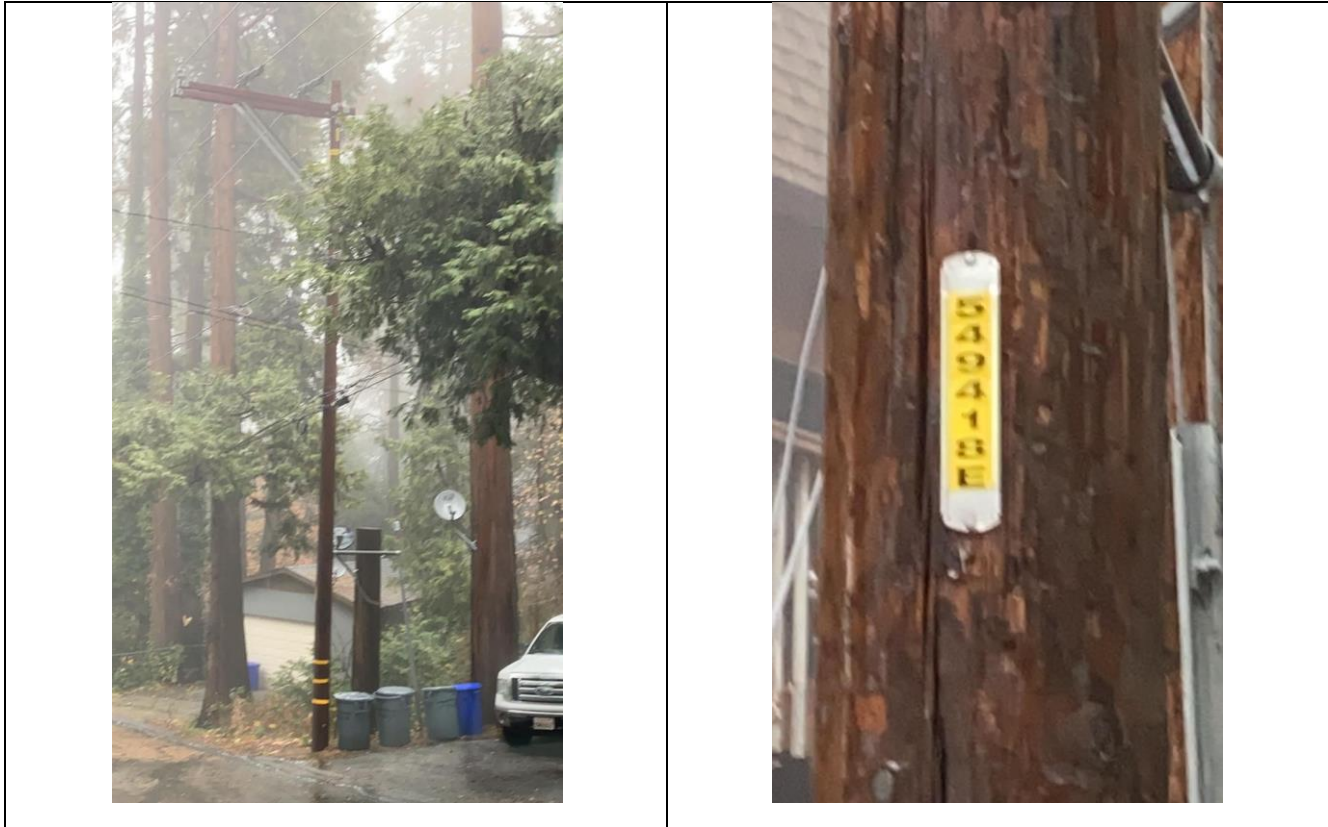
Item5GImg1: Overall pole

| Item | Structure ID | HFTD | Initiative Number | Violation Type | Severity | Violation Description |
|---|---|---|---|---|---|---|
| 12 | 549418E | Tier 3 | 7.3.3.3.1 | Adherence to Protocol | Minor | Failure to install vibration dampers on a span |
| 13 | 549418E | Tier 3 | 7.3.3.3.1 | Adherence to Protocol | Minor | Failure to install fiberglass guy strain insulator |

| Item | Structure ID | HFTD | Initiative Number | Violation Type | Severity | Violation Description |
|---|---|---|---|---|---|--|
| 14 | 549418E | Tier 3 | 7.3.3.3.1 | Adherence to Protocol | Minor | Failure to install vice top polymer pin type insulators |

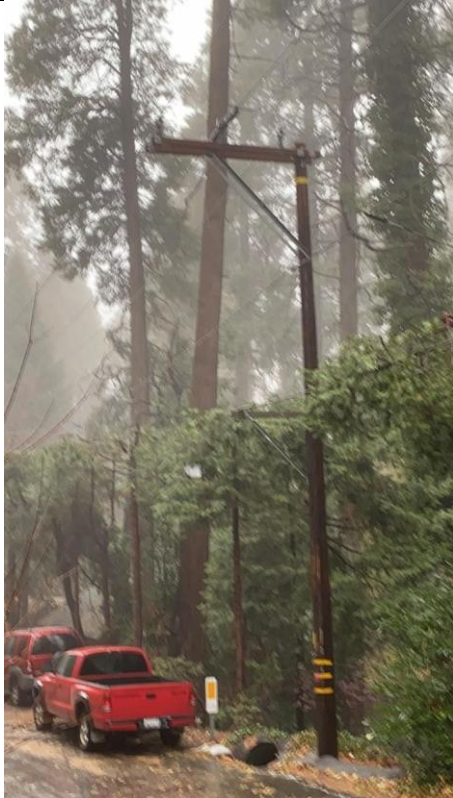
| Item6GImg1: Overall pole | Item6GImg2: Pole ID |

| Item | Structure ID | HFTD | Initiative Number | Violation Type | Severity | Violation Description |
|---|---|---|---|---|---|--|
| 15 | 4421488E | Tier 3 | 7.3.3.3.1 | Adherence to Protocol | Minor | Failure to install vibration dampers on a span |
| 16 | 4421488E | Tier 3 | 7.3.3.3.1 | Adherence to Protocol | Minor | Failure to install vice top polymer pin type insulators with nylon inserts |

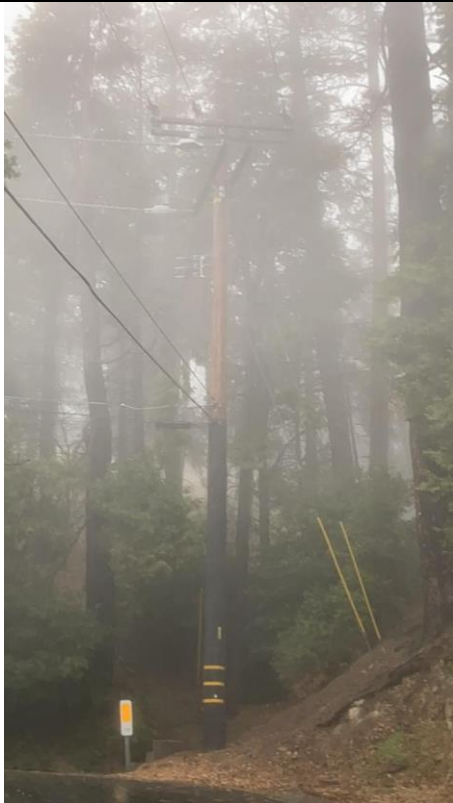
Item8GImg1: Overall pole

| Item | Structure ID | HFTD | Initiative Number | Violation Type | Severity | Violation Description |
|---|---|---|---|---|---|--|
| 18 | 1403136E | Tier 3 | 7.3.3.3.1 | Completeness | Moderate | Failure to install covered conductor |

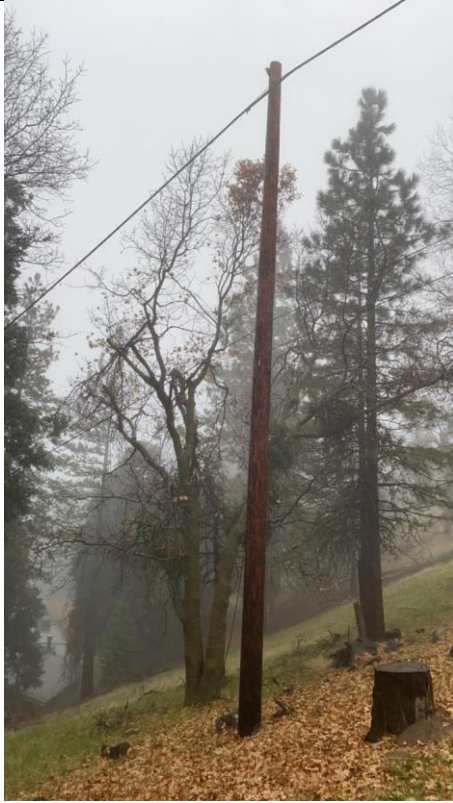
Item9GImg1: Overall pole

| Item | Structure ID | HFTD | Initiative Number | Violation Type | Severity | Violation Description |
|---|---|---|---|---|---|--|
| 20 | 4558869E | Tier 3 | 7.3.3.3.1 | Completeness | Moderate | Failure to install cover conductor |

| Item | Structure ID | HFTD | Defect Type | Severity | Defect Description |
|---|---|---|--|---|--|
| 2 | 4558869E | Tier 3 | Conductor frayed or broken strands | Minor | Conductor strands are broken |

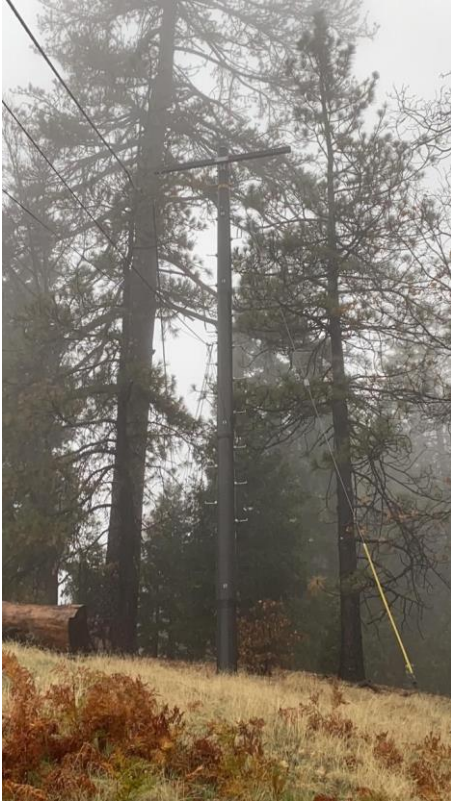
Item10GImg1: Overall pole

| Item | Structure ID | HFTD | Initiative Number | Violation Type | Severity | Violation Description |
|---|---|---|---|---|---|--|
| 22 | 1763105E | Tier 3 | 7.3.3.3.1 | Completeness | Moderate | Failure to install cover conductor |

| Item | Structure ID | HFTD | Defect Type | Severity | Defect Description |
|---|---|---|--|---|--|
| 3 | 1763105E | Tier 3 | Conductor frayed or broken strands | Minor | Conductor strands are broken |

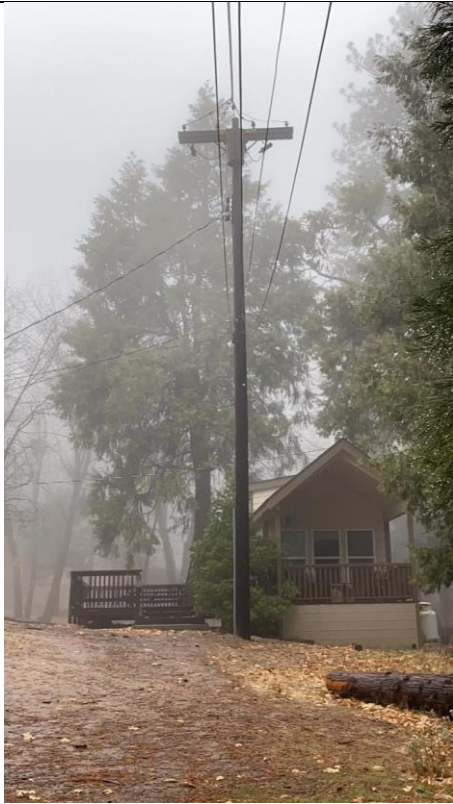
Item11GImg1: Overall pole

| Item | Structure ID | HFTD | Initiative Number | Violation Type | Severity | Violation Description |
|---|---|---|---|---|---|--|
| 24 | 1414393E | Tier 3 | 7.3.3.3.1 | Completeness | Moderate | Failure to install covered conductor |
