NOD_SCE_ATJ_20211118-01

NOTICE OF DEFECT

Energy Safety Inspection Report

Report Name: SCE_ ATJ_20211118-01
Inspection Date(s): November 18, 2021
Inspector: Anthony Trujillo
Utility: Southern California Edison
Attention: Erik Takayesu, Vice President Asset Strategy and Planning

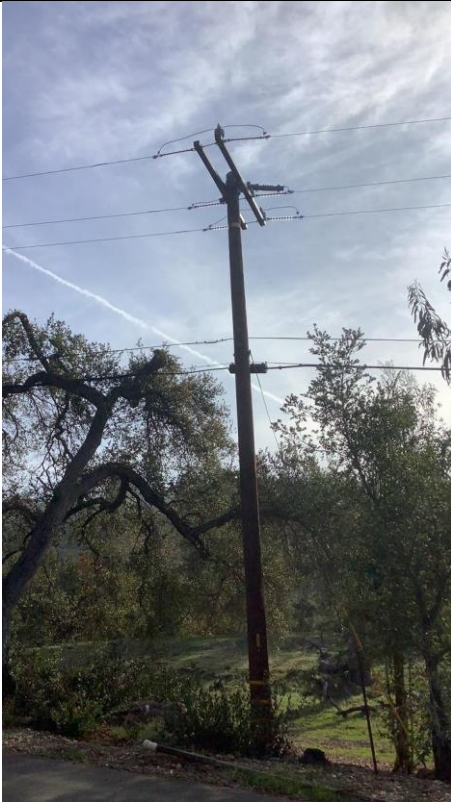
Item1Gimg1: Overall Pole

1. Defect 1: Poles numbered 4339409E and 4926384E had loose guy wires. The primary purpose of a guy wire is to provide stability to a structure (e.g., a pole) where imbalanced loads are present. To provide this stability a guy wire must be maintained taut. A loose guy wire increases the risk of structure failure and potential ignition under adverse weather conditions, as the guy wire can no longer serve its intended purpose of balancing an imbalanced load. Energy Safety considers this defect to be in the Minor risk category.

Structure ID: 4339409E

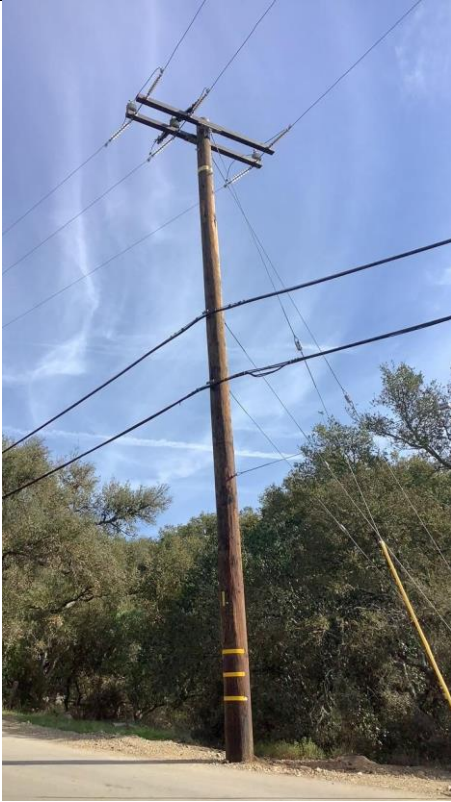
Item4GImg1: Overall pole

Structure ID: 4926384E

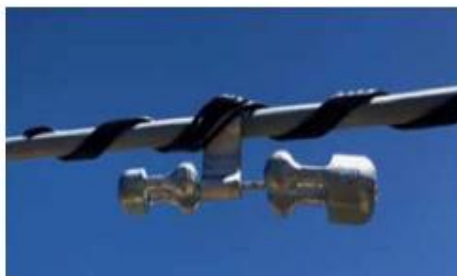
Figure 1: Stockbridge Damper

Installing vibration dampers on the covered conductor mitigates Aeolian vibration by protecting the covered conductor from abrasion and fatigue damage. The vibration damper standard was put into effect in October 2020 and is required for all covered conductors in light loading areas (elevation below 3,000 feet). Recently, SCE has been experiencing an acute shortage of Stockbridge Dampers (refer to Figure 1) for 336 ACSR Covered Conductor due to the high demand and supplier constraints. Additionally, the spiral vibration dampers (refer to Figure 2) for 1/0 ACSR, #2 Copper, and 2/0 Copper may be running low on stock.
